### **CONSOLIDATED SEWER MAINTENANCE DISTRICT CONDITION-ASSESSMENT PROGRAM REPORT PROJECT NO. Y0TV1415B**

**CONDITION-ASSESSMENT REPORT  
LOS ANGELES COUNTY PUBLIC WORKS  
CONSOLIDATED SEWER MAINTENANCE DISTRICT**

PROJECT NAME:	Y0TV1415B	PROJECT MGR:	Eric Liu
PROJECT DATE:	4/27/2016	CONTACT NO:	(626) 300-3369
SUP. DISTRICT(s):	4	MAP PAGE(S):	2348, 2349, 2350, 2389, 2390, 2391, 2392, 2432, 2433, 2434
Report By:	Eric Liu	Report Date:	08/26/2019

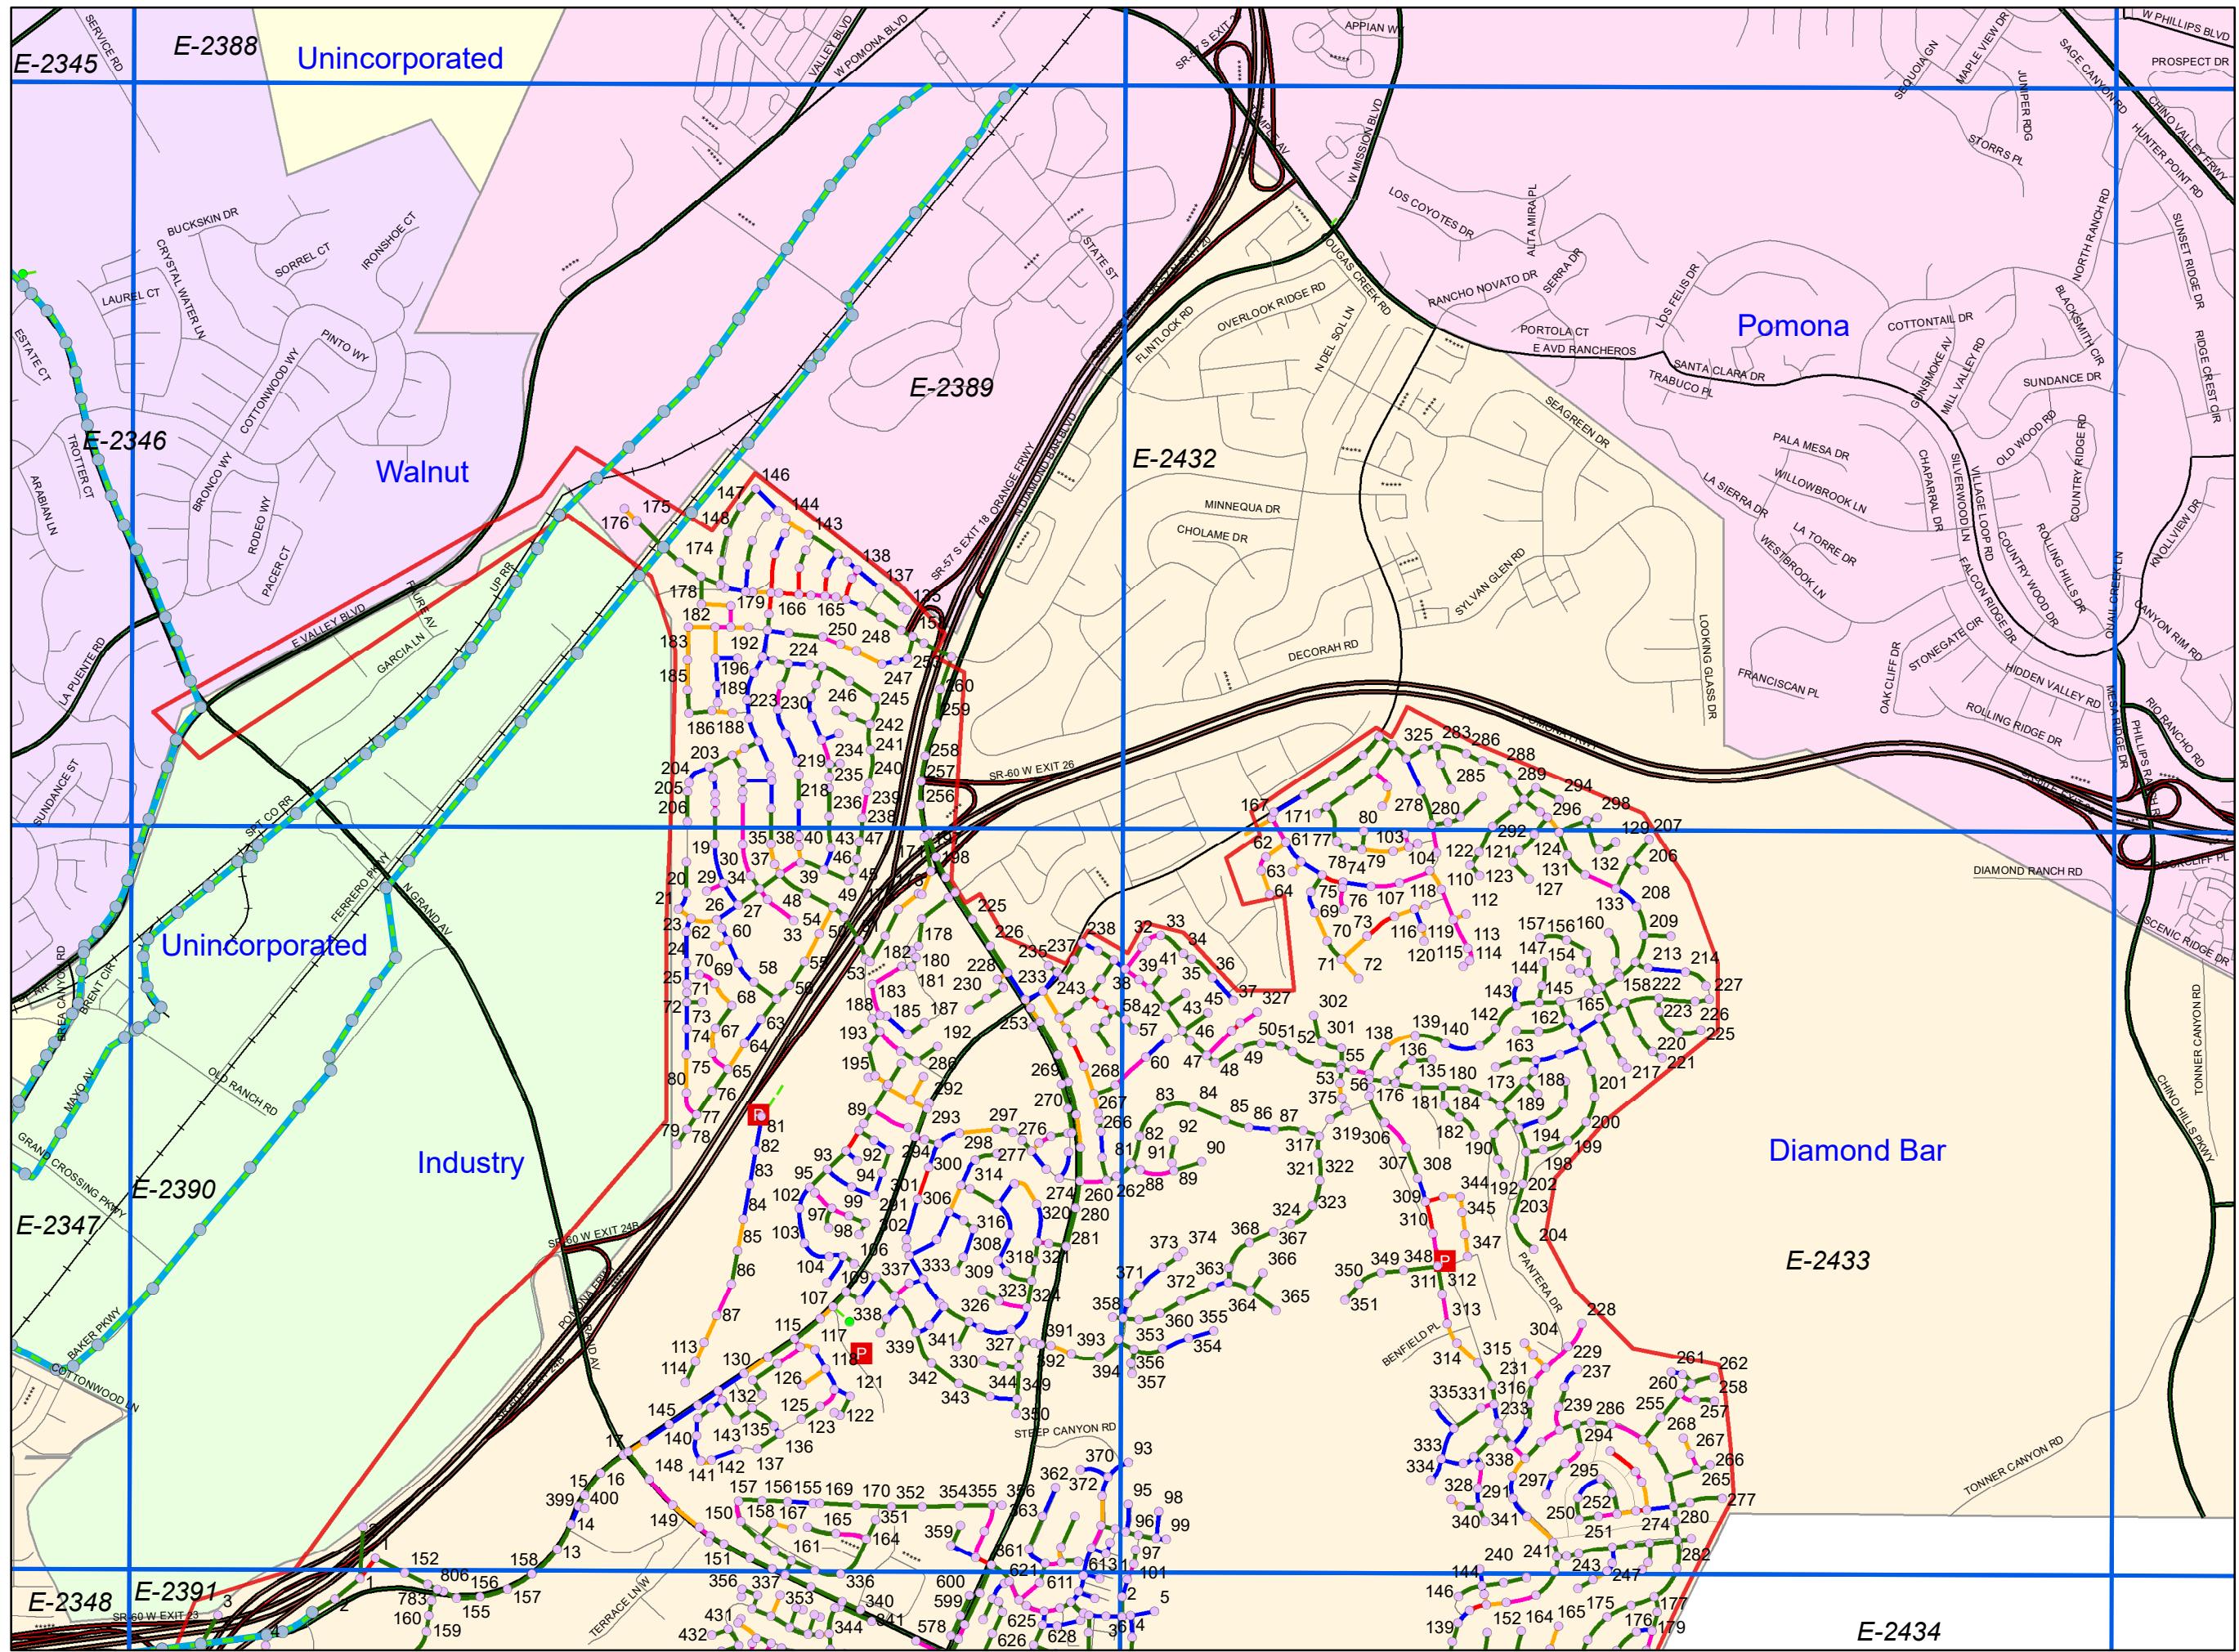
### QUICK MAINTENANCE RATING (QMR)

A color-coded map showing the quick maintenance rating for each pipe segment is provided in Enclosure 2.

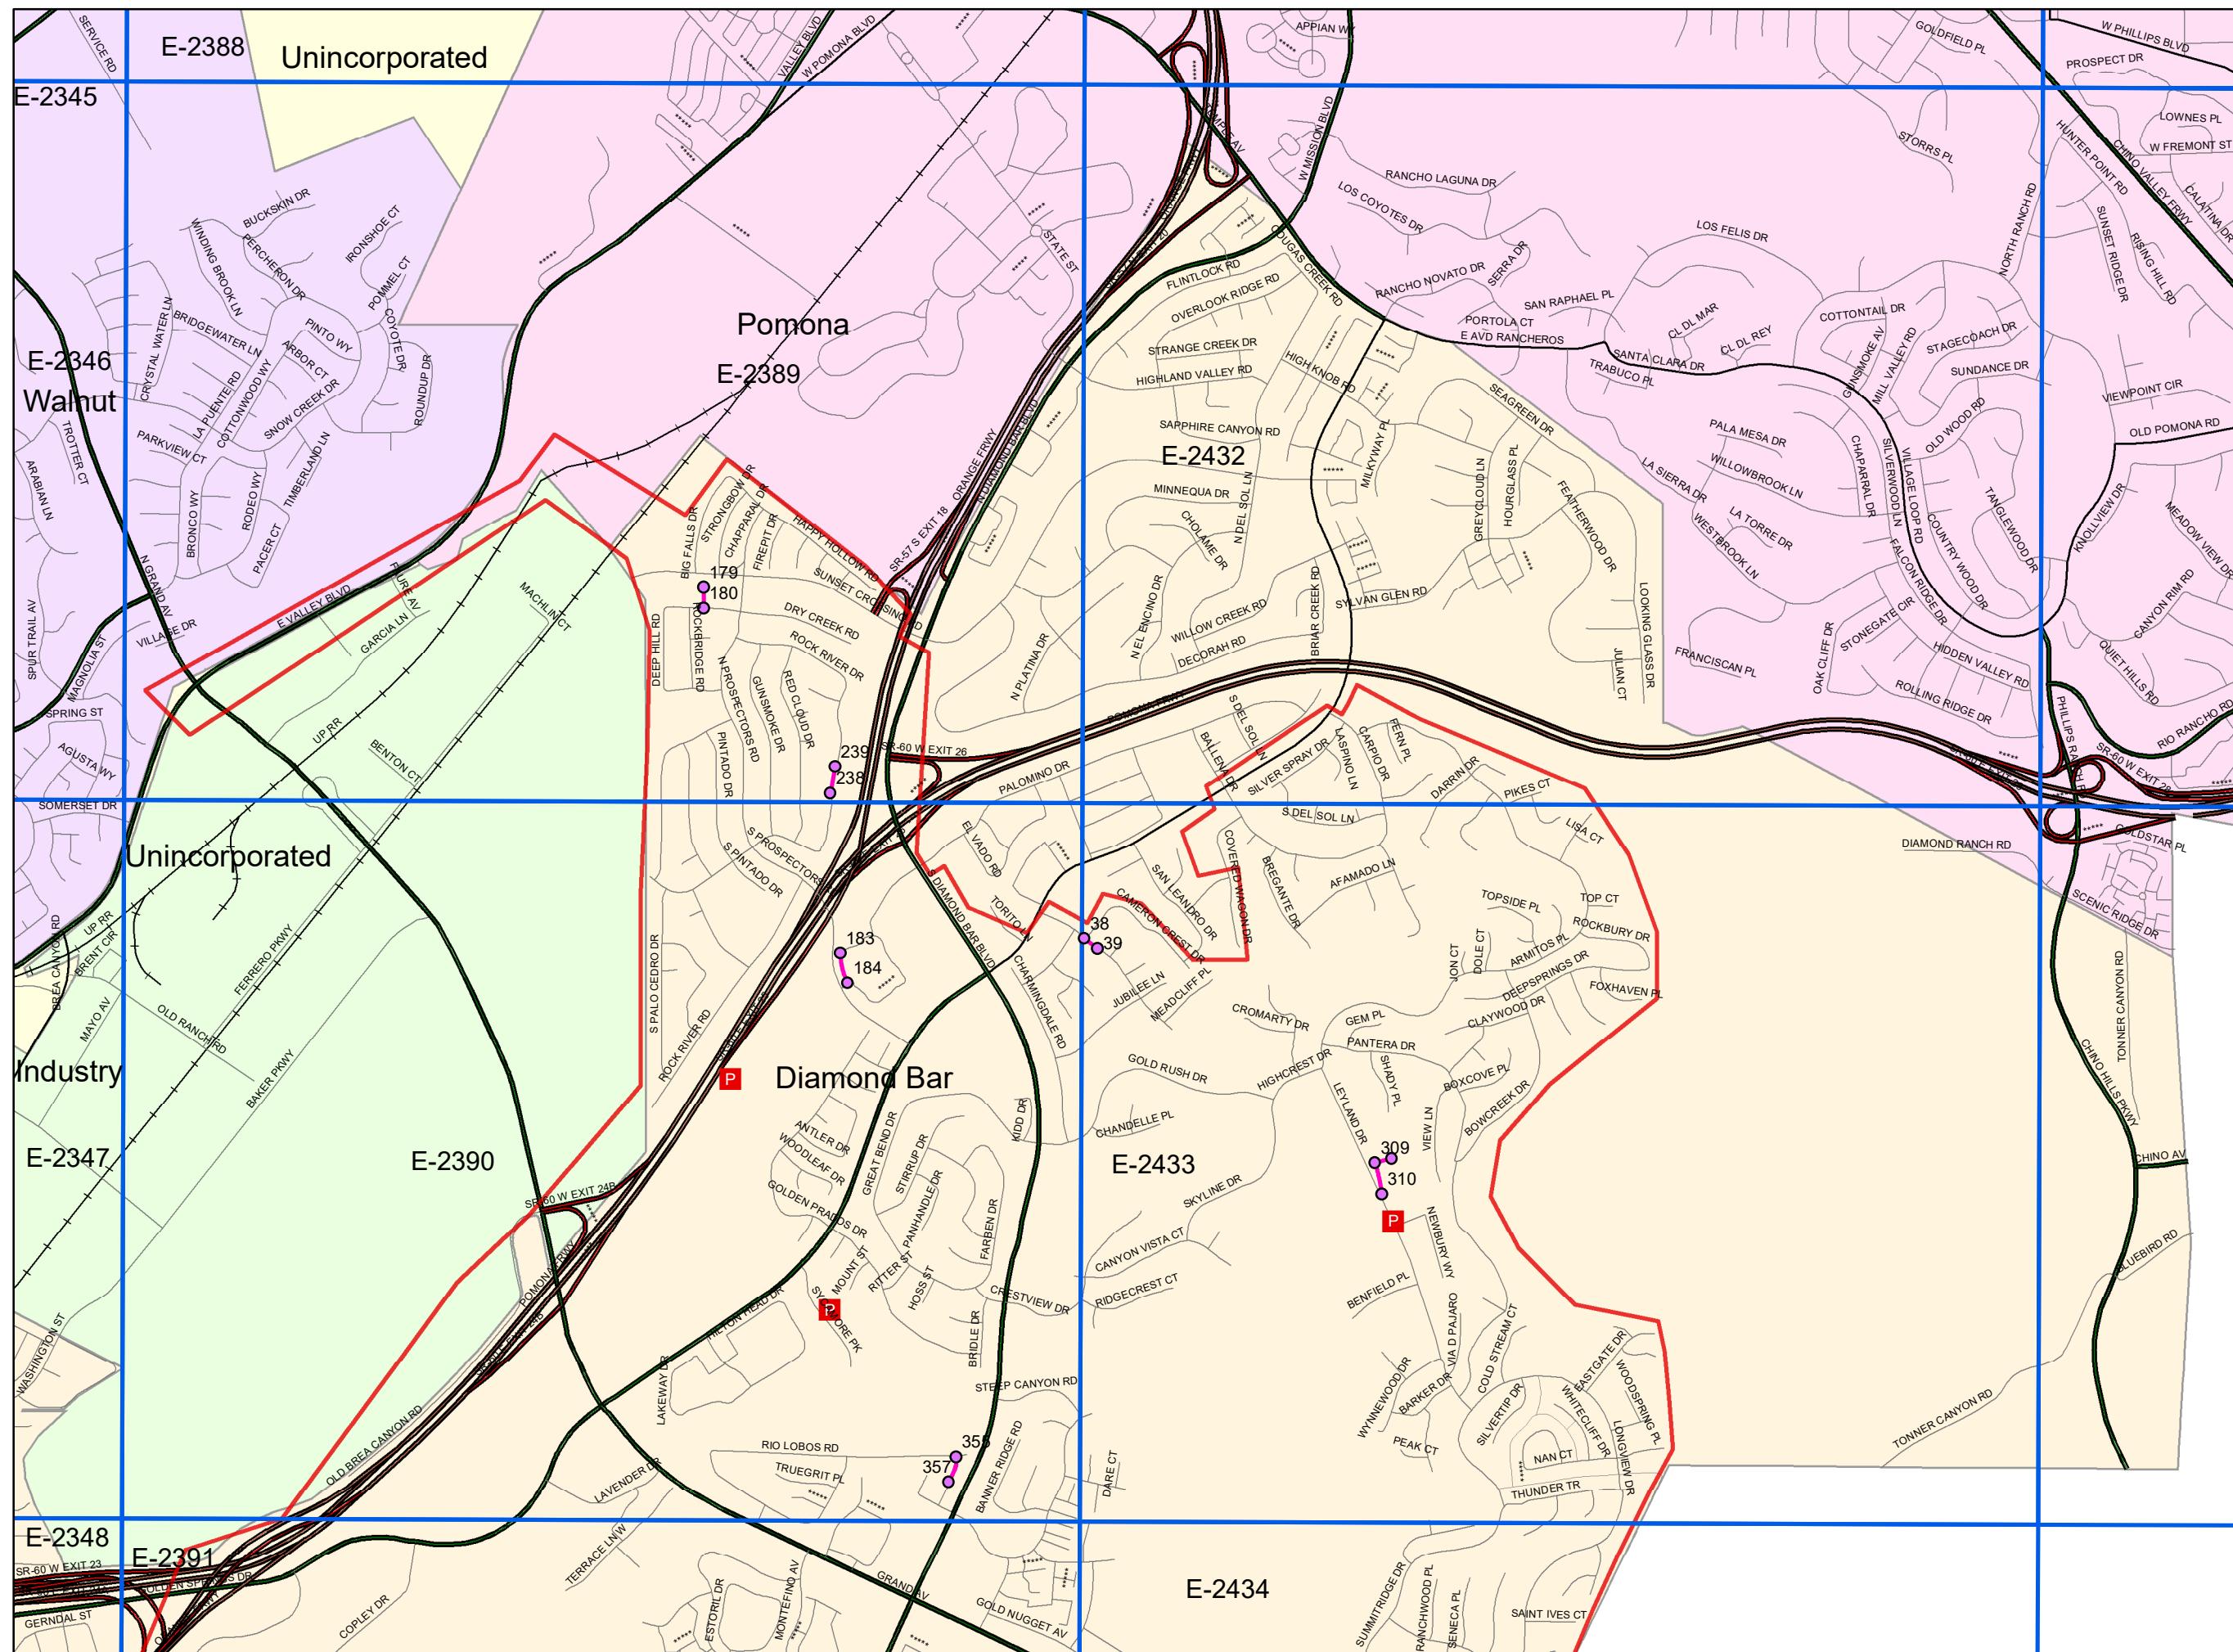
### HIGH WATER LEVELS

**ENCLOSURE 2**  
**HIGH WATER LEVELS**  
**CITY OF DIAMOND BAR (Y0TV1415B)**

ITEM NO.	QMR	START MH	END MH	STREET	OBSERVATION: LOCATION	CAPACITY	CORRECTIVE ACTION
1	5441	2433-0309	2433-0310	LEYLAND DR	High water mark	NO	Hydrojet
2	523C	2391-0518	2391-0511	MEADOWGLEN RD	High water level	NO	Hydrojet
3	5232	2349-0112	2349-0109	CASTLE ROCK RD	High water level	NO	Hydrojet
4	5200	2349-0076	2349-0075	DIAMOND BAR BV	High water level	NO	Hydrojet
5	5200	2349-0074	2392-0277	DIAMOND BAR BV	High water mark	NO	Hydrojet
6	5142	2349-0120	2349-0119	COLD SPRING LN	High water level	NO	Hydrojet
7	5142	2392-0154	2392-0153	DIAMOND BAR BV	High water level, Camera underwater	NO	Hydrojet
8	5141	2391-0315	2391-0314	DIAMOND BAR BV	High water level	NO	Hydrojet
9	5141	2433-0343	2433-0309	NEWBURY WY	High water mark	NO	Hydrojet
10	5122	2349-0083	2349-0082	CROOKED CREEK DR	High water level	NO	Hydrojet
11	4A00	2391-0530	2391-0541	DIAMOND BAR BV	High water mark, Camera underwater	NO	Hydrojet
12	4900	2434-0194	2434-0111	LONGVIEW DR	Camera underwater	NO	Hydrojet

13	4600	2389-0239	2389-0238	ROCK RIVER DR	Camera underwater	NO	Hydrojet
14	432C	2389-0180	2389-0179	DRY CREEK	Sag	NO	Hydrojet
15	4132	2434-0206	2434-0069	EASEMENT	High water mark	NO	Hydrojet
16	4131	2390-0184	2390-0183	PRIVATE RD	High water mark	NO	Hydrojet
17	4125	2390-0355	2390-0357	COGBURN LN	High water mark	NO	Hydrojet
18	4121	2391-0324	2391-0320	KIOWA CREST DR	High water mark	NO	Hydrojet
19	4121	2392-0182	2392-0181	BLAZE TR	High water mark	NO	Hydrojet
20	4121	2434-0083	2434-0085	SUMMITRIDGE DR	High water mark	NO	Hydrojet
21	4111	2391-0241	2391-0240	MOUNTAIN LAUREL WY	High water mark	NO	Hydrojet
22	4100	2434-0105	SMPS00760	EASEMENT	High water mark	NO	Hydrojet
23	4100	2434-0086	2434-0087	DELTA DR	High water mark	NO	Hydrojet
24	4100	2434-0071	2434-0072	RIMFORD PL	High water mark	NO	Hydrojet
25	4100	2392-0277	2392-0312	DIAMOND BAR BV	High water mark	NO	Hydrojet
26	4100	2433-0039	2433-0038	RANCHERIA DR	High water mark	NO	Hydrojet

27	4100	2434-0104	2434-0105	LONGVIEW DR	High water mark	NO	Hydrojet
28	4100	2349-0144	2348-0595	EASEMENT	High water mark	NO	Hydrojet
29	3100	2392-0275	2392-0124	DIAMOND BAR BV	High water mark	NO	Hydrojet

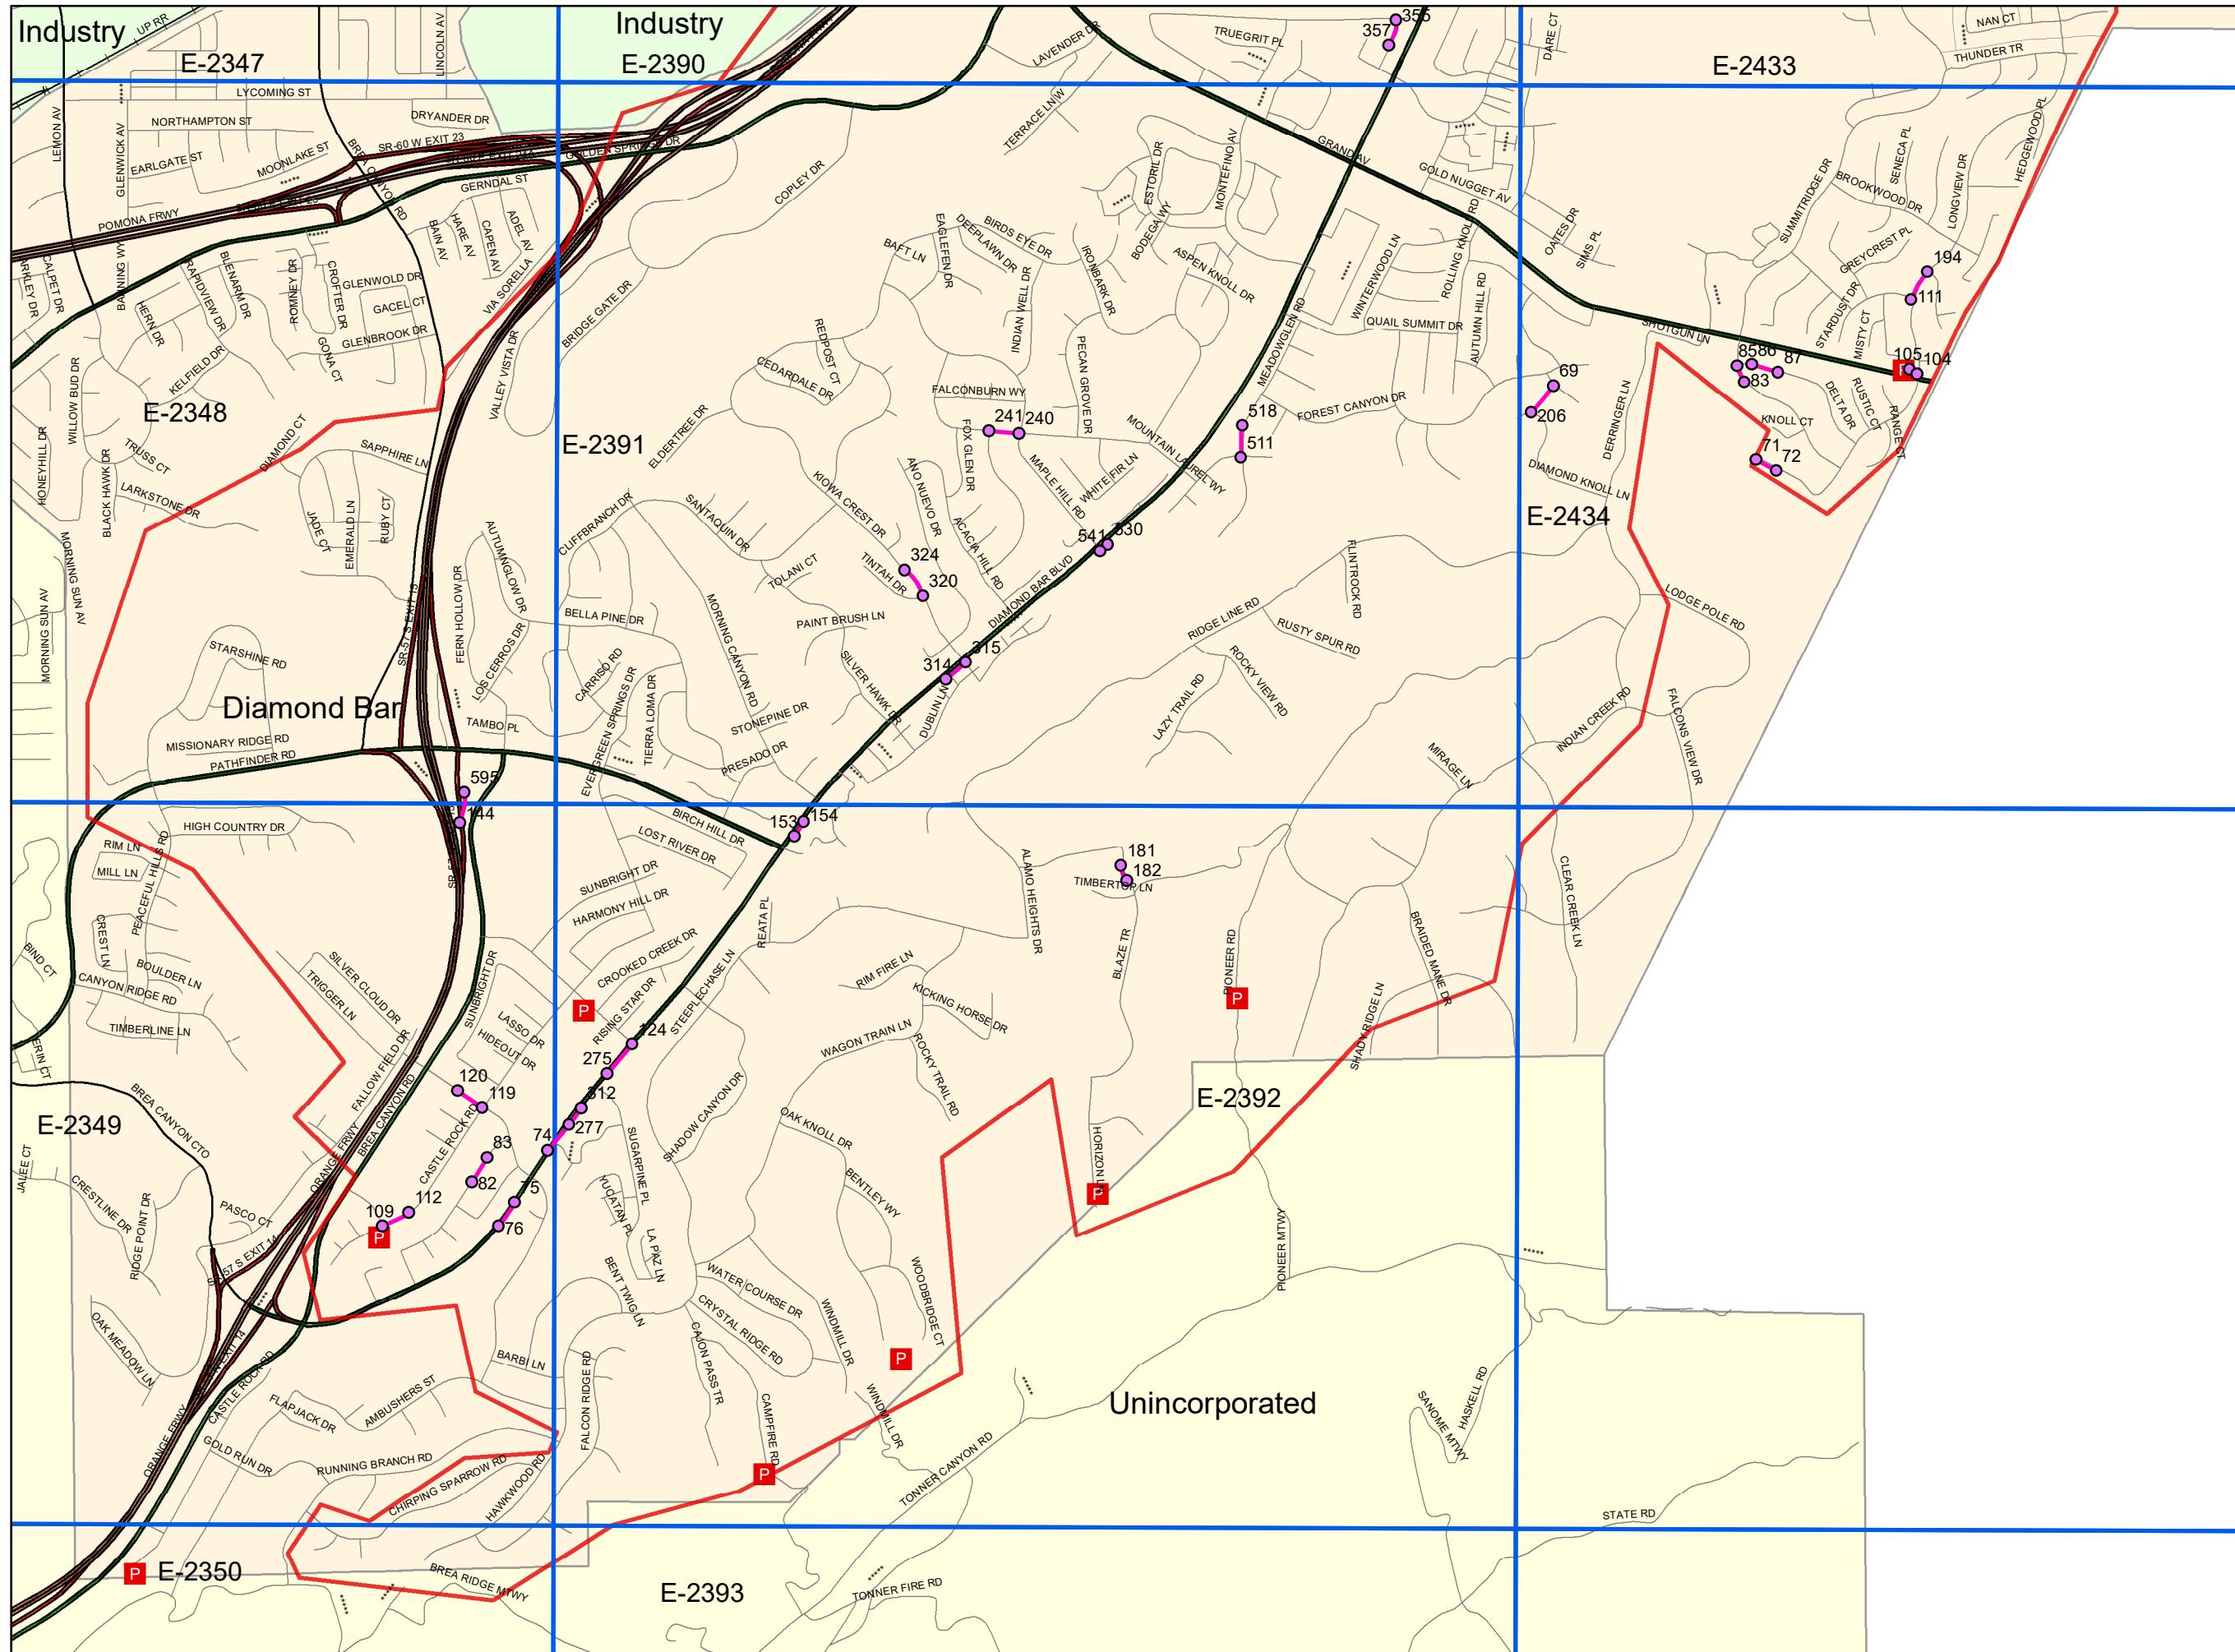
### HIGH WATER LEVELS

A map showing the sewer lines with high-water levels is provided in Enclosure 2.

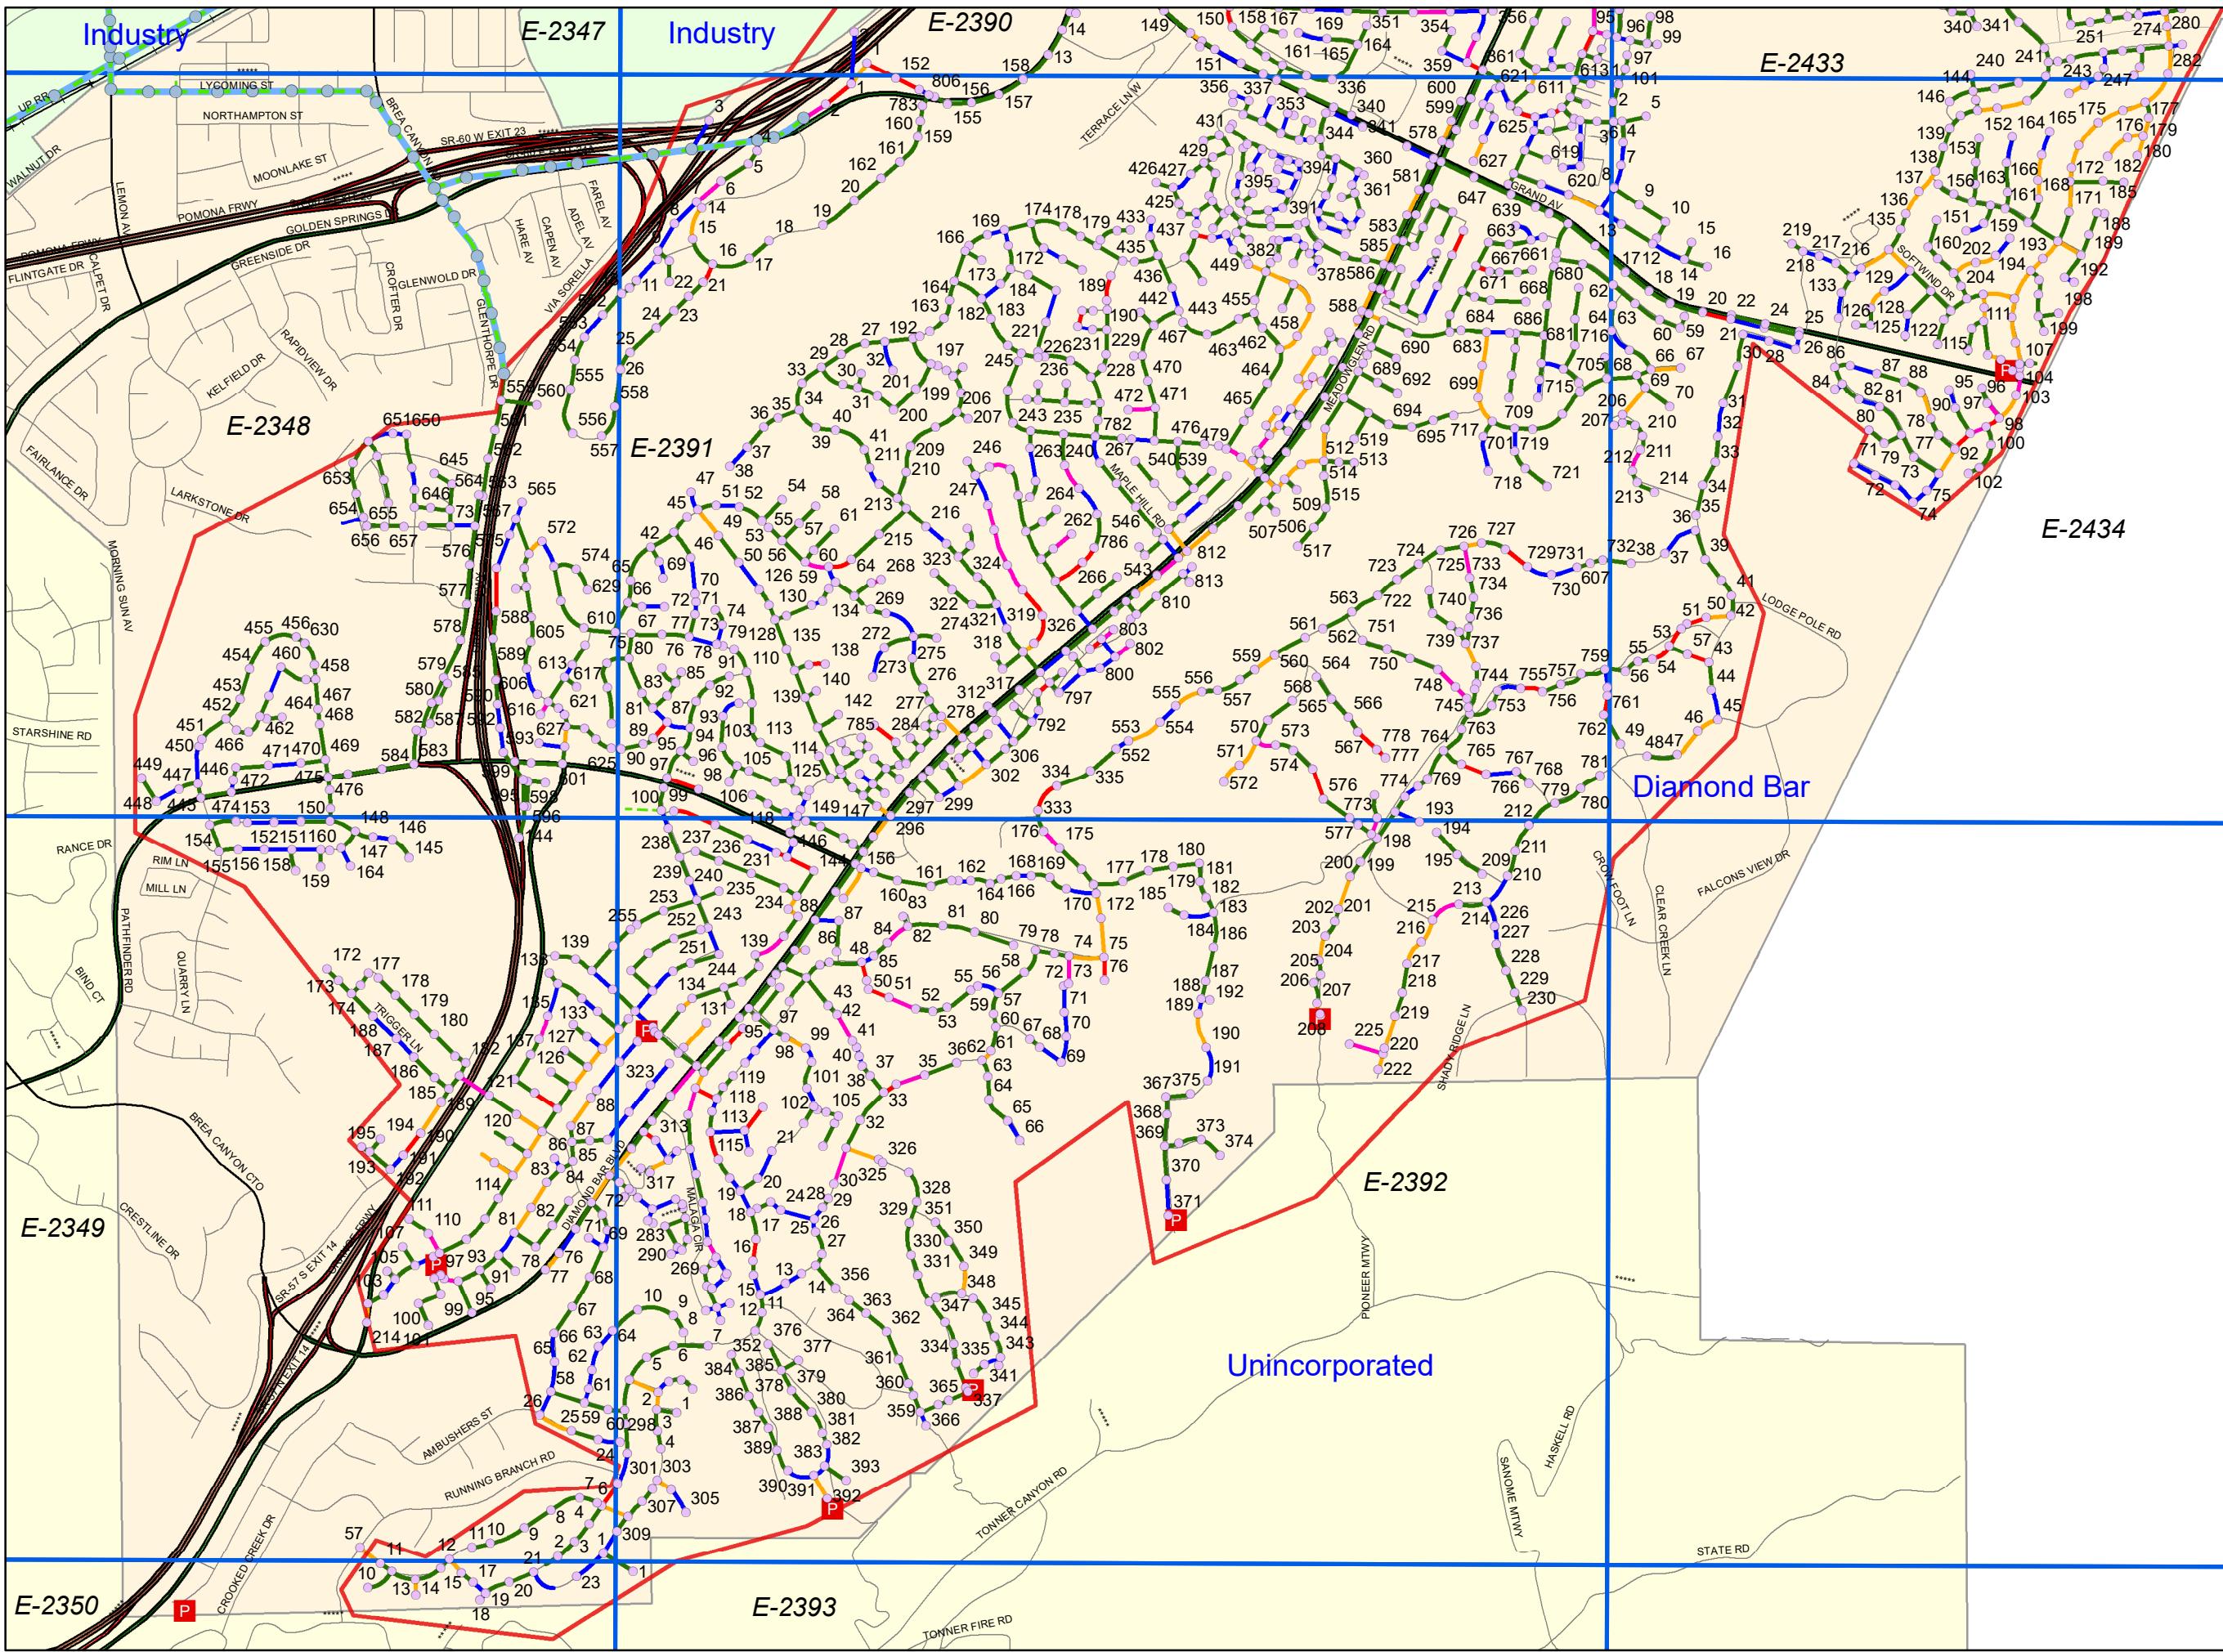
### QUICK STRUCTURAL RATING (QSR)

A color-coded map showing the Quick Structural Rating for each pipe segment is located in Enclosure 3.
