CONSOLIDATED SEWER MAINTENANCE DISTRICT CONDITION ASSESSMENT PROGRAM REPORT PROJECT Y0TV0506D

**CONDITION ASSESSMENT REPORT
COUNTY OF LOS ANGELES DEPARTMENT OF PUBLIC WORKS
CONSOLIDATED SEWER MAINTENANCE DISTRICT**

PROJECT NAME:	Y0TV0506D	PROJECT MGR:	Kari Eskridge
PROJECT DATE:	4/17/06-8/14/06	CONTACT NO:	(626) 300-3390
SUP. DISTRICT(s):	5	MAP PAGE(S):	2166, 2212
Report By:	Colin McCarter	Report Date:	01/09/09

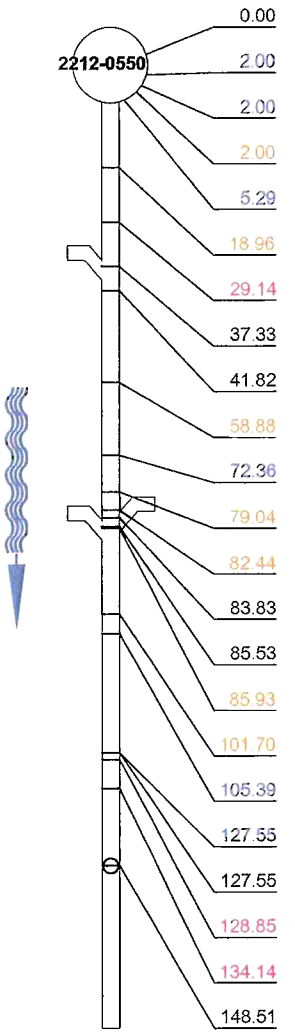
Remark: **Cracks**

18.96	Crack Multiple, from 06 to 11 o'clock, within 8 inch: YES	00:03:00	1857a	S 3
	29.14	Fracture Multiple, from 09 to 03 o'clock, within 8 inch: YES	00:03:28	1858a, b	S 4

79.04	Crack Multiple, from 08 to 02 o'clock, within 8 inch: YES	00:05:59	1863a	S 3
	82.44	Crack Multiple, from 01 to 09 o'clock, within 8 inch: YES	00:06:15	1864a	S 3
