CONSOLIDATED SEWER MAINTENANCE DISTRICT CONDITION ASSESSMENT PROGRAM REPORT PROJECT NOS. Y0TV1314B1 AND Y0TV1314B2

# CONDITION ASSESSMENT REPORT LOS ANGELES COUNTY PUBLIC WORKS CONSOLIDATED SEWER MAINTENANCE DISTRICT

PROJECT NAME: Y0TV1314B2 PROJECT MGR: ERIC LIU

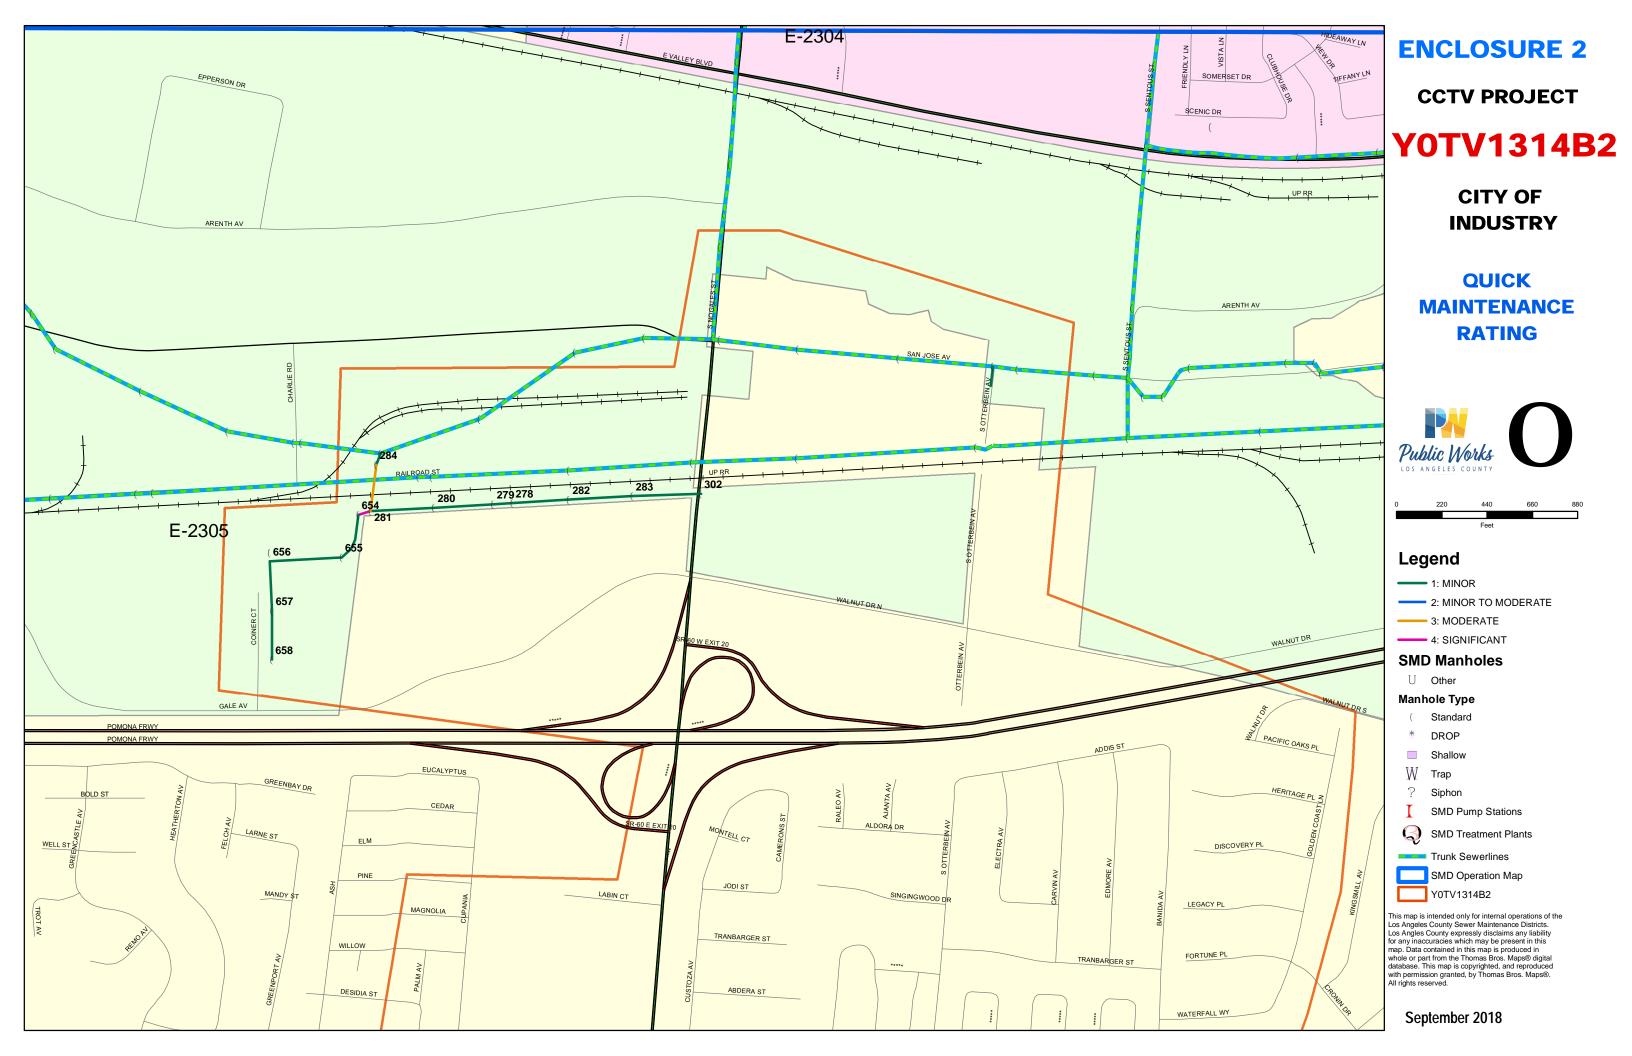
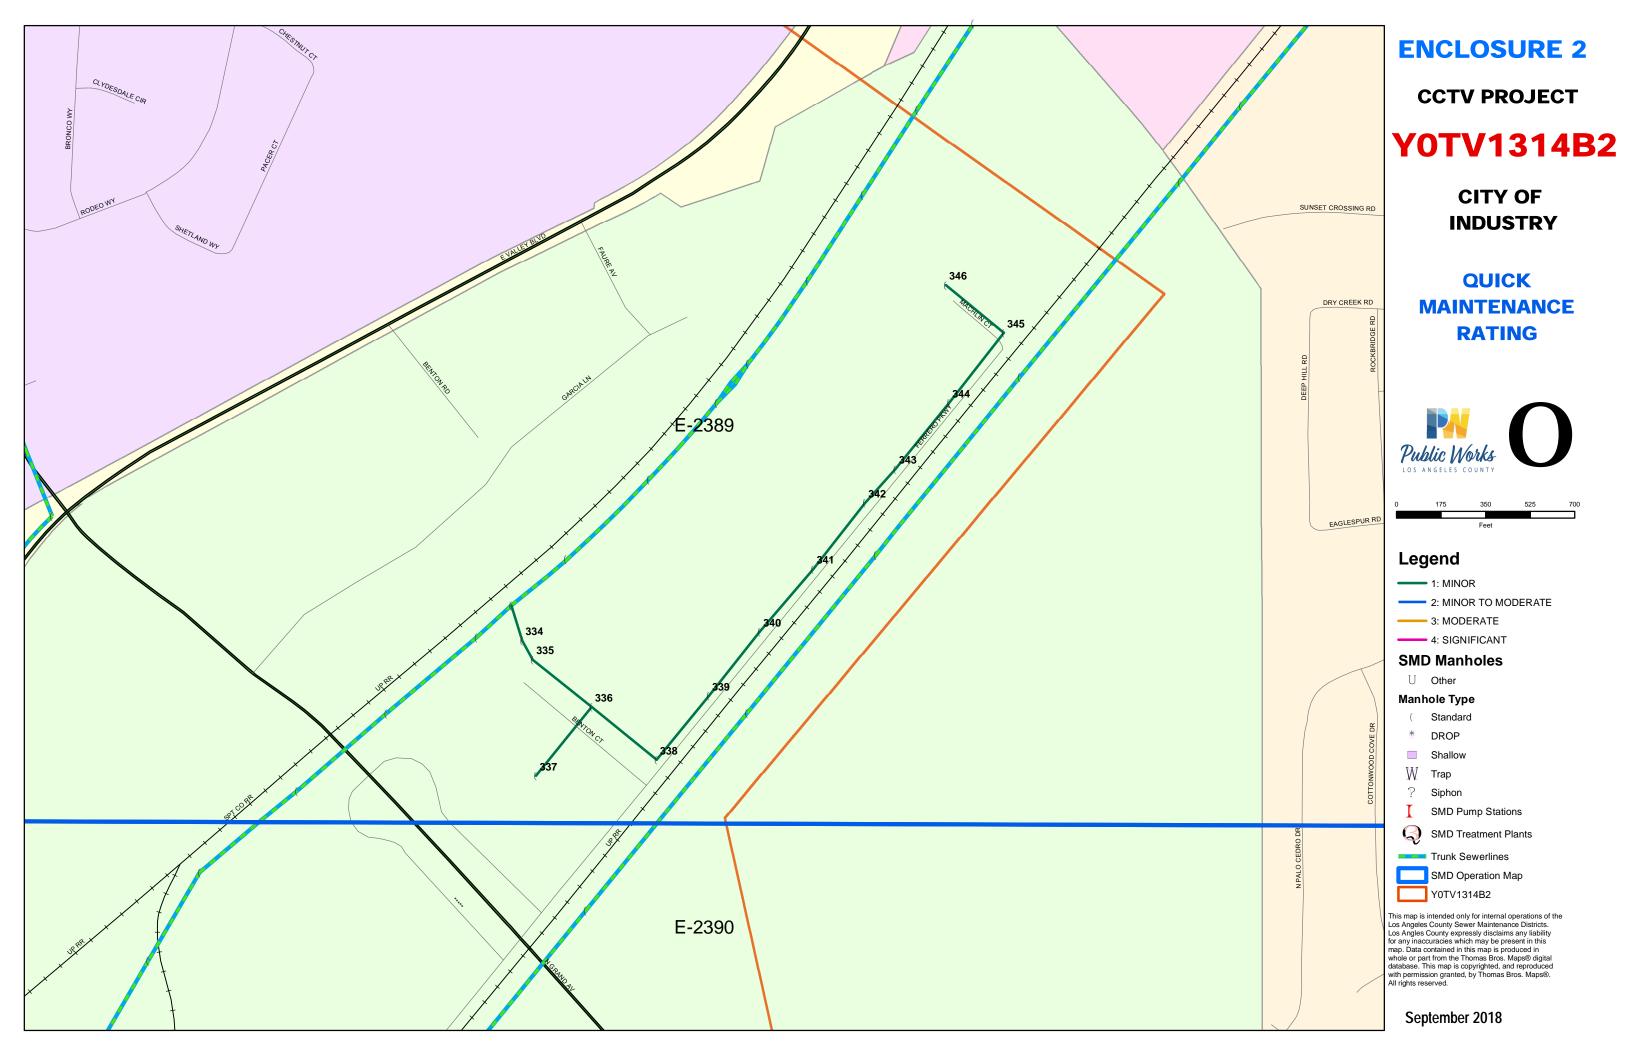
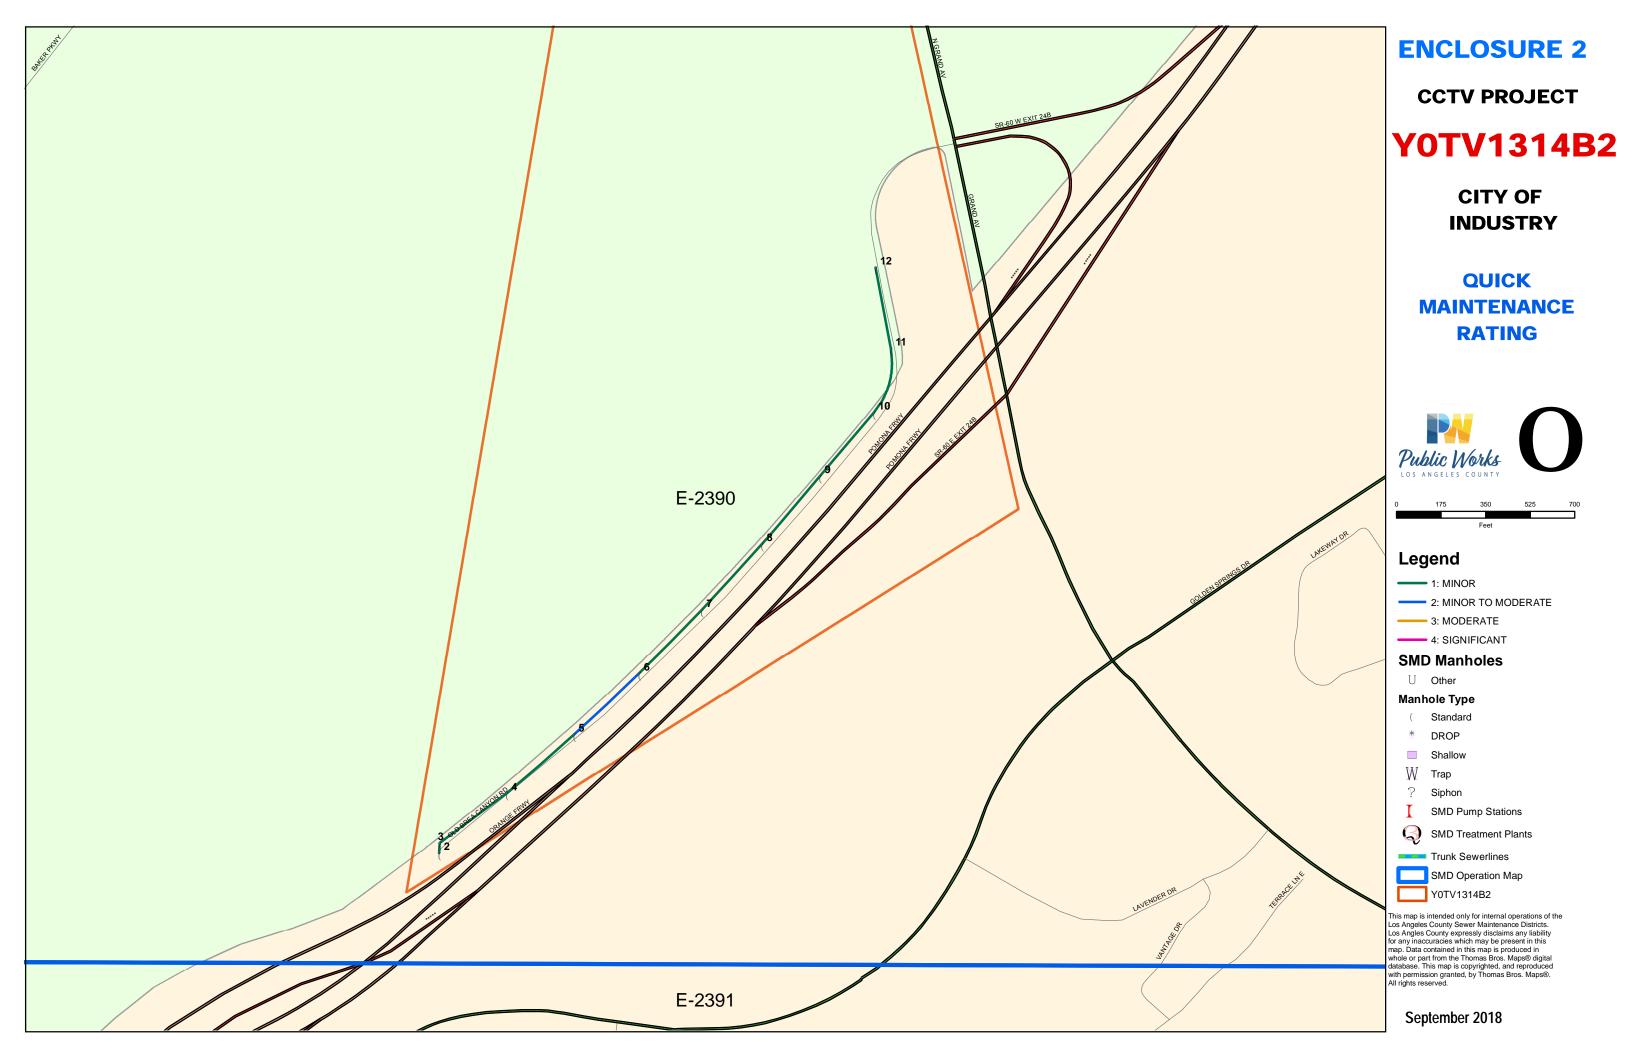
Quick Maintenance Rating Map

Our inspection revealed that approximately 95.7 percent of the system televised in your City as part of Project No. Y0TV1314B2 was free of significant blockages or restrictions that would impede sewer flows. However, the remaining 4.3 percent of the pipe segments within the City had a PACP maintenance grade of 3, 4, or 5 as indicated in the Quick Maintenance Rating Table shown below. These segments have been incorporated into our routine cleaning schedule with corrective action taken.

A color-coded map showing the quick maintenance rating for each pipe segment is provided in Enclosure 2.

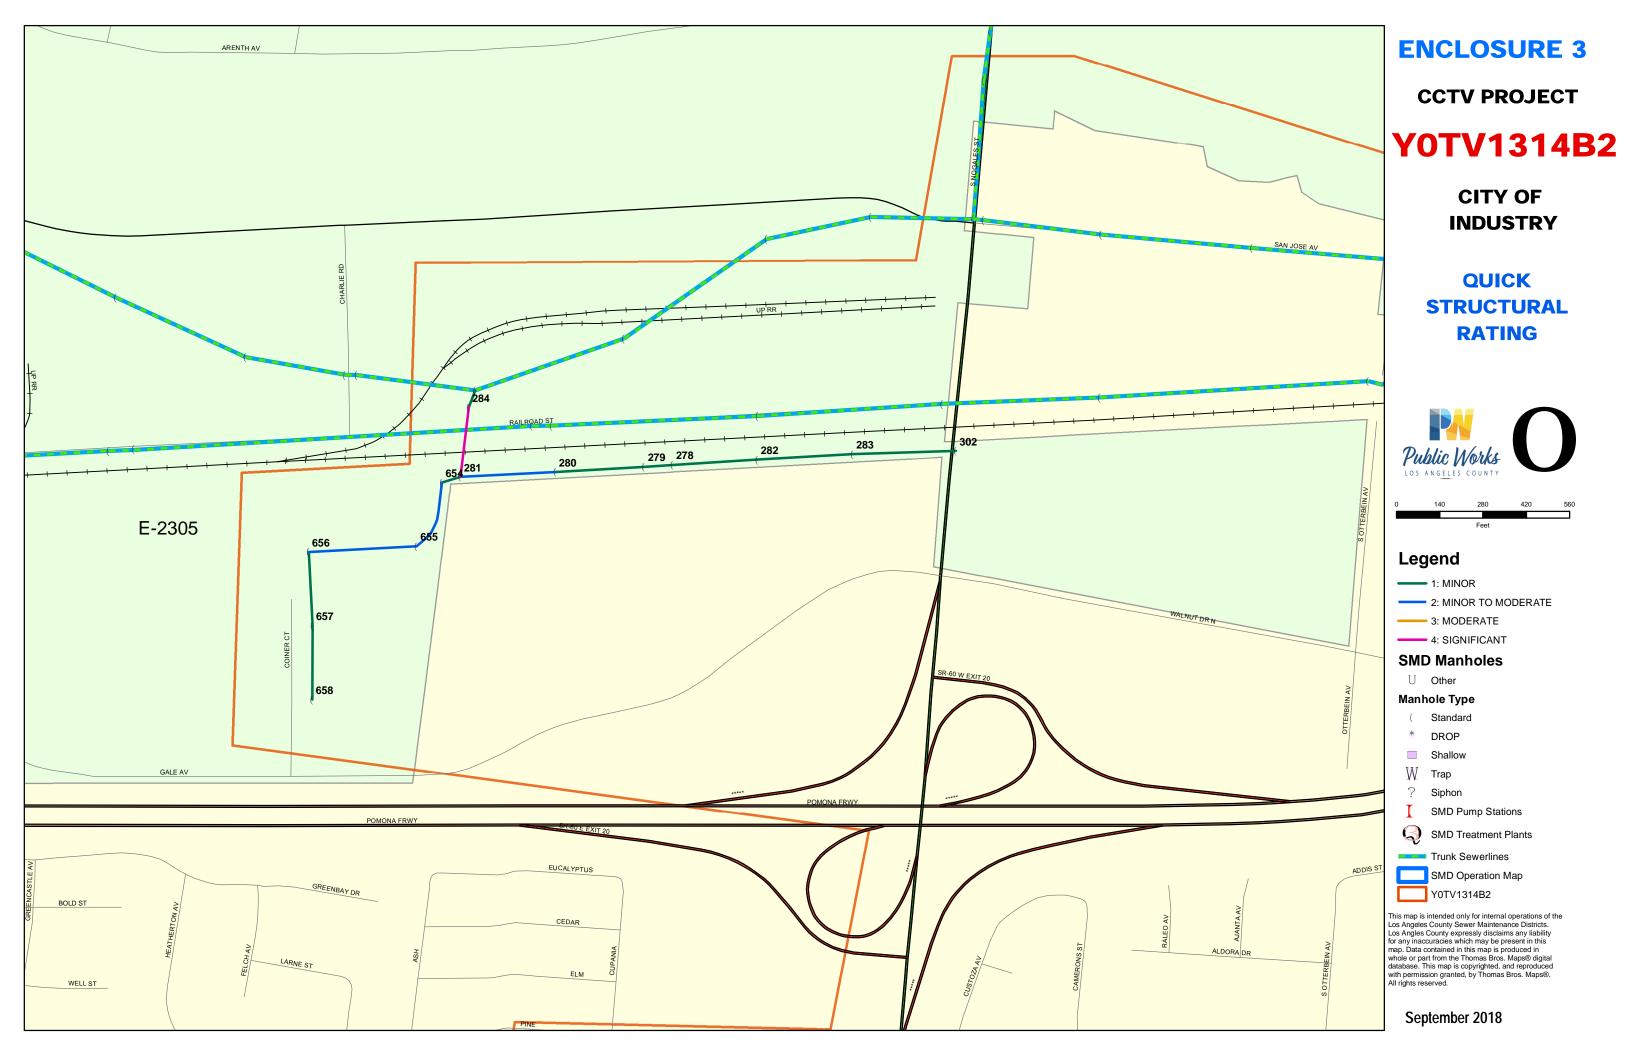
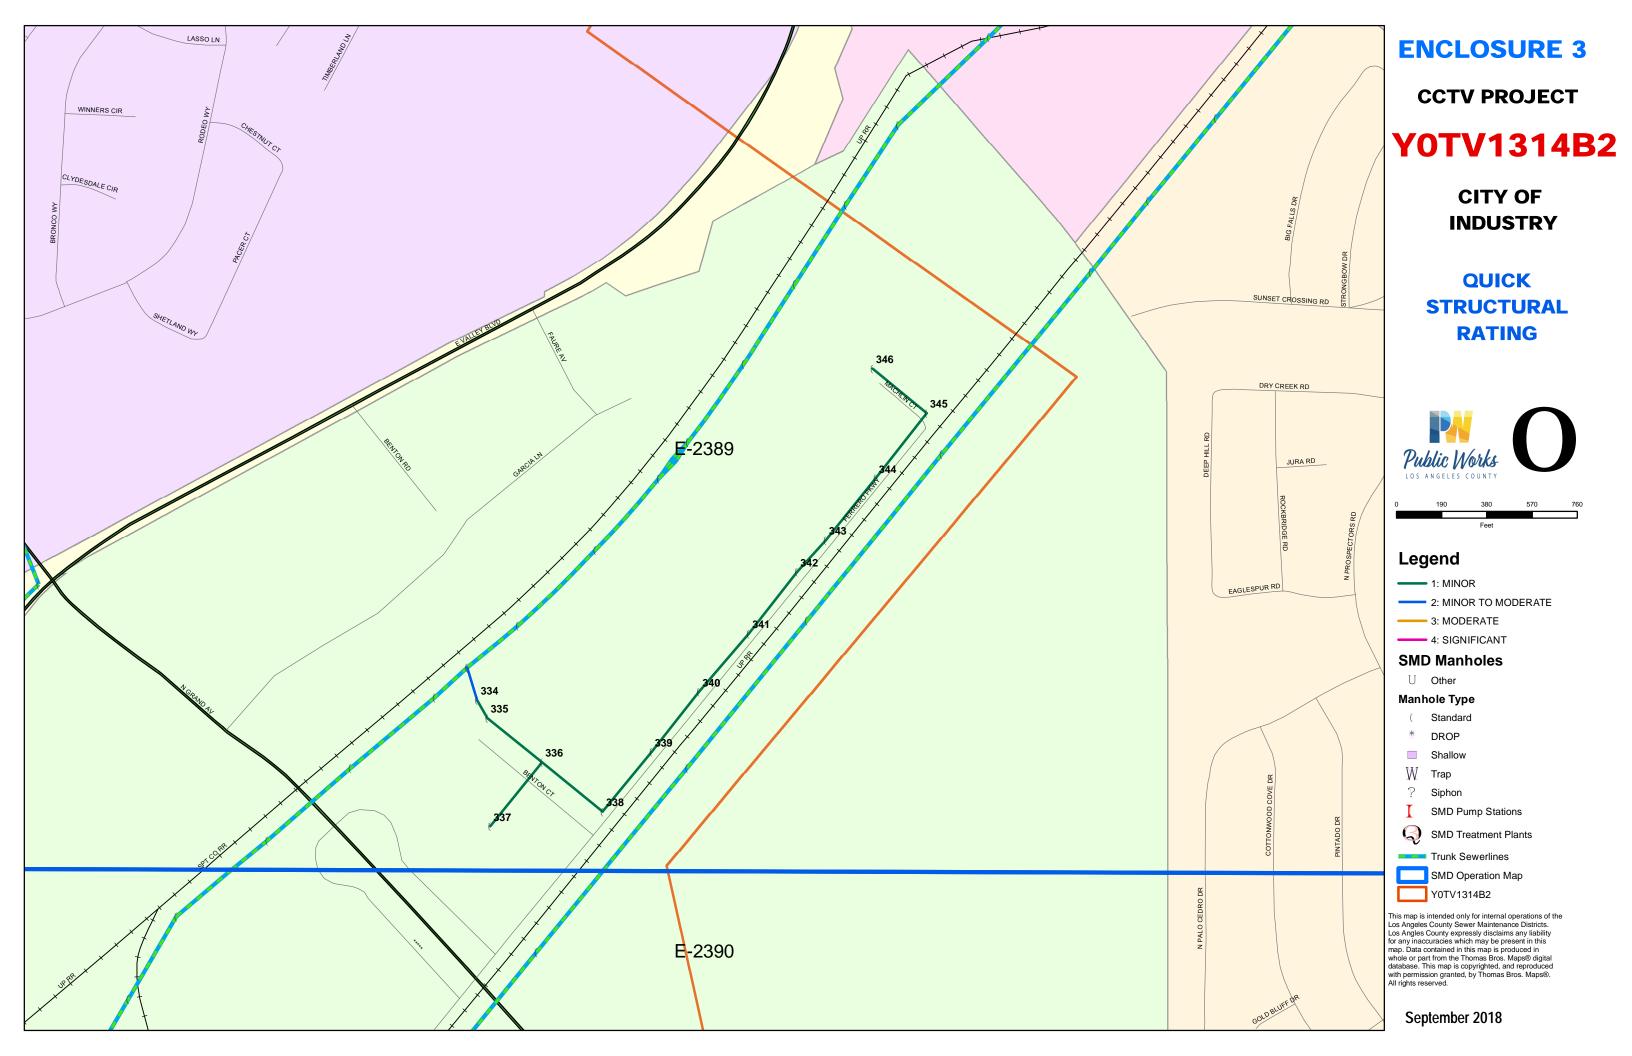
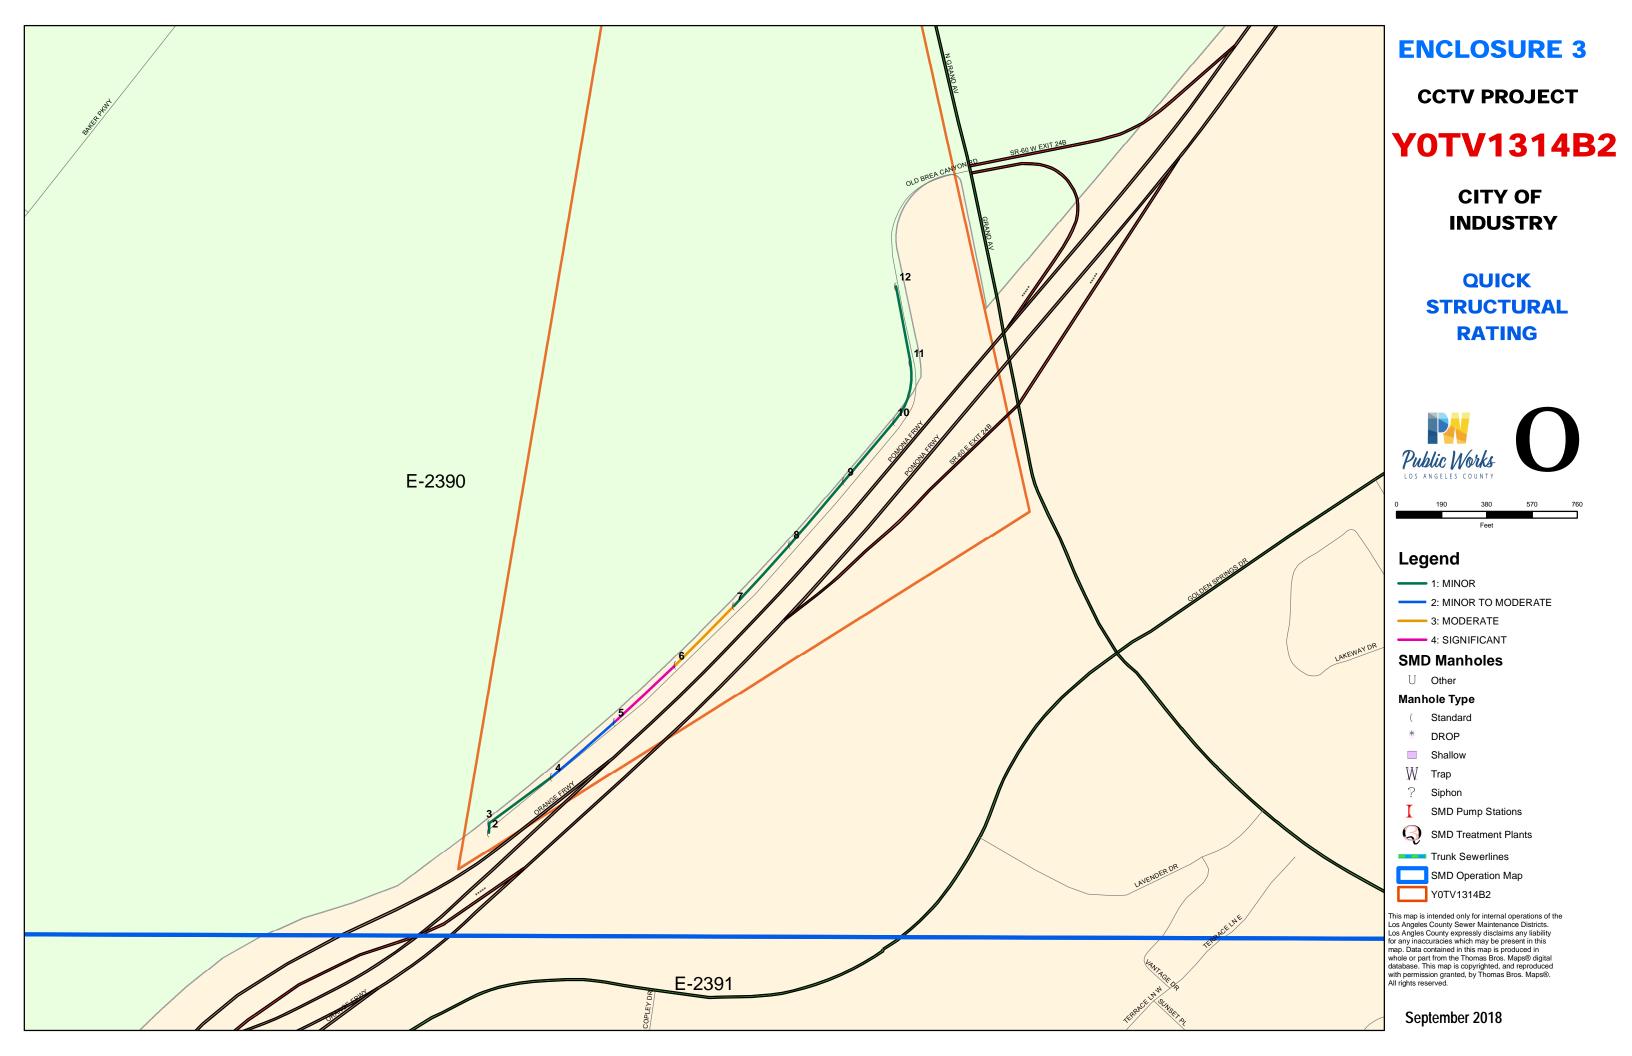
- Quick Structural Rating Report Priority List
- Quick Structural Rating Map

Our inspection revealed that approximately 93.7 percent of the inspected pipe segments within the City were free of severe structural defects. However, the remaining 6.3 percent of the inspected pipe segments had a PACP structural grade of 4 or 5 as indicated in the Quick Structural Rating Table shown below. These segments have been placed on a priority list based on the severity and the need for action. For items 1 through 2 in the Quick Structural Rating Report Priority List (Enclosure 3), which warrant a corrective action, the proposed corrective action will be programmed in the next 24 months as part of the ongoing Accumulative Capital Outlay Program.

A color-coded map showing the Quick Structural Rating for each pipe segment is located in Enclosure 3.

ITEM NO.	START MH	END MH	STREET	OBSERVATION	PROPOSED CORRECTIVE ACTION
1	2305-0281	2305-0284	UPRR	Fractures	Lining: MH to MH
2	2390-0006	2390-0005	BREA CANYON RD	Fractures	No action needed*
