### **CONSOLIDATED SEWER MAINTENANCE DISTRICT CONDITION ASSESSMENT PROGRAM REPORT PROJECT NO. Y0TV0607D**

**CONDITION ASSESSMENT REPORT  
COUNTY OF LOS ANGELES DEPARTMENT OF PUBLIC WORKS  
CONSOLIDATED SEWER MAINTENANCE DISTRICT**

PROJECT NAME:	Y0TV0607D	PROJECT MGR:	Kari Eskridge
PROJECT DATE:	5/16/07-8/20/07	CONTACT NO:	(626) 300-3390
SUP. DISTRICT(s):	4	MAP PAGE(S):	1490, 1491, 1544, 1545
Report By:	Hanna Kebede	Report Date:	11/19/09

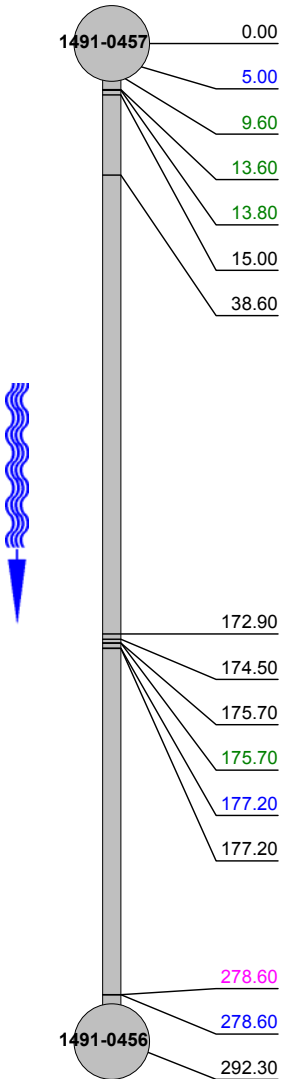
177.20	Fracture Circumferential, from 2 to 6 o'clock, within 8 inch: YES	00:10:05	5892	S 2
	177.20	Roots Fine Joint, from 7 to 9 o'clock, within 8 inch: YES	00:10:53	5893

278.60	Fracture Multiple, from 7 to 6 o'clock, within 8 inch: NO	00:14:07	5894	S 4
	278.60	Roots Fine Barrel, from 4 to 6 o'clock, within 8 inch: NO	00:14:36	5895	M 2

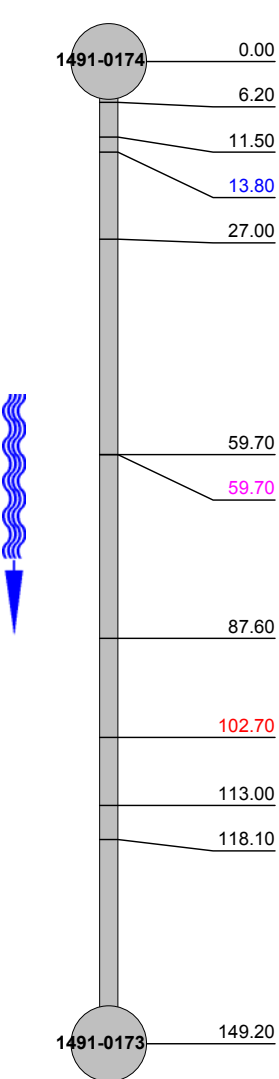
0.00	Manhole, within 8 inch: NO, Remarks: UPSTREAM MH 1491-0174-SUR	00:00:34	13292	
	6.20	Roots Fine Joint, from 5 to 7 o'clock, within 8 inch: YES	00:02:15	13293

11.50	Roots Fine Joint, from 7 to 9 o'clock, within 8 inch: YES	00:03:34	13294	
	<u>13.80</u>	Water Level, 5", within 8 inch: NO	00:04:02	13295	M 2
	27.00 <b>S1</b>	Roots Fine Joint, from 7 to 5 o'clock, within 8 inch: YES, Start	00:04:35	13296

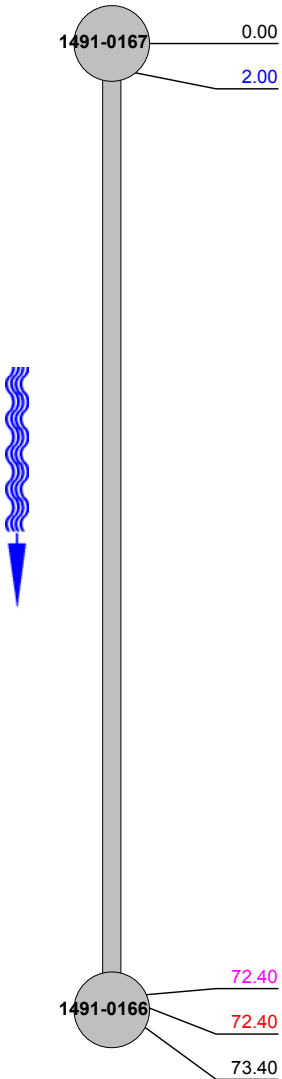
1:175	position	observation	MPEG	photo	grade
	0.00	Manhole, within 8 inch: NO, Remarks: Upstream Survey Begins	00:00:46	6995	
	2.00	Water Level, 10 #, within 8 inch: NO	00:02:17	6996	M 2
	72.40	Fracture Multiple, from 7 to 5 o'clock, within 8 inch: NO	00:05:13	6997	S 4
	72.40	Broken, from 10 to 2 o'clock, within 8 inch: NO	00:06:04	6998, b	S 5
	73.40	Manhole, within 8 inch: NO, Remarks: Downstream Survey Ends	00:07:06	6999
