CONSOLIDATED SEWER MAINTENANCE DISTRICT CONDITION-ASSESSMENT PROGRAM REPORT PROJECT NO. Y0TV0910B AND Y0TV1011B

**CONDITION-ASSESSMENT REPORT
LOS ANGELES COUNTY PUBLIC WORKS
CONSOLIDATED SEWER MAINTENANCE DISTRICT**

PROJECT NAME: Y0TV0910B	PROJECT MGR: Kari Eskridge
PROJECT DATE: 7/21/2010	CONTACT NO: (626) 300-3390
SUP. DISTRICT(s): 1	MAP PAGE(S): 2022, 2023, 2075
Report By: David Lee	Report Date: 9/9/2019

PROJECT NAME:	Y0TV1011B	PROJECT MGR:	Hanna Kebede
PROJECT DATE:	8/3/2011	CONTACT NO:	(626) 300-4686
SUP. DISTRICT(s):	1	MAP PAGE(S):	1971, 1972, 2024, 2025
Report By:	David Lee	Report Date:	9/3/2019

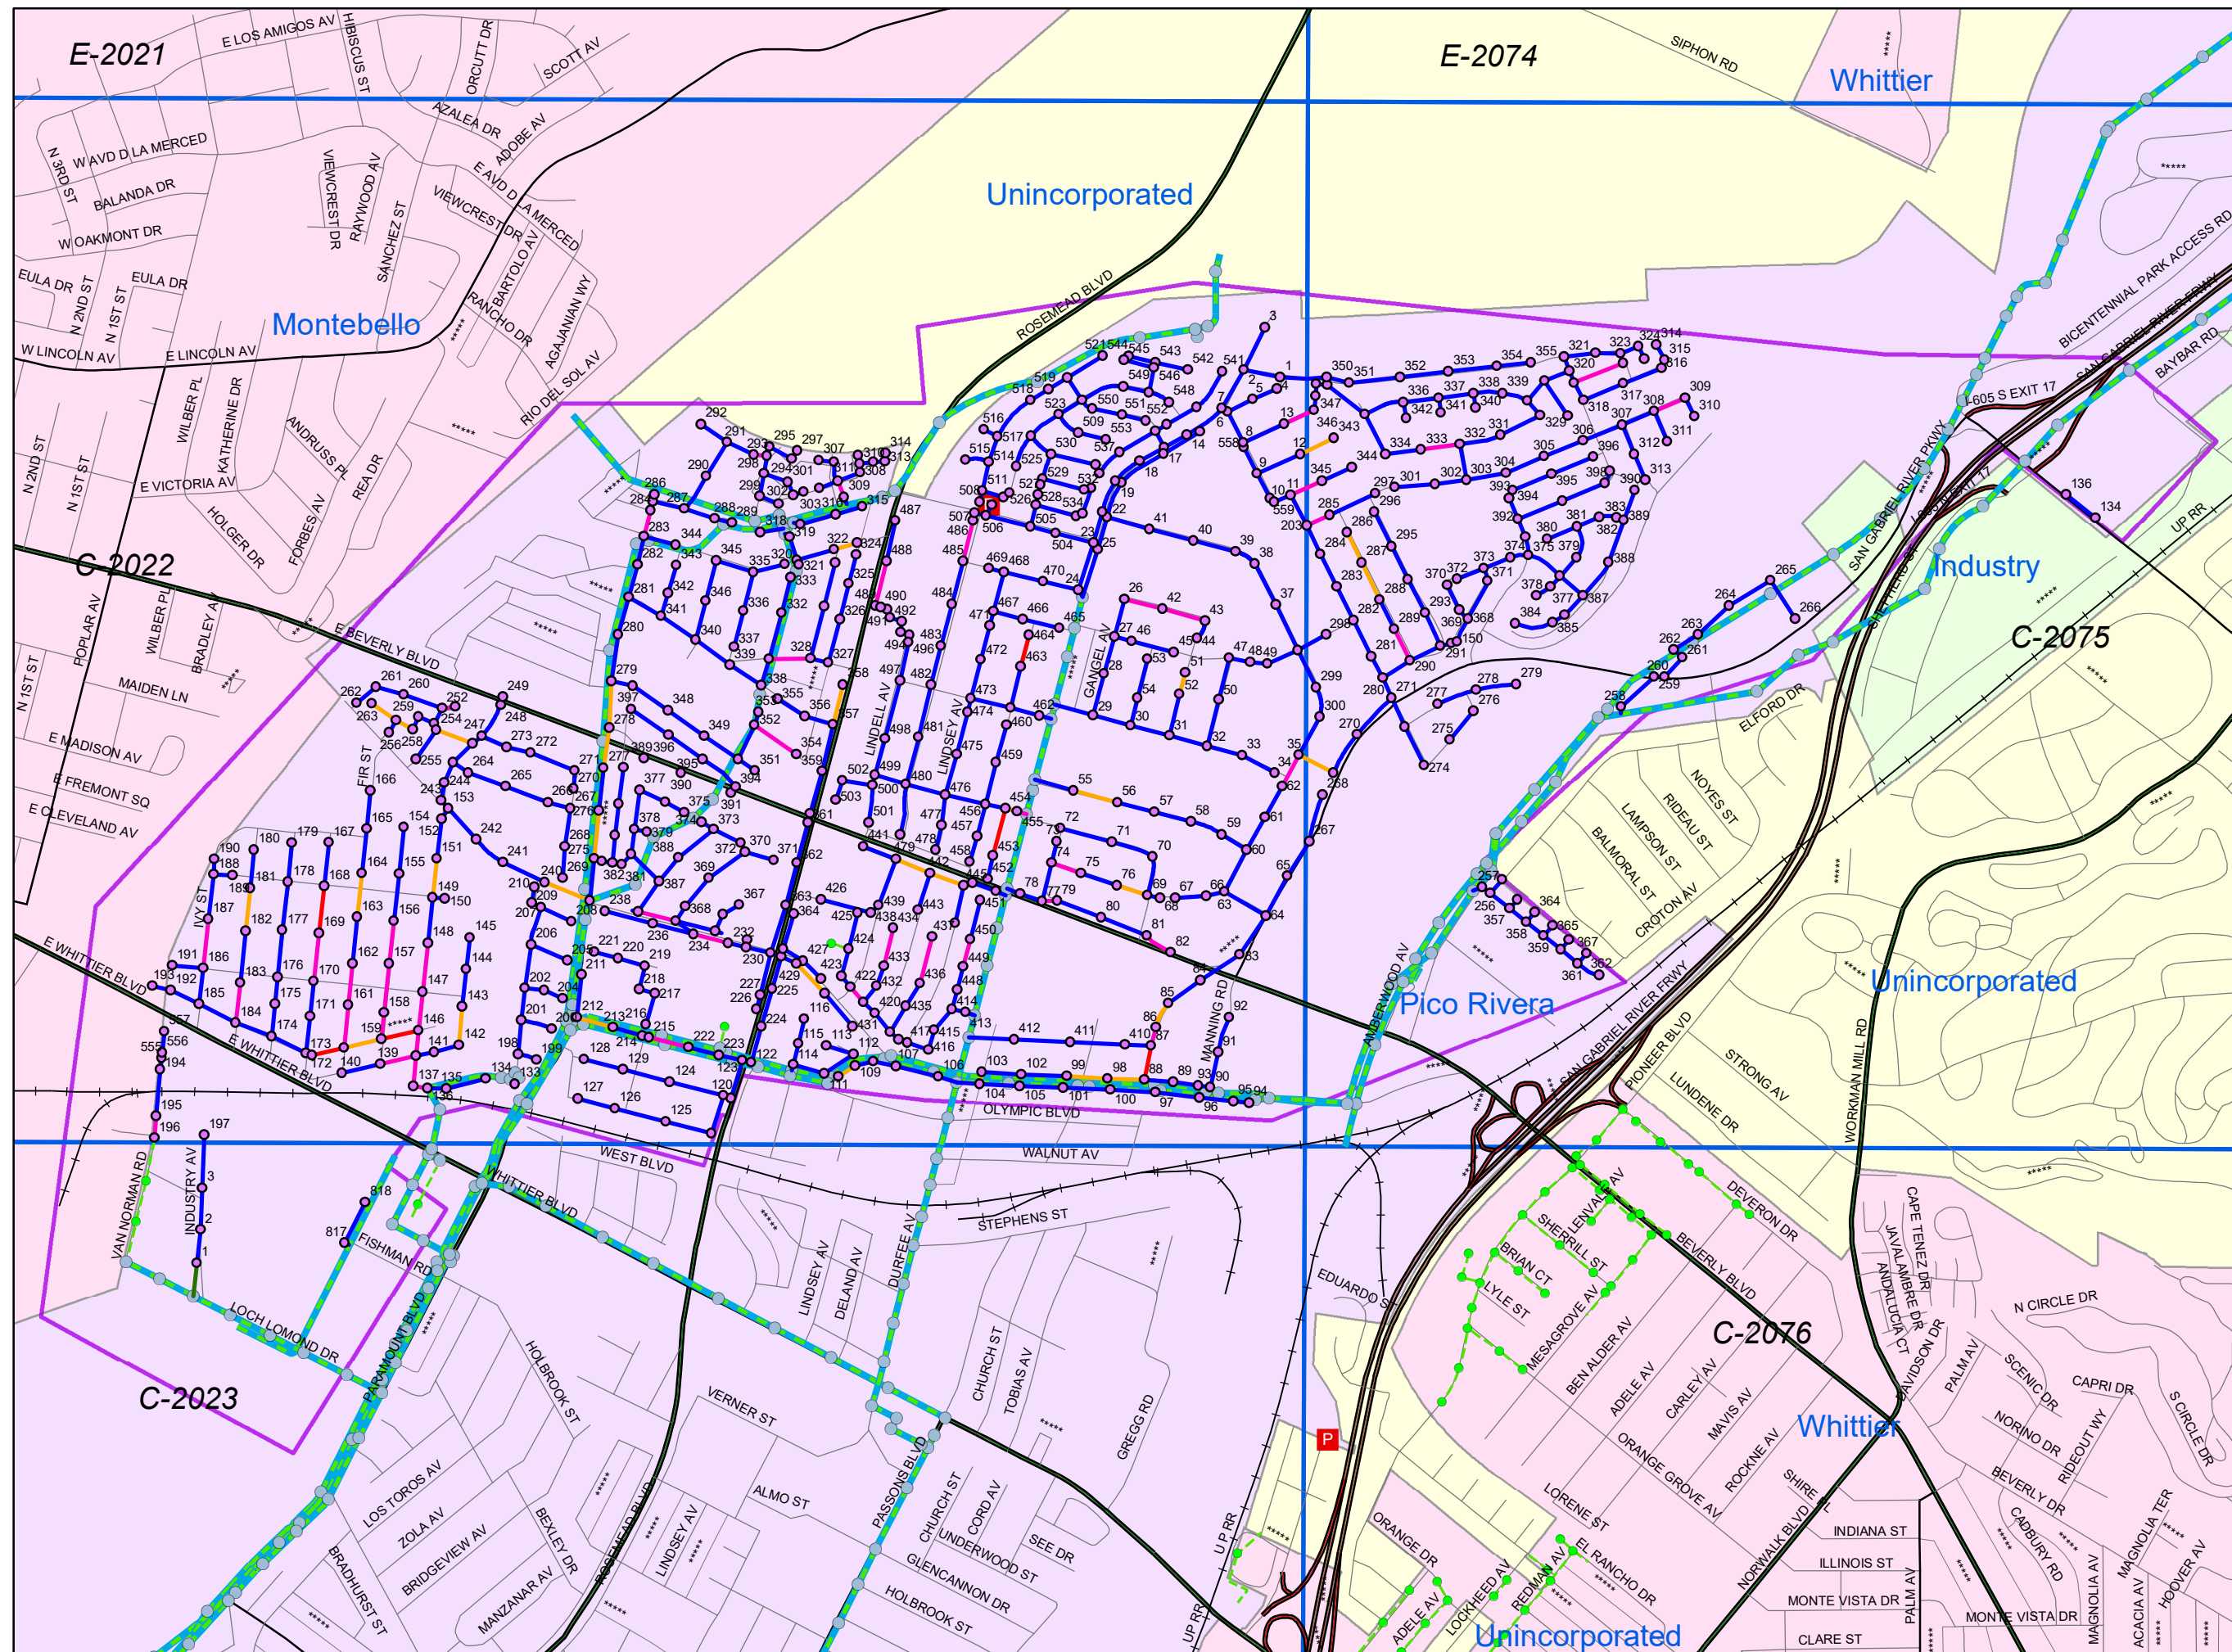
QUICK MAINTENANCE RATING (QMR)

Our inspection revealed that approximately 85.7 percent of the system televised in your City as part of Project No. Y0TV0910B was free of significant blockages or restrictions that would impede sewer flows. The remaining 14.3 percent of the pipe segments had a PACP maintenance grade of 3, 4, or 5 as indicated in the Quick Maintenance Rating Table shown below. These segments have been incorporated into our periodic cleaning schedule for enhanced maintenance.

DEFECT GRADE	PIPE LENGTH (FT)	PERCENT TOTAL INSPECTED PIPE LENGTH	NO. OF SEGMENTS
1: Minor	626	0.4	5
2: Minor to Moderate	133,667	85.3	611
3: Moderate	8,136	5.2	32
4: Significant	12,357	7.9	51
5: Most Significant	1,828	1.2	7
TOTAL	156,614	100.0	706

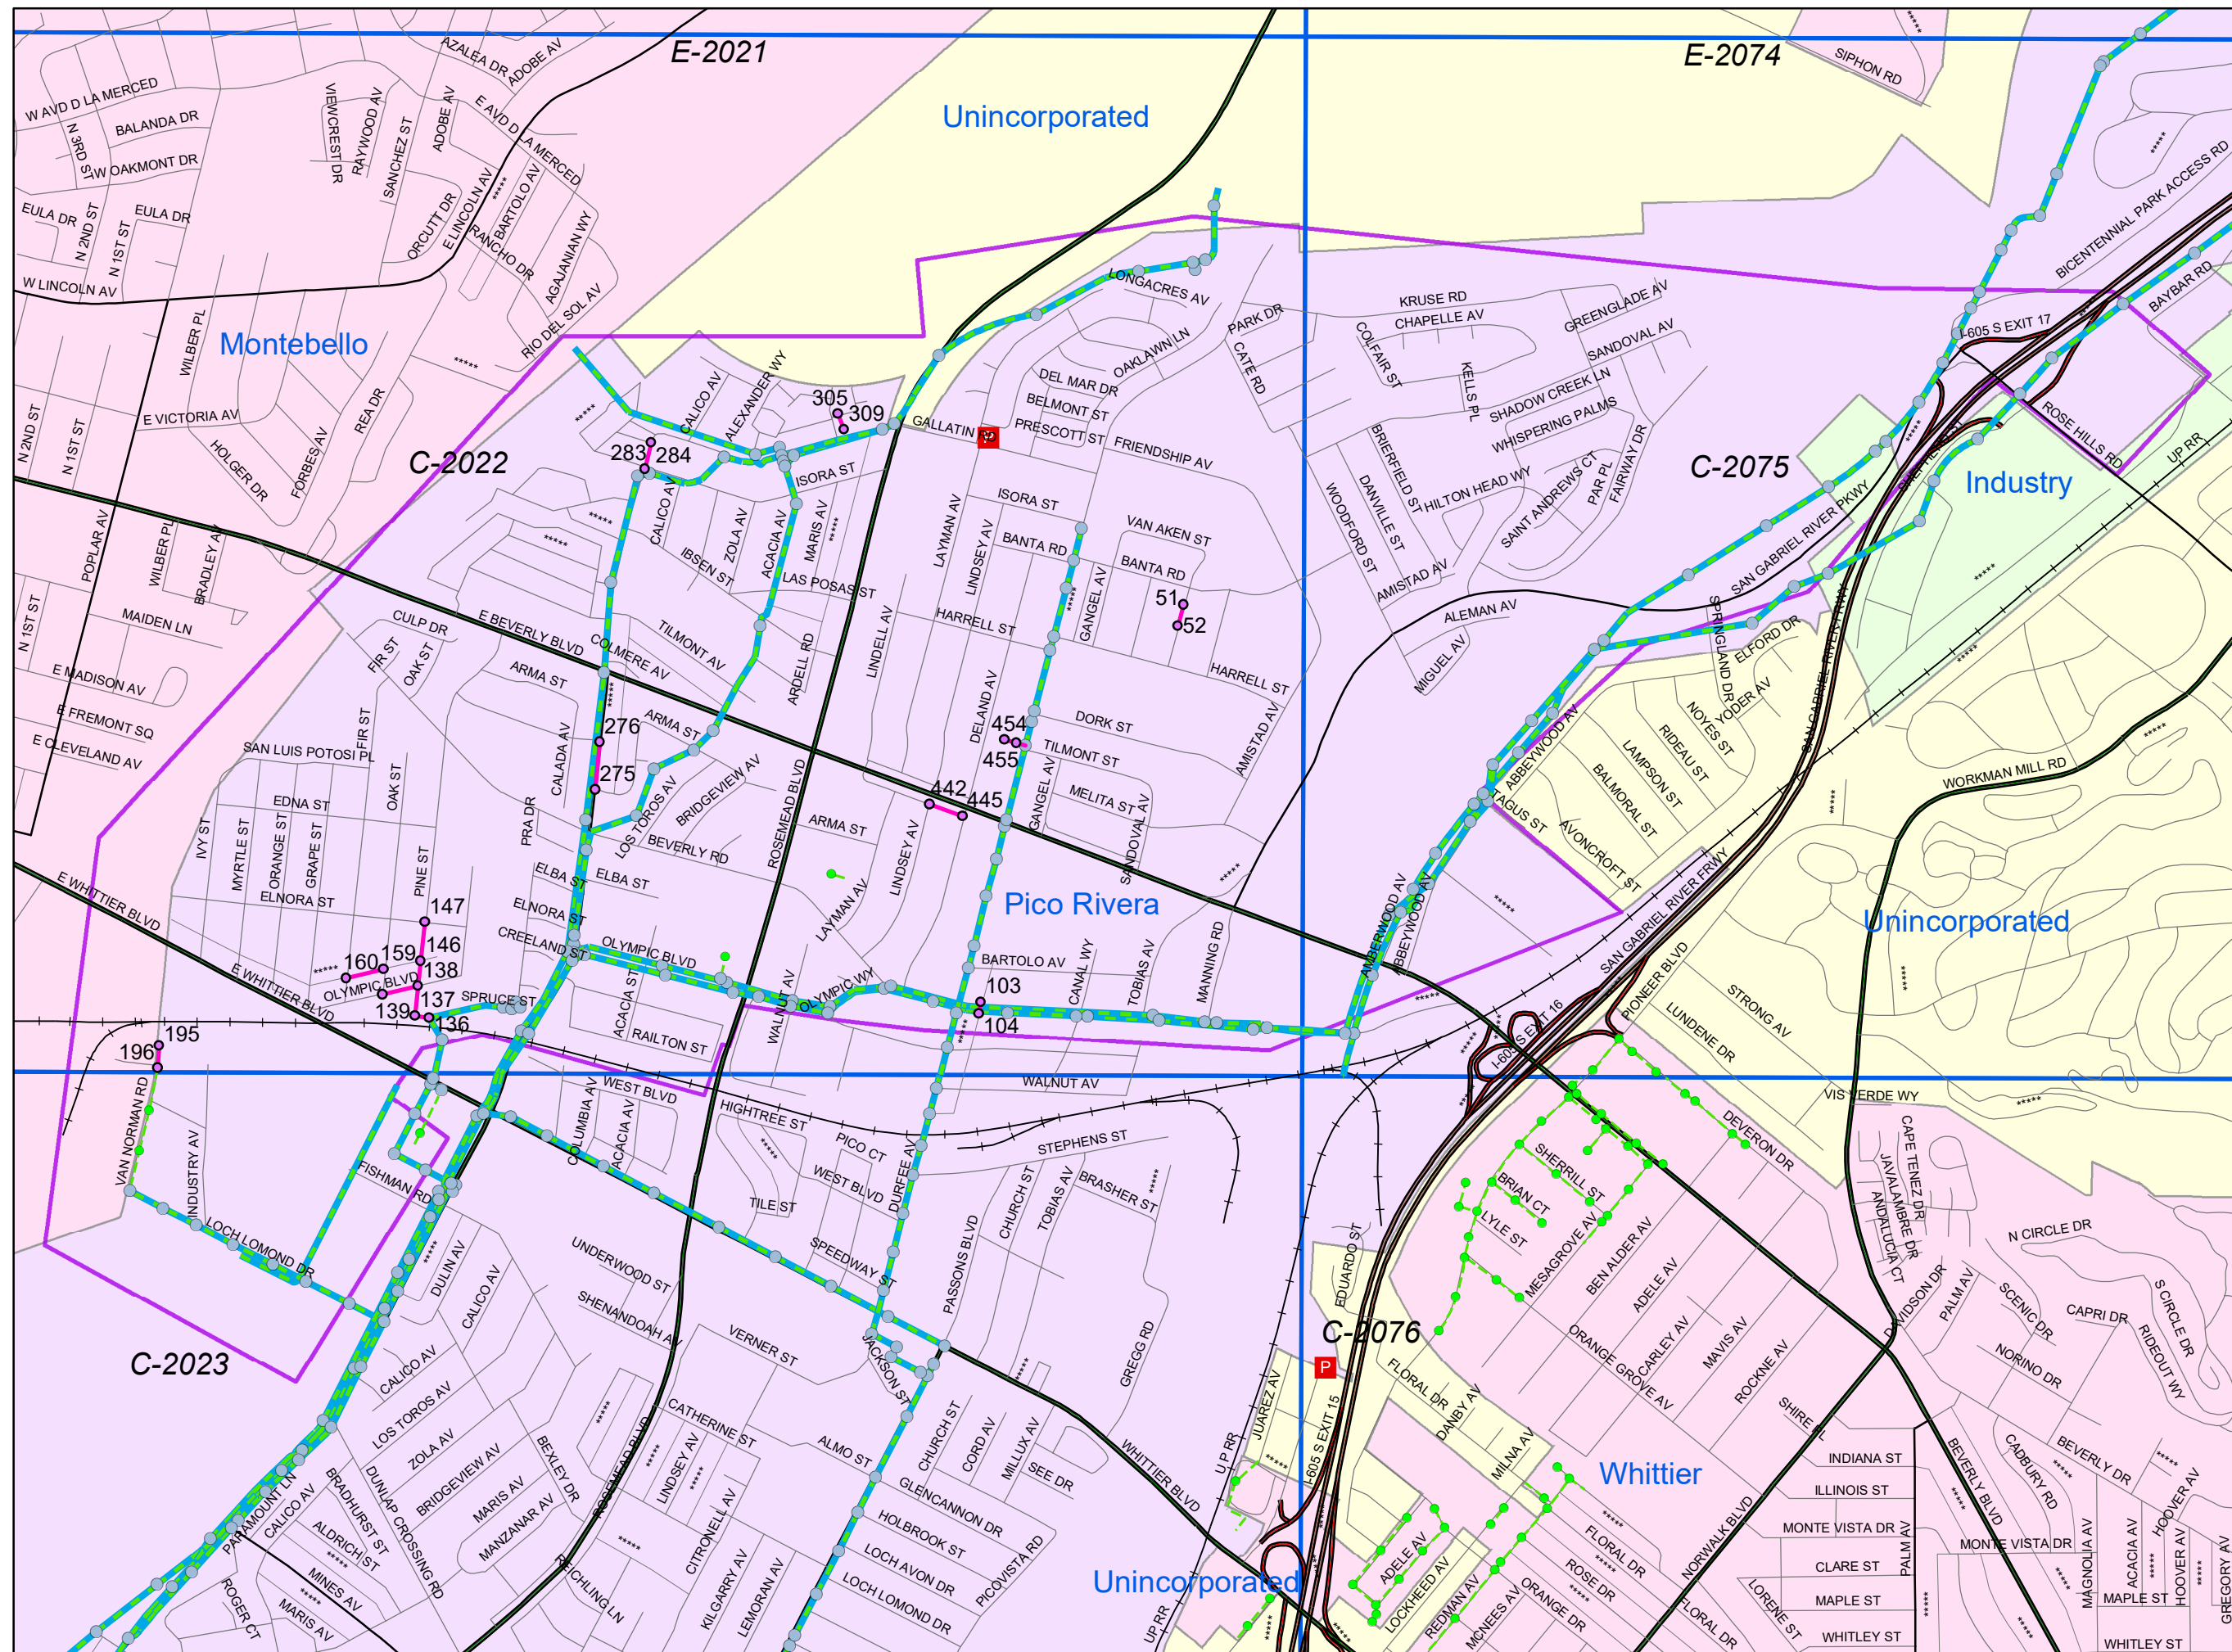
HIGH WATER LEVELS

Our inspection revealed that approximately 97.7 percent of the system televised has adequate capacity. Approximately 2.3 percent of the segments inspected exhibited visual signs associated with high-water levels. The capacity of the sewer pipe can be determined by analyzing several PACP codes, including Water Level, Water Mark, and miscellaneous remarks, which indicate the camera was underwater or there were sags in the line. A sewer pipe is considered at capacity when 50 percent of the diameter of the sewer pipe is full of water. However, there are conditions in which the Water Level or Water Mark has reached 50 percent or greater due to heavy flows in adjoining pipes, a temporary stoppage caused by debris in the sewer lines, or a sag in the line. Therefore, additional review of these pipe segments was conducted to determine if any capacity issues exist.

All sewer pipes where the Water Level, Water Mark, and miscellaneous remarks of camera underwater or sags in the line are at or above 50 percent capacity have been listed and analyzed on the High-Water Level Table in Enclosure 2. The nature of these high-water level conditions is also summarized on this table. When the items have been identified to have high water levels due to sewer line capacity, a Yes is indicated in the capacity column. These areas should be reviewed by the City for existing and future capacity needs.

ITEM NO.	START MH	END MH	STREET	OBSERVATION: LOCATION	CAPACITY	CORRECTIVE ACTION
1	2022-0051	2022-0052	WARRINGTON AV	Camera underwater	NO	Hydro
2	2022-0103	2022-0104	BEVERLY RD	High water level	NO	Hydro
3	2022-0136	2022-0137	SPRUCE ST	Camera underwater	NO	Hydro
4	2022-0137	2022-0138	PINE ST	Camera underwater	NO	Hydro
5	2022-0138	2022-0139	OLYMPIC BV	Camera underwater	NO	Hydro
6	2022-0138	2022-0146	PINE ST	High water level	NO	Hydro
7	2022-0146	2022-0147	PINE ST	High water level	NO	Hydro
8	2022-0159	2022-0160	ALLEY	Camera underwater	NO	Hydro
9	2022-0195	2022-0196	VAN NORMAN RD	Camera underwater	NO	Hydro
10	2022-0275	2022-0276	PARAMOUNT BV	High water level	NO	Hydro
11	2022-0283	2022-0284	PARAMOUNT BV	Camera underwater	NO	Hydro
12	2022-0305	2022-0309		Camera underwater	NO	Hydro
13	2022-0442	2022-0445	BEVERLY BV	Camera underwater	NO	Hydro
14	2022-0454	2022-0455		Camera underwater	NO	Hydro
15	2022-0455	2022-TRNK		Camera underwater	NO	Hydro

16	2074-0044	2074-0043	FAWCETT AV	Camera underwater	NO	Hydro

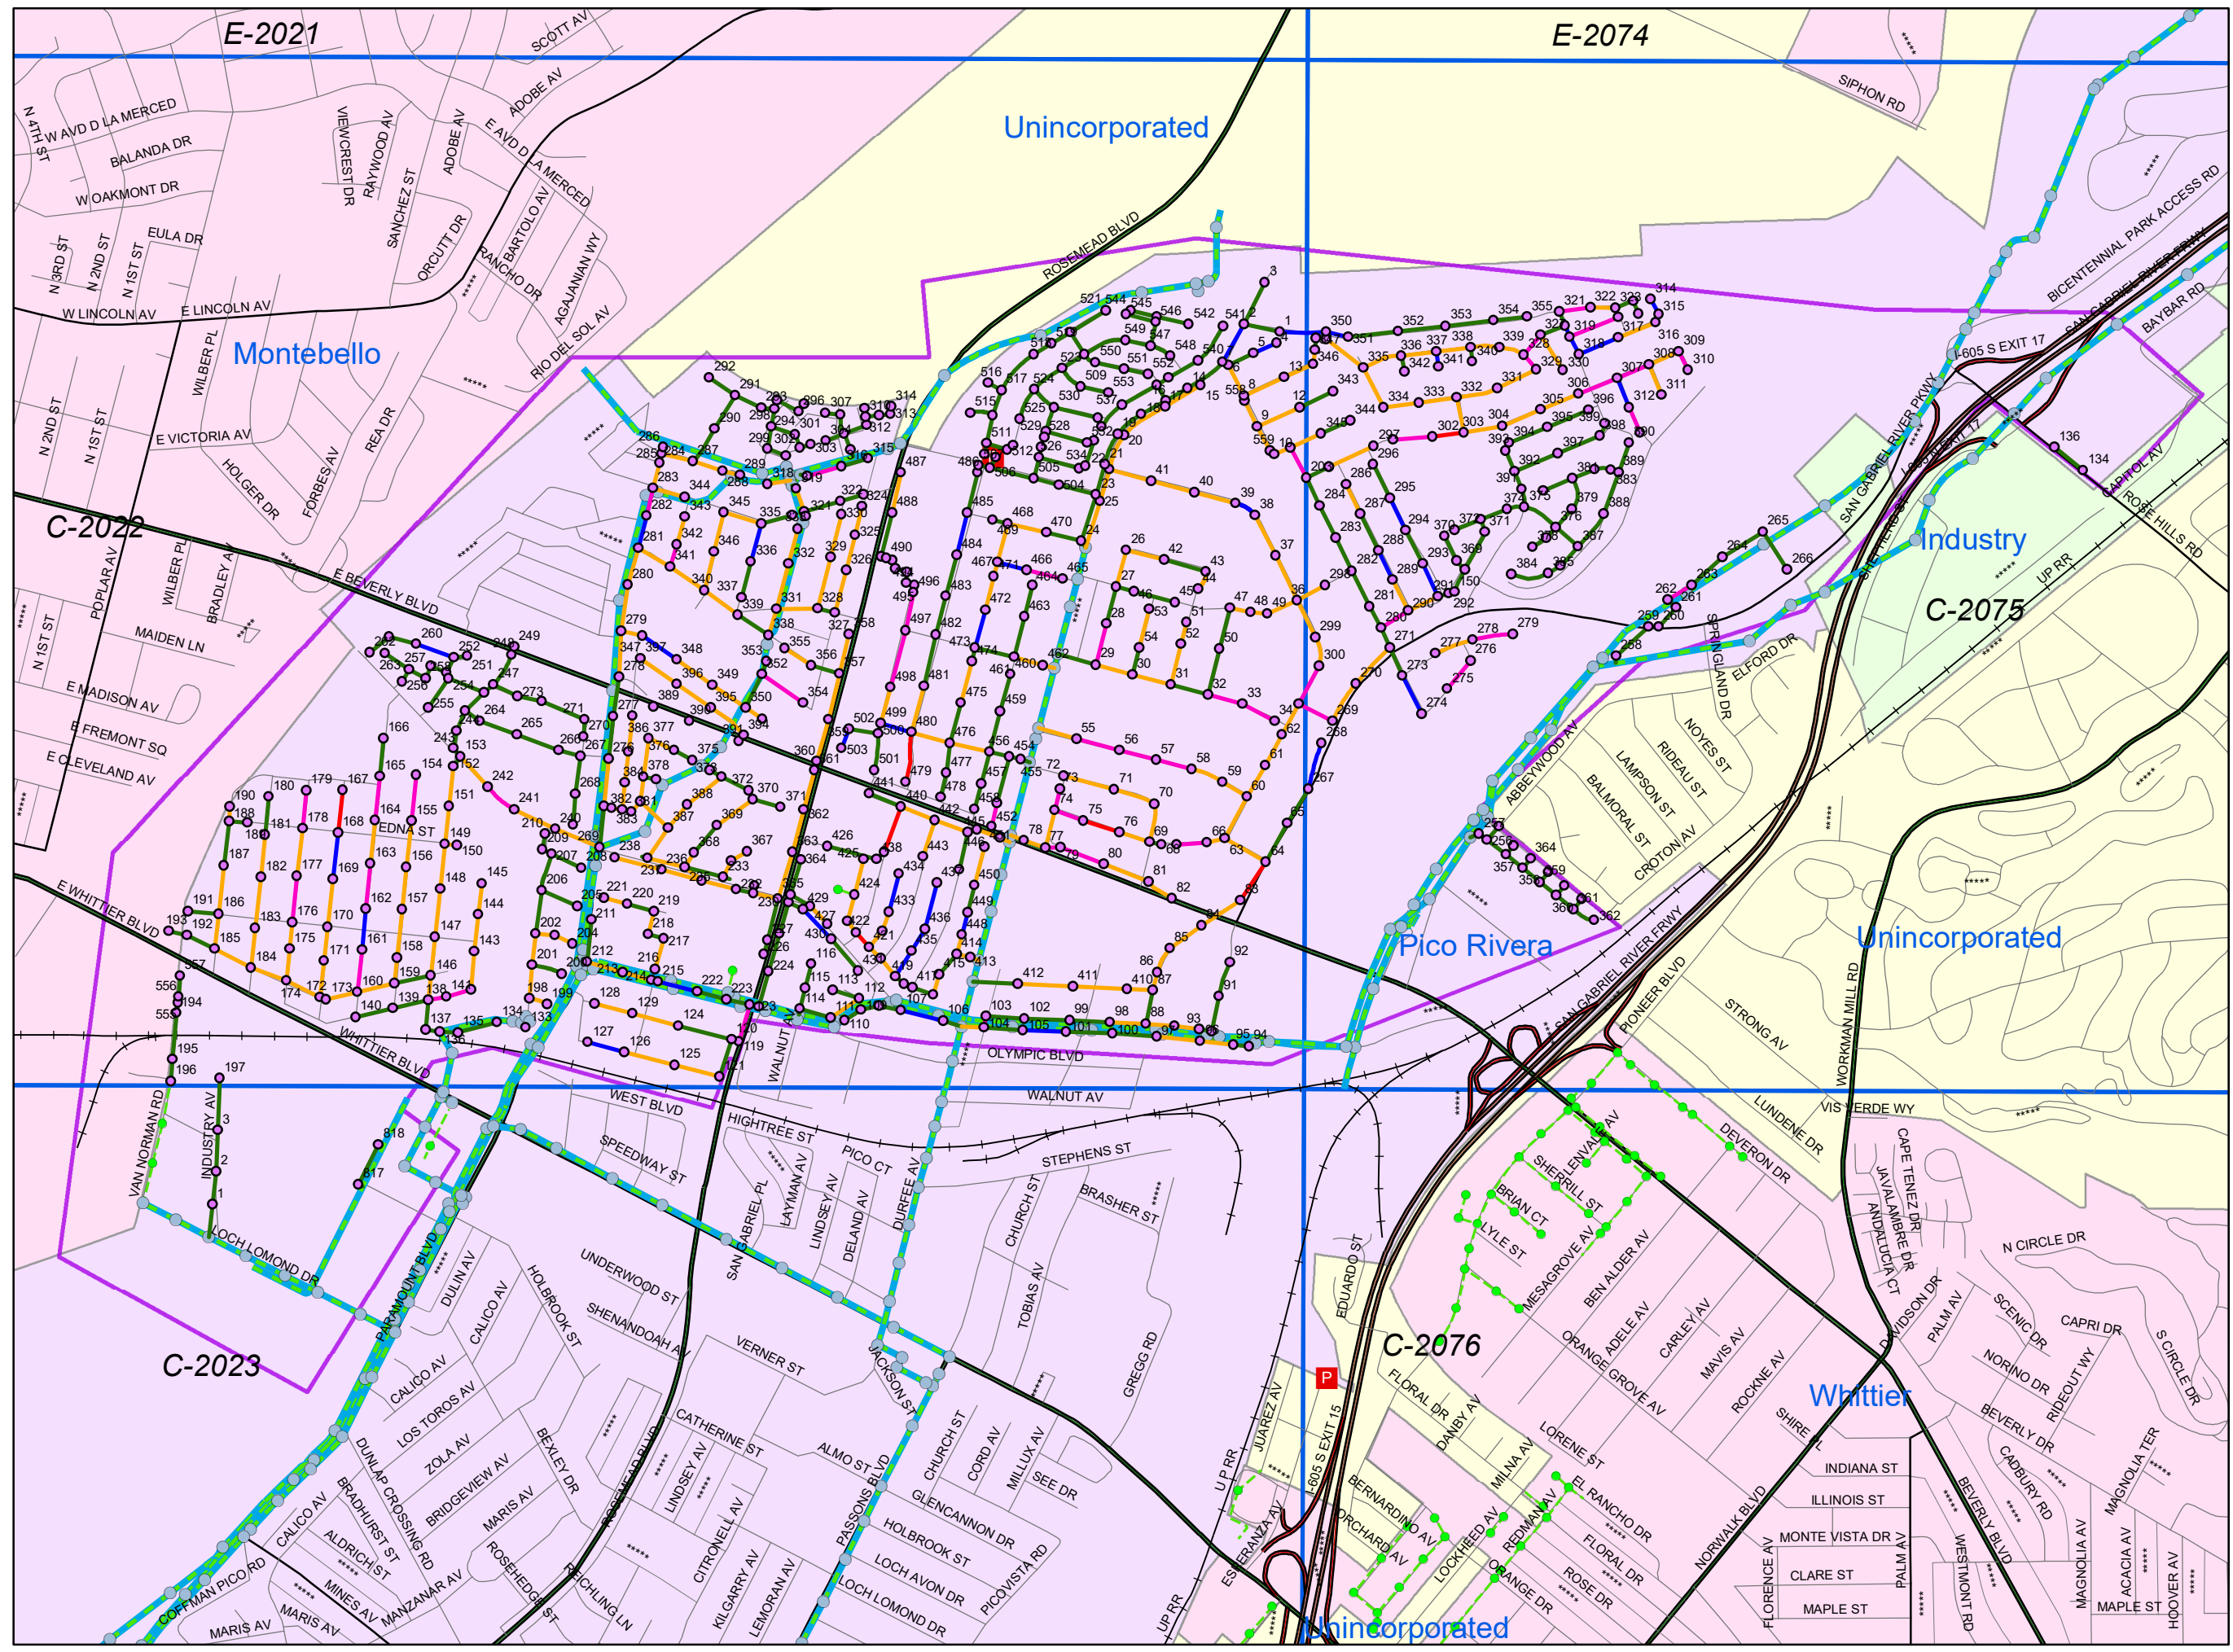
PICO RIVERA
QUICK
STRUCTURAL
RATING
(QSR)

Our inspection revealed that approximately 91.0 percent of the inspected pipe segments within the City were free of severe structural defects. The remaining 9.0 percent of the inspected pipe segments had a PACP structural grade of 4 or 5 as indicated in the Quick Structural Rating Table shown below. These segments have been placed on a priority list for rehabilitations based on the severity and the need for action. For items 1 through 55 in the Quick Structural Rating Report Priority List (Enclosure 3), which warrant a corrective action, the proposed corrective action will be programmed in the next 24 months as part of the ongoing Accumulative Capital Outlay Program.

ITEM NO.	START MH	END MH	STREET	OBSERVATION	PROPOSED CORRECTIVE ACTION
1	2022-0479	2022-0480	LAYMAN AV	Holes	Lining
2	2022-0167	2022-0168	GRAPE ST	Broken; Fractures	Lining
3	2022-0075	2022-0076	MELITA ST	Broken	Lining
4	2022-0421	2022-0422	EASEMENT	Broken	Lining
5	2022-0064	2022-0083	TOBIAS AV	Hole	No action needed*
6	2075-0302	2075-0303	SANDOVAL AV	Hole; Fractures	Lining
7	2022-0439	2022-0440	LAYMAN AV	Hole	No action needed*
8	2075-0274	2075-0275	MIGUEL AV	Fractures	Lining
9	2075-0203	2022-0011	WOODFORD ST	Fractures	Lining
10	2022-0138	2022-0141	OLYMPIC BV	Fractures	Lining
11	2075-0300	2022-0035	AMISTAD AV	Fractures	Lining
12	2022-0160	2022-0161	FIR ST	Fractures	Lining
13	2022-0162	2022-0163	FIR ST	Fractures	Lining
14	2075-0275	2075-0276	MIGUEL AV	Fractures	Lining
15	2022-0079	2022-0080	BEVERLY BV	Fractures	Lining
16	2022-0057	2022-0058	DORK ST	Fractures	Lining
17	2022-0073	2022-0074	GANGEL AV	Fractures	Lining

18	2022-0141	2022-0142	OLYMPIC BV	Fractures	No action needed*
19	2075-0301	2075-0302	SANDOVAL AV	Fractures	Lining
20	2022-0066	2022-0067	MELITA ST	Fractures	No action needed*
21	2022-0055	2022-0056	DORK ST	Fractures	No action needed*
22	2022-0056	2022-0057	DORK ST	Fractures	No action needed*
23	2022-0077	2022-0079	BEVERLY BV	Fractures	No action needed*
24	2022-0154	2022-0155	OAK ST	Fractures	No action needed*
25	2022-0164	2022-0165	FIR ST	Fractures	No action needed*
26	2022-0178	2022-0179	ORANGE ST	Fractures	No action needed*
27	2075-0306	2075-0307	SANDOVAL AV	Fractures	No action needed*
28	2022-0176	2022-0177	ORANGE ST	Fractures	No action needed*
29	2022-0282	2022-0283	PARAMOUNT BV	Fractures	No action needed*

ITEM NO.	START MH	END MH	STREET	OBSERVATION	PROPOSED CORRECTIVE ACTION
30	2022-0352	2022-0354	ARDELL RD	Fractures	No action needed*
31	2022-0074	2022-0075	MELITA ST	Fractures	No action needed*
32	2024-0488	2024-0487	ALLEY	Broken	No action needed*
33	2075-0269	2022-0035	EASEMENT	Fractures	No action needed*
34	2022-0241	2022-0242	BEVERLY RD	Fractures	Lining
35	2022-0496	2022-0497	LINDELL AV	Fractures	No action needed*
36	2022-0497	2022-0498	LINDELL AV	Fractures	No action needed*
37	2075-0278	2075-0279	ALEMAN AV	Fractures	No action needed*
38	2075-0307	2075-0308	SANDOVAL AV	Fractures	No action needed*
39	2075-0327	2075-0328	EASEMENT	Fractures	Lining
40	2075-0321	2075-0322	KRUSE RD	Fractures	No action needed*
41	2075-0328	2075-0329	CHAPELLE AV	Fractures	Lining
42	2022-0119	2022-0123	ROSEMEAD BV	Fractures	No action needed*
43	2022-0465	2022-0466	BANTA RD	Fractures	No action needed*
44	2075-0280	2075-0290	AMISTAD AV	Fractures	No action needed*

45	2075-0312	2075-0313	BRADGATE DR	Fractures	No action needed*
46	2022-0316	2022-0317	GALLATIN BV	Broken	No action needed*
47	2022-0341	2022-0342	CALICO AV	Fractures	No action needed*
48	2022-0032	2022-0033	HARRELL ST	Fractures	No action needed*
49	2022-0033	2022-0034	HARRELL ST	Fractures	No action needed*
50	2075-0309	2075-0310	SANDOVAL AV	Fractures	No action needed*
51	2022-0028	2022-0029	GANGEL AV	Fractures	No action needed*
52	2022-0103	2022-0104	BEVERLY RD	Fractures	No action needed*
53	2022-0452	2022-0453	EASEMENT	Fractures	Lining
54	2075-0262	2075-0263	EASEMENT	Fractures	No action needed*
55	2075-0319	2075-0326	EASEMENT	Fractures	No action needed*

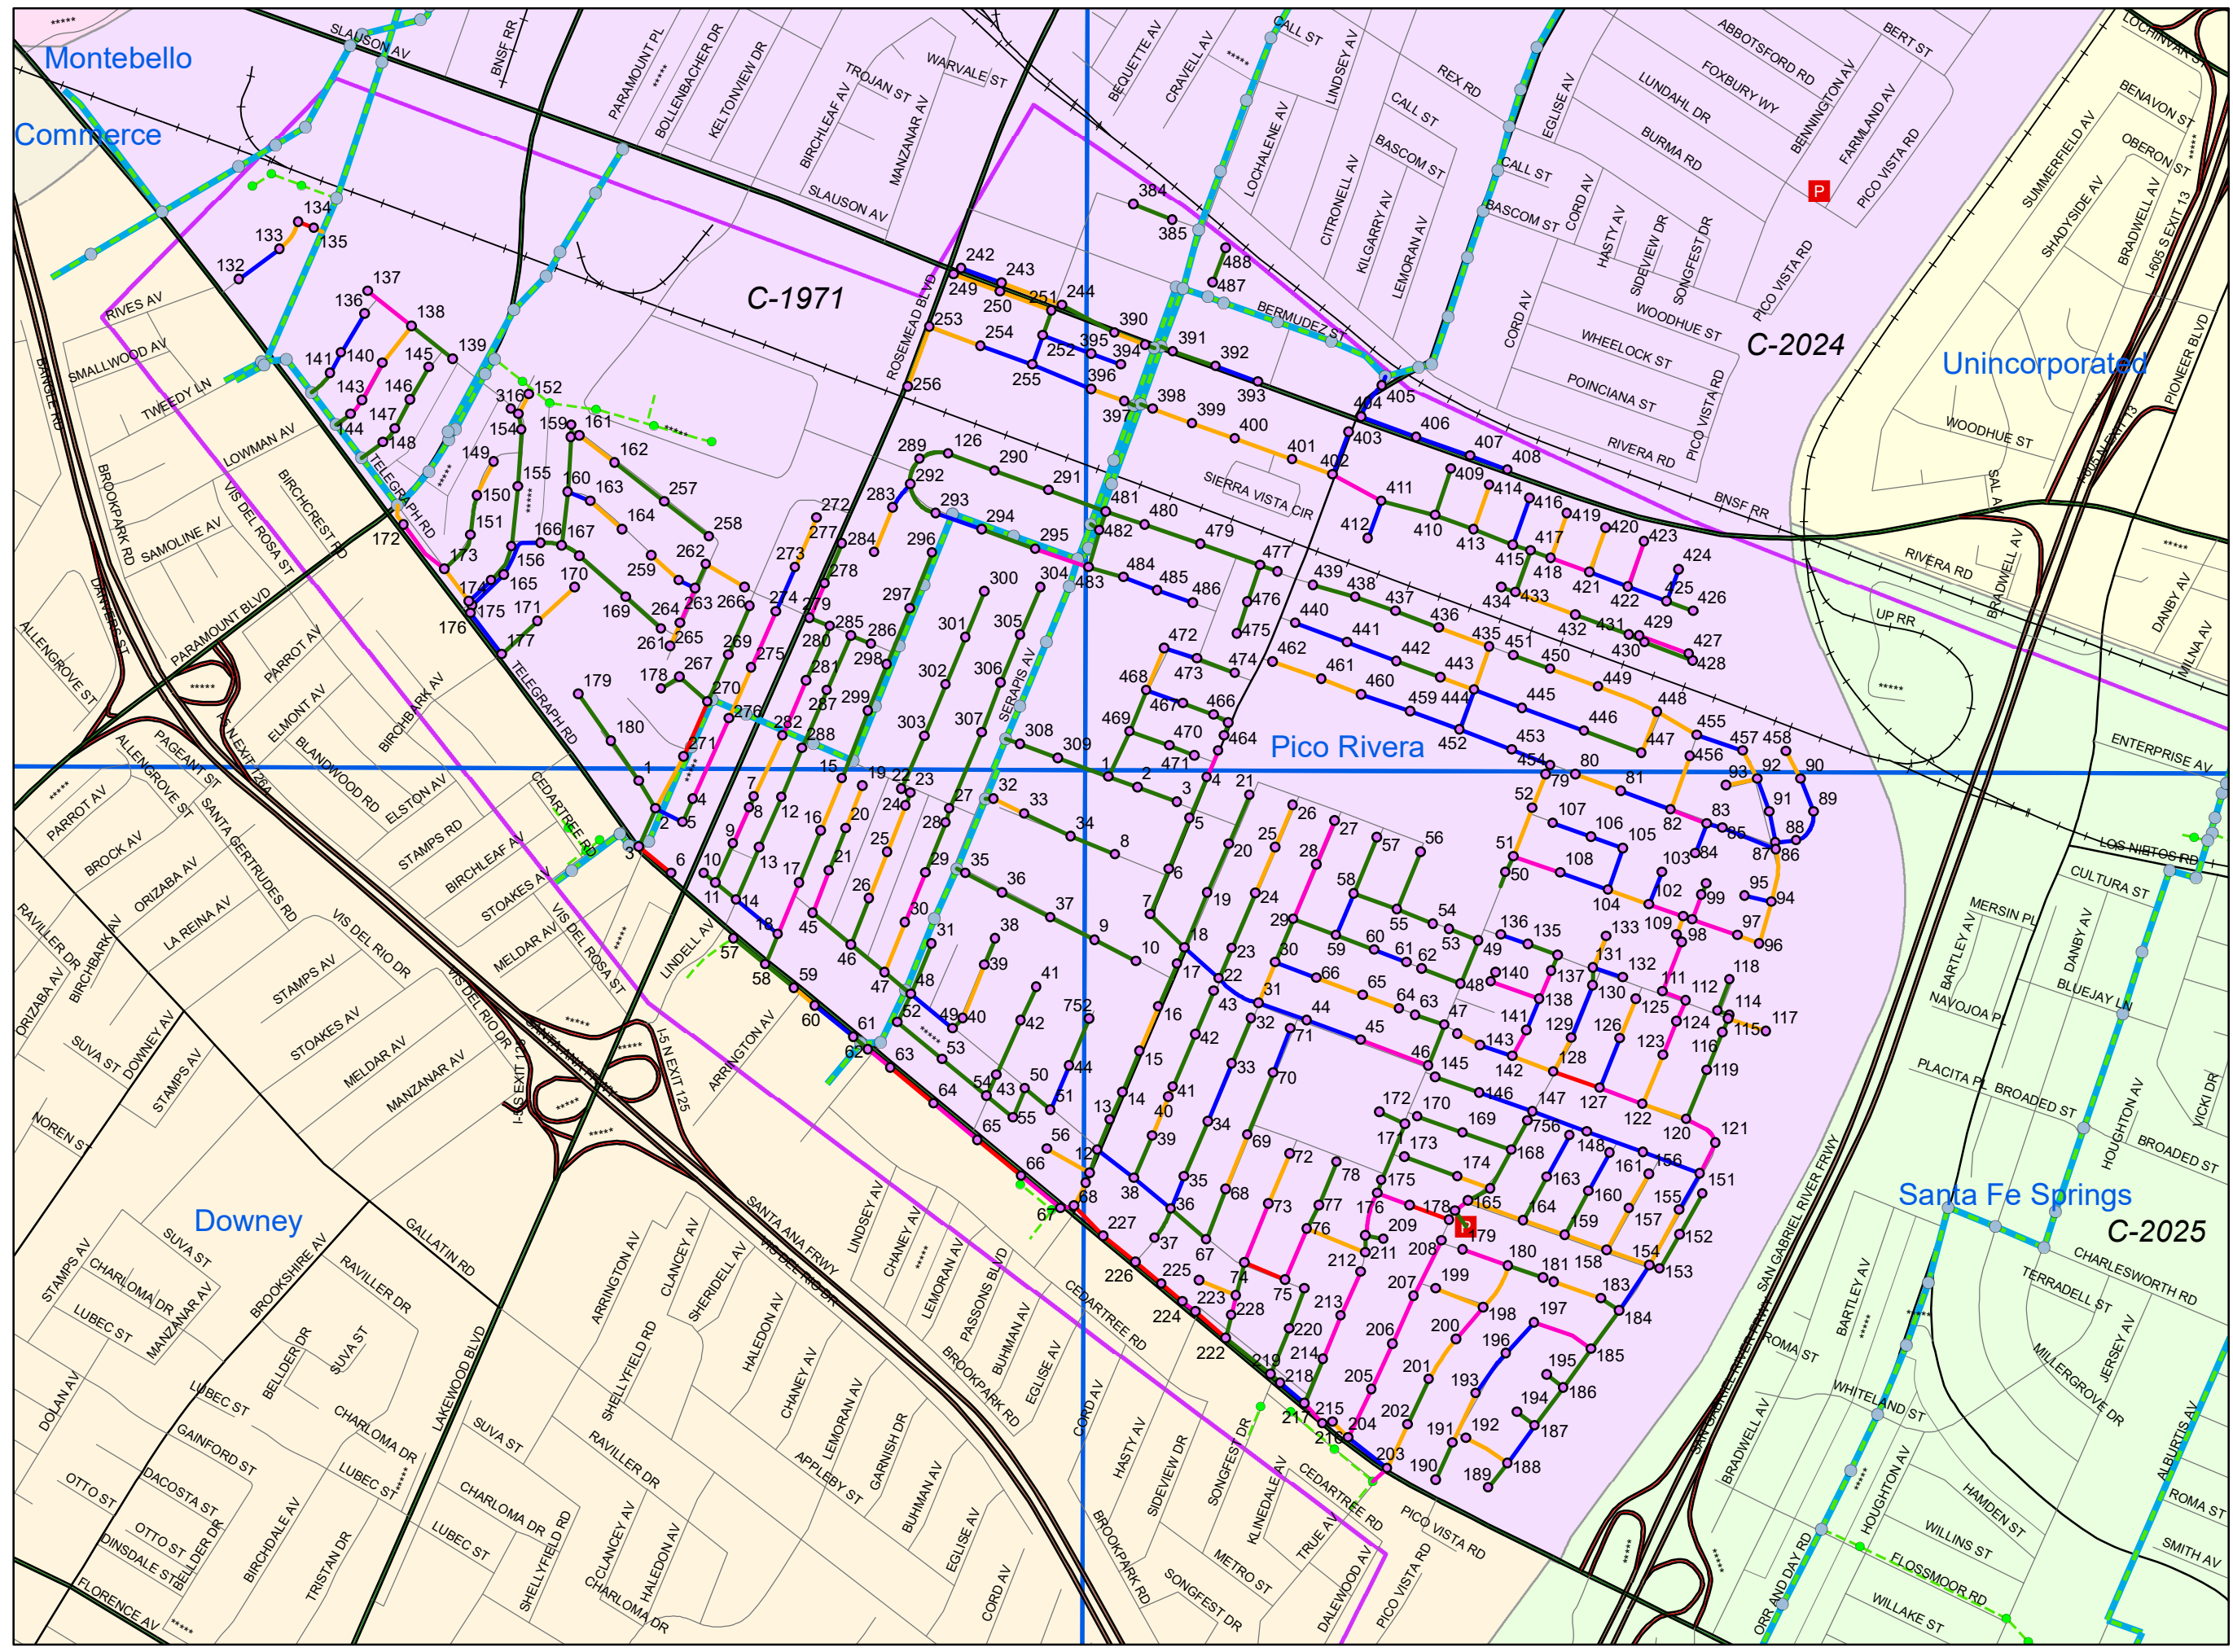
QUICK
MAINTENANCE
RATING
(QMR)

Our inspection revealed that approximately 64.2 percent of the system televised in your City as part of Project No. Y0TV1011B was free of significant blockages or restrictions that would impede sewer flows. The remaining 35.8 percent of the pipe segments had a PACP maintenance grade of 3, 4, or 5 as indicated in the Quick Maintenance Rating Table shown below. These segments have been incorporated into our periodic cleaning schedule for enhanced maintenance.

DEFECT GRADE	PIPE LENGTH (FT)	PERCENT TOTAL INSPECTED PIPE LENGTH	NO. OF SEGMENTS
1: Minor	57,022	45.2	244
2: Minor to Moderate	24,145	19.0	96
3: Moderate	26,572	21.1	105
4: Significant	15,222	12.1	59
5: Most Significant	3,219	2.6	13
TOTAL	126,180	100.0	517

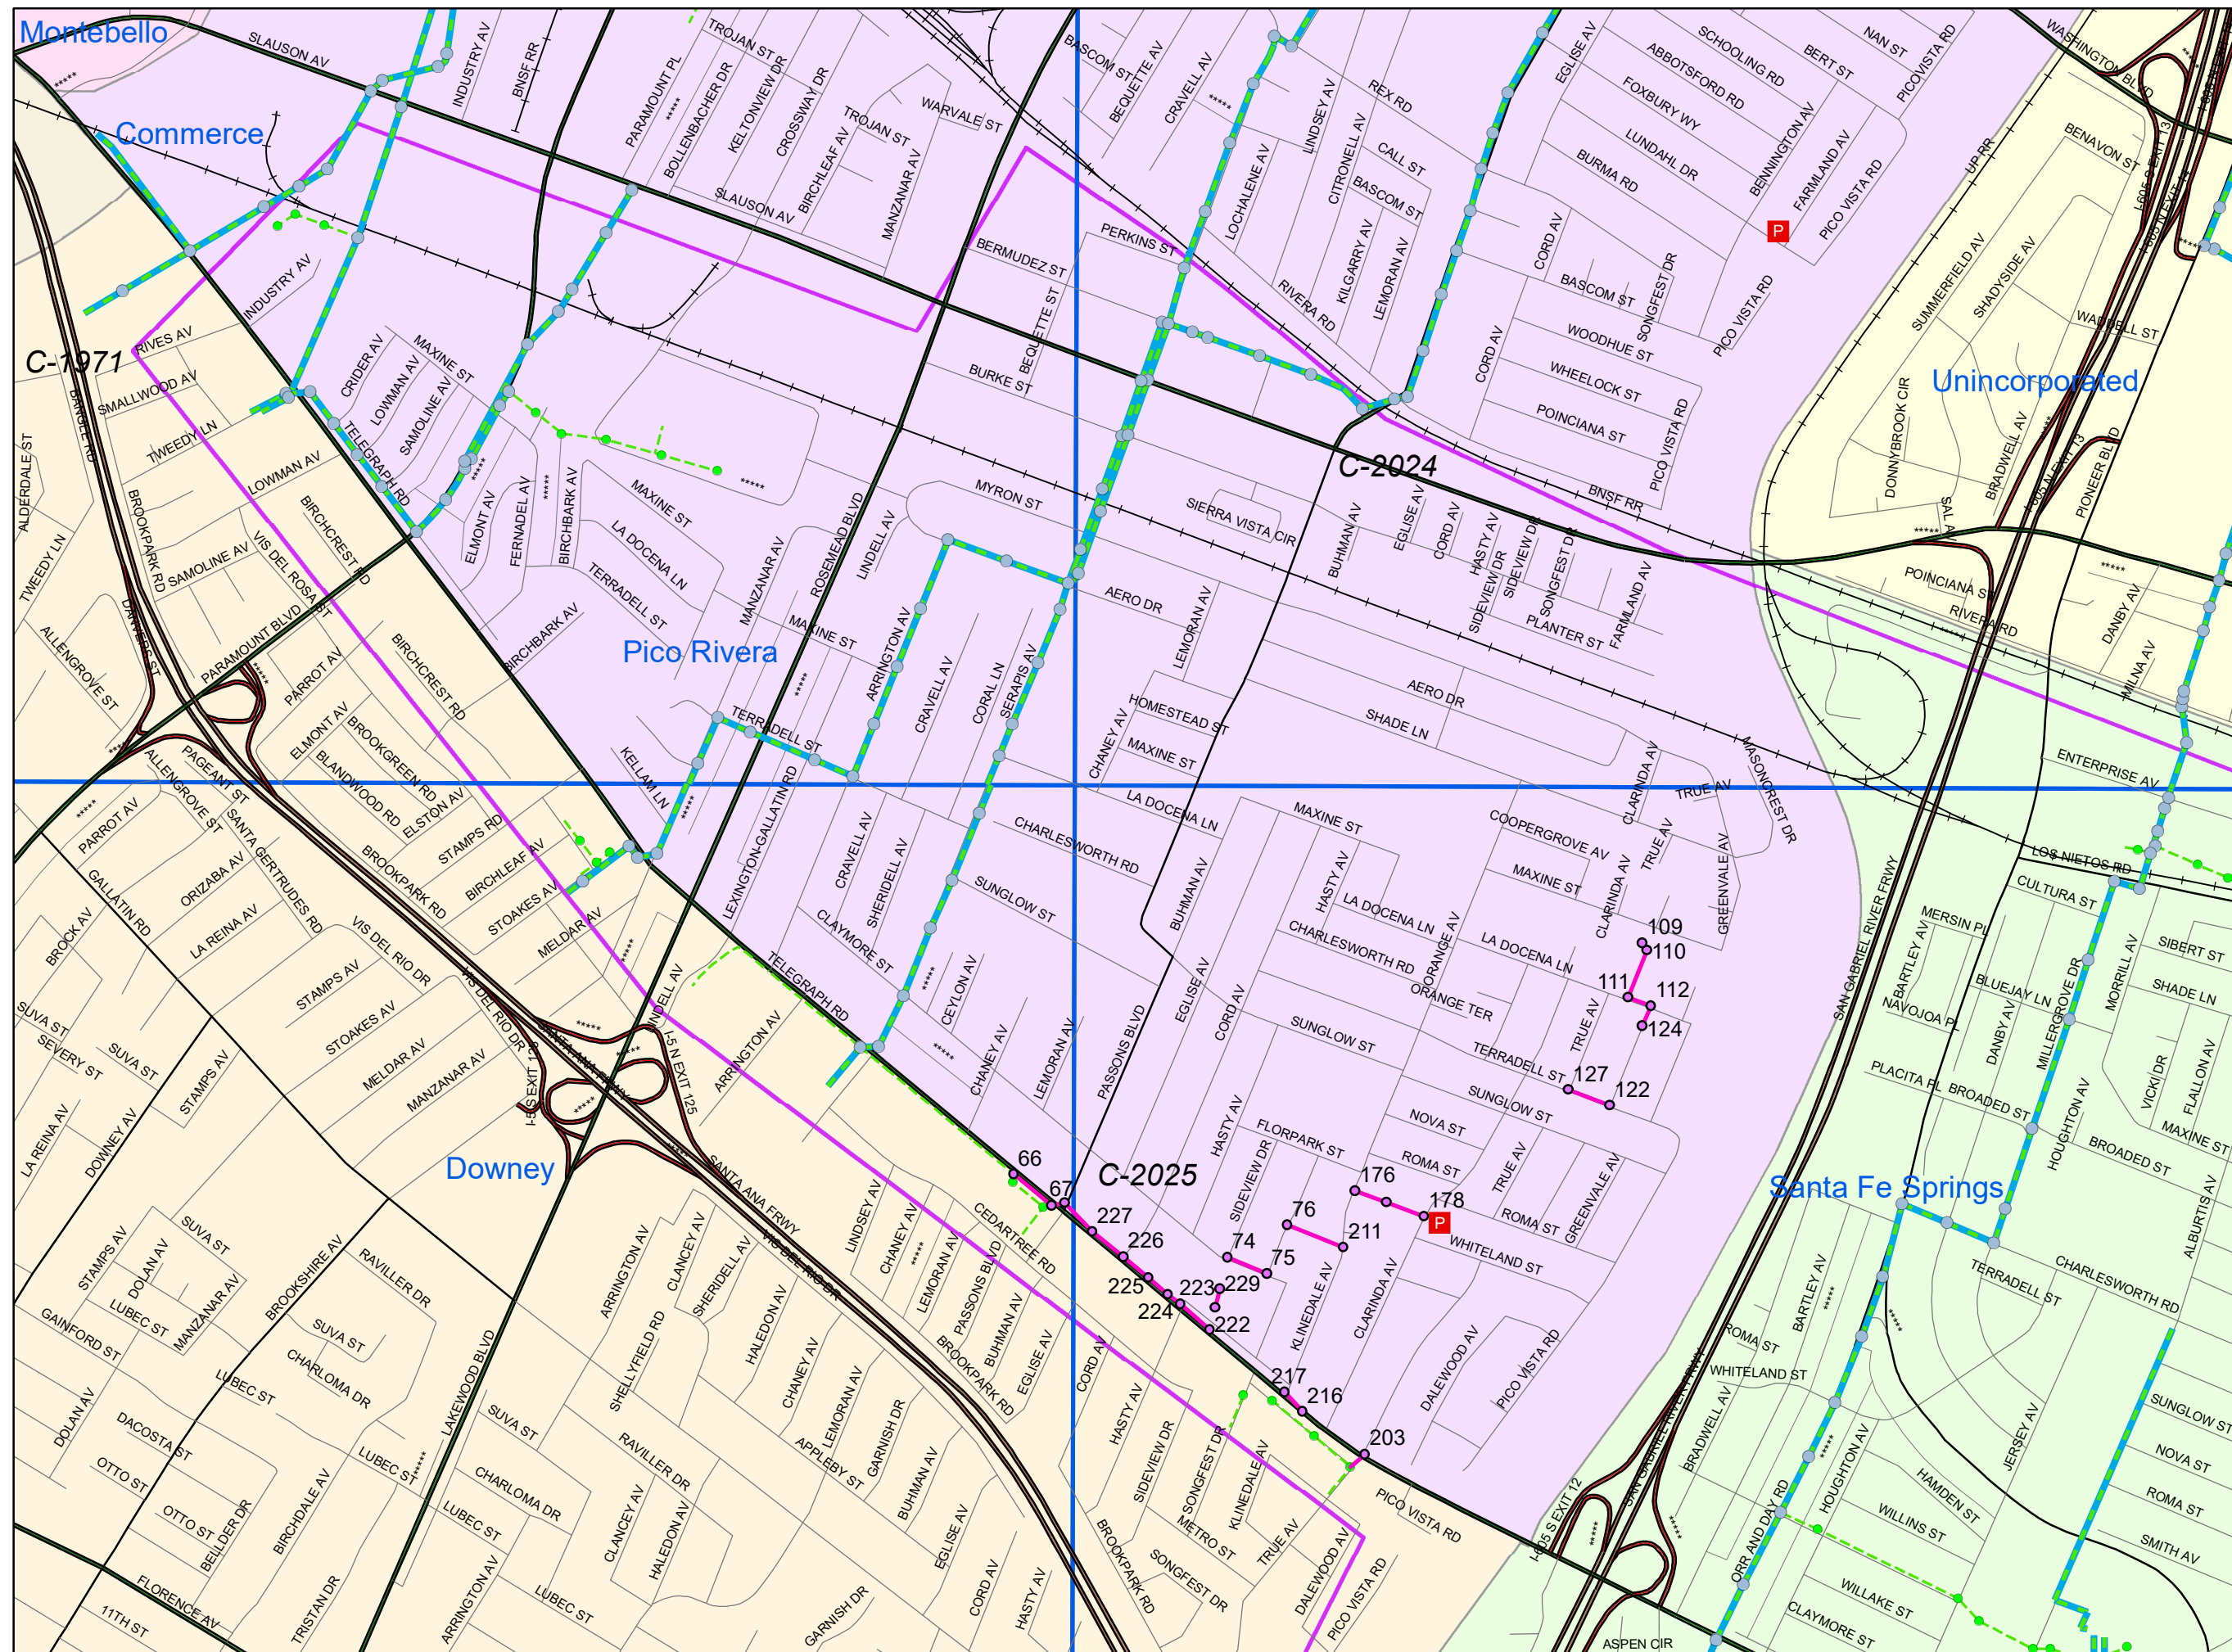
HIGH WATER LEVELS

Our inspection revealed that approximately 96.1 percent of the system televised has adequate capacity. Approximately 3.9 percent of the segments inspected exhibited visual signs associated with high-water levels. The capacity of the sewer pipe can be determined by analyzing several PACP codes, including Water Level, Water Mark, and miscellaneous remarks, which indicate the camera was underwater or there were sags in the line. A sewer pipe is considered at capacity when 50 percent of the diameter of the sewer pipe is full of water. However, there are conditions in which the Water Level or Water Mark has reached 50 percent or greater due to heavy flows in adjoining pipes, a temporary stoppage caused by debris in the sewer lines, or a sag in the line. Therefore, additional review of these pipe segments was conducted to determine if any capacity issues exist.

All sewer pipes where the Water Level, Water Mark, and miscellaneous remarks of camera underwater or sags in the line are at or above 50 percent capacity have been listed and analyzed on the High-Water Level Table in Enclosure 2. The nature of these high-water level conditions is also summarized on this table. When the items have been identified to have high-water levels due to sewer line capacity, a Yes is indicated in the capacity column. These areas should be reviewed by the City for existing and future capacity needs.

ITEM NO.	START MH	END MH	STREET	OBSERVATION: LOCATION	CAPACITY	CORRECTIVE ACTION
1	1972-0067	1972-0066	TELEGRAPH RD	Camera underwater	NO	Hydro
2	1972-0068	1972-0067	TELEGRAPH RD	Camera underwater	NO	Hydro
3	2025-0075	2025-0074	CLAYMORE ST	High water mark	NO	Hydro
4	2025-0109	2025-0110	EASEMENT	High water level	NO	Hydro
5	2025-0111	2025-0110	EASEMENT	Camera underwater	NO	Hydro
6	2025-0111	2025-0112	LA DOCENA LN	High water level	NO	Hydro
7	2025-0112	2025-0124	DALEWOOD AV	Camera underwater	NO	Hydro
8	2025-0127	2025-0122	TERRADELL ST	Camera underwater	NO	Hydro
9	2025-0177	2025-0176	FLORPARK ST	High water mark	NO	Hydro
10	2025-0178	2025-0177	FLORPARK ST	High water mark	NO	Hydro
11	2025-0211	2025-0076	HAMDEN ST	High water mark	NO	Hydro
12	2025-0216	2025-0217	TELEGRAPH RD	High water level	NO	Hydro
13	2025-0222	2025-0223	TELEGRAPH RD	High water mark	NO	Hydro
14	2025-0223	2025-0224	TELEGRAPH RD	High water mark	NO	Hydro

15	2025-0224	2025-0225	TELEGRAPH RD	High water level	NO	Hydro
16	2025-0225	2025-0226	TELEGRAPH RD	High water mark	NO	Hydro and Rodder
17	2025-0226	2025-0227	TELEGRAPH RD	High water mark	NO	Hydro
18	2025-0227	1972-0068	TELEGRAPH RD	High water mark	NO	Hydro
19	2025-0229	2025-0228	EASEMENT	High water mark	NO	Hydro
20	2025-CITY	2025-0203	TELEGRAPH RD	High water mark	NO	Hydro
