CONSOLIDATED SEWER MAINTENANCE DISTRICT CONDITION-ASSESSMENT PROGRAM REPORT PROJECT NO. Y0TV0910B AND Y0TV1011B

**CONDITION-ASSESSMENT REPORT
LOS ANGELES COUNTY PUBLIC WORKS
CONSOLIDATED SEWER MAINTENANCE DISTRICT**

PROJECT NAME: Y0TV0910B	PROJECT MGR: Kari Eskridge
PROJECT DATE: 7/21/2010	CONTACT NO: (626) 300-3390
SUP. DISTRICT(s): 1	MAP PAGE(S): 2022, 2023, 2075
Report By: David Lee	Report Date: 9/9/2019

PROJECT NAME:	Y0TV1011B	PROJECT MGR:	Hanna Kebede
PROJECT DATE:	8/3/2011	CONTACT NO:	(626) 300-4686
SUP. DISTRICT(s):	1	MAP PAGE(S):	1971, 1972, 2024, 2025
Report By:	David Lee	Report Date:	9/3/2019

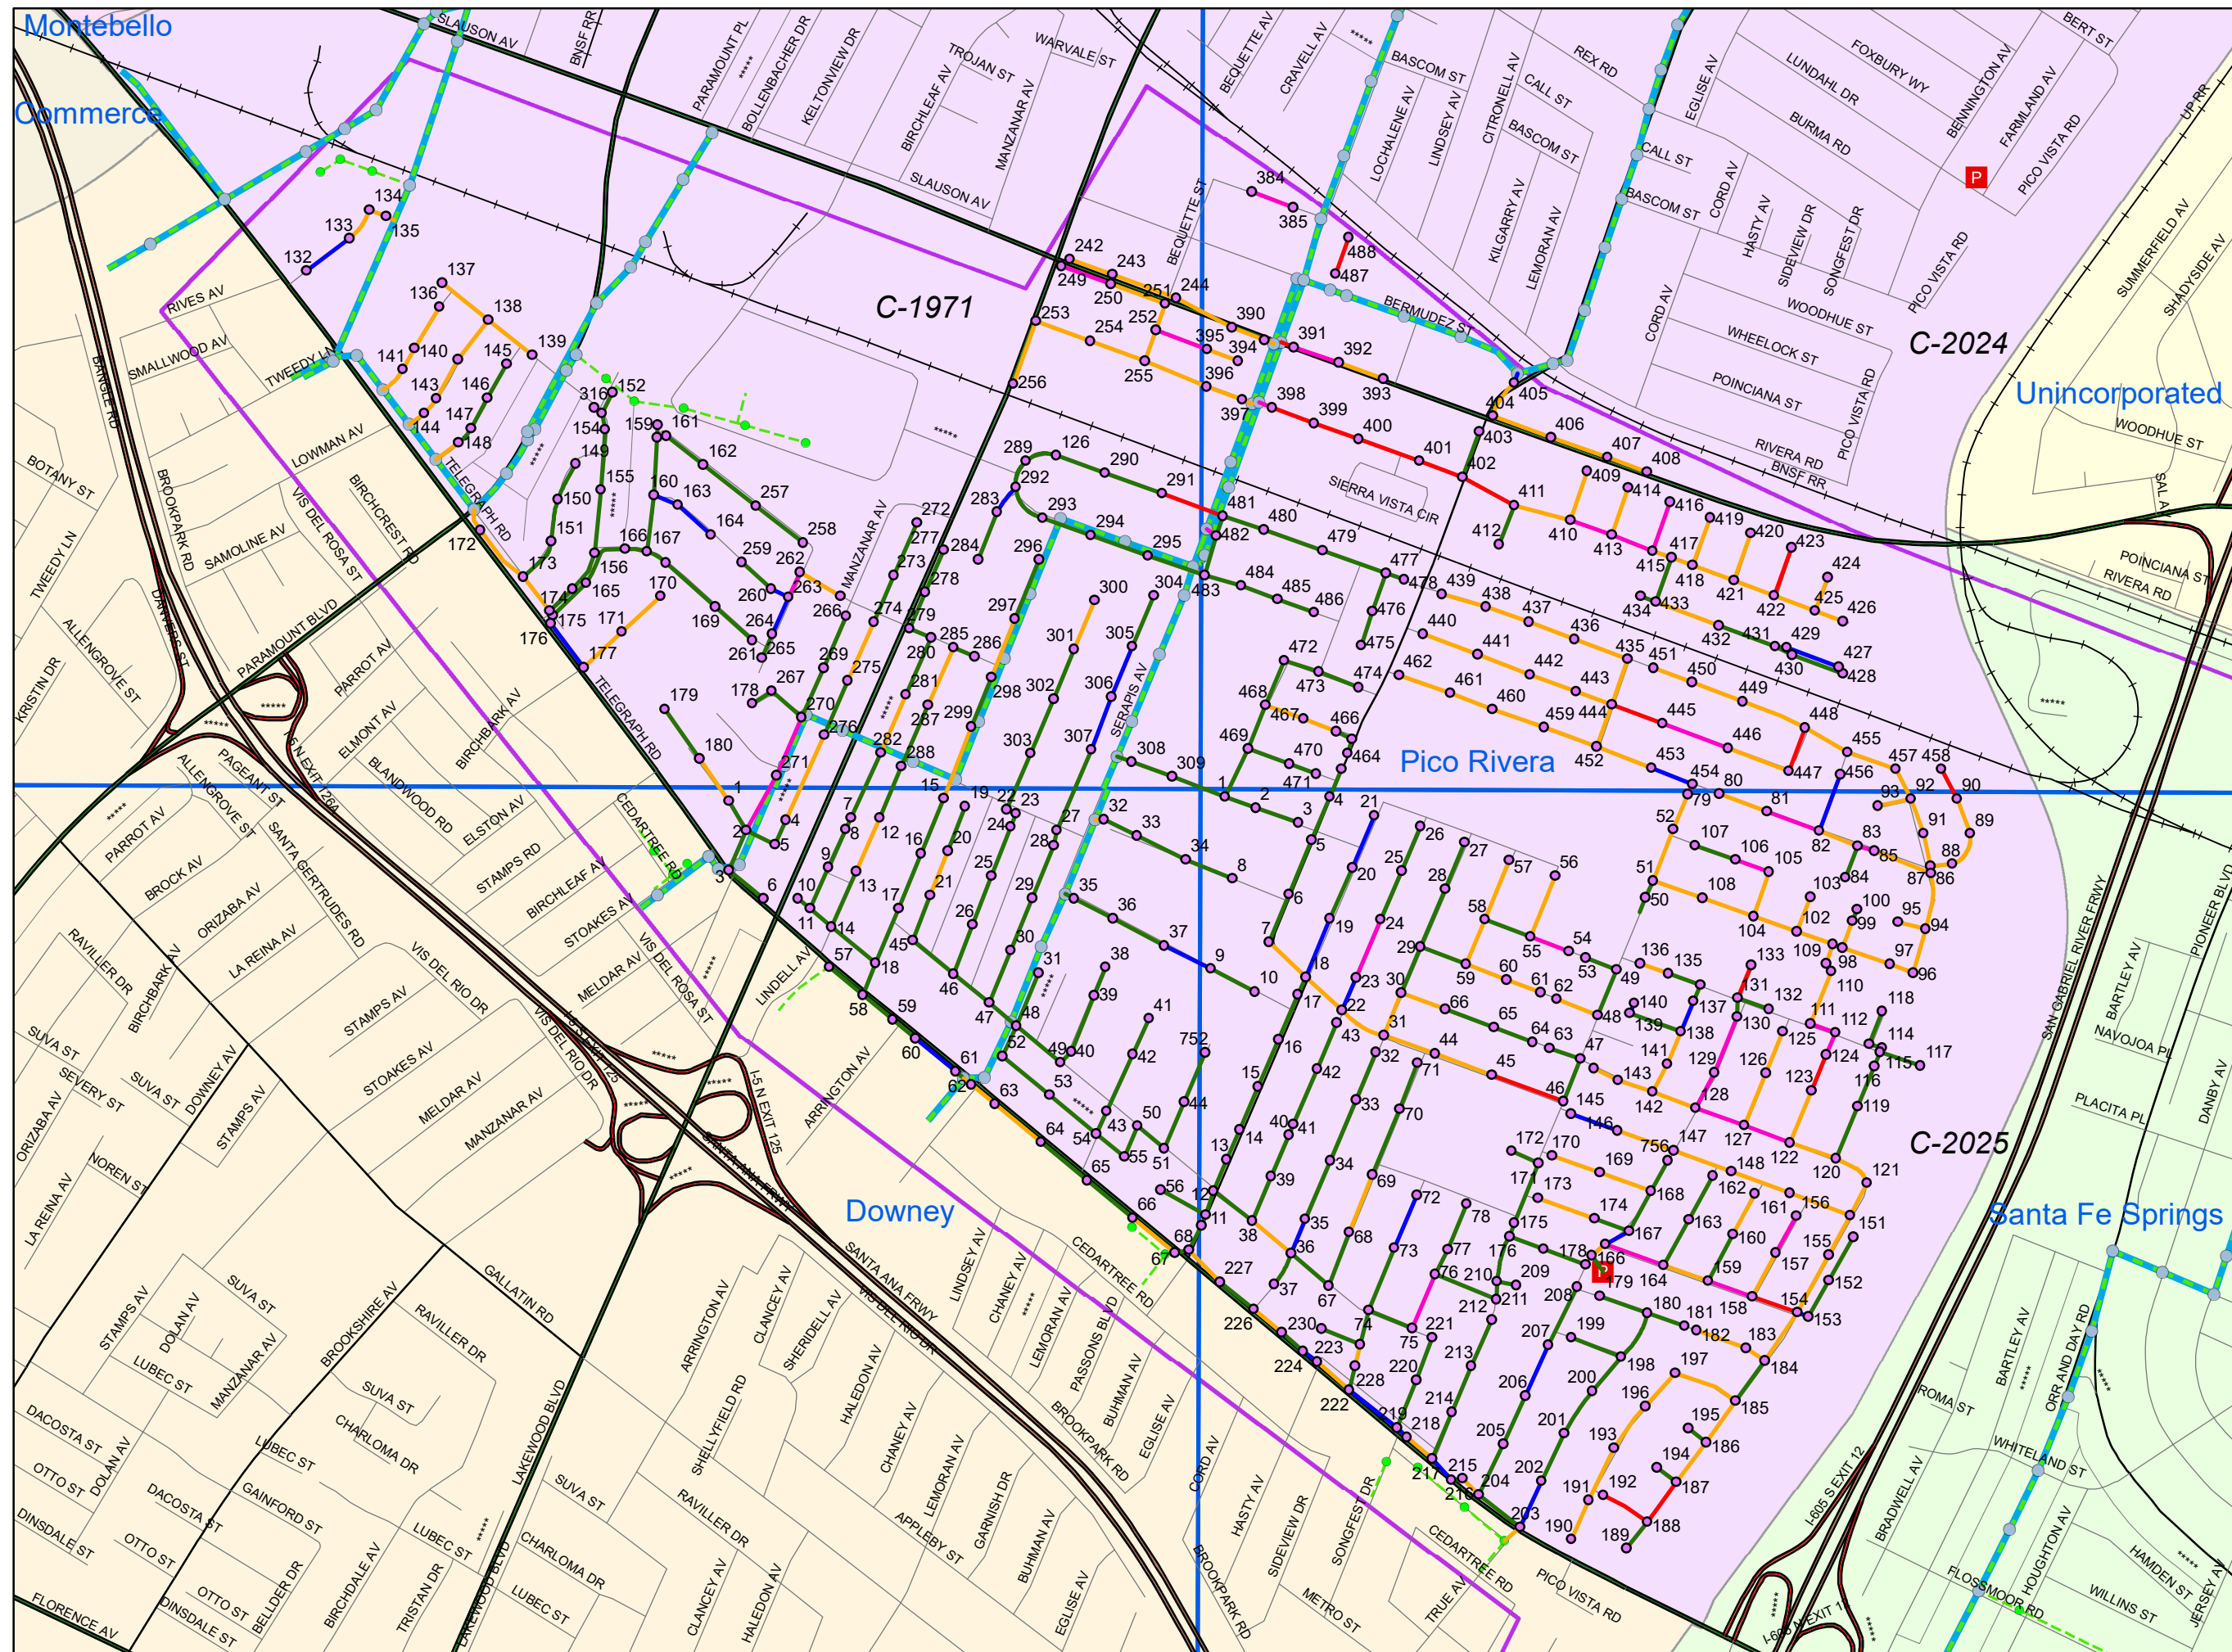
QUICK STRUCTURAL RATING (QSR)

Our inspection revealed that approximately 90.6 percent of the inspected pipe segments within the City were free of severe structural defects. The remaining 9.4 percent of the inspected pipe segments had a PACP structural grade of 4 or 5 as indicated in the Quick Structural Rating Table shown below. These segments have been placed on a priority list for rehabilitations based on the severity and the need for action. For items 1 through 47 in the Quick Structural Rating Report Priority List (Enclosure 3), which warrant a corrective action, the proposed corrective action will be programmed in the next 24 months as part of the ongoing Accumulative Capital Outlay Program.

ITEM NO.	START MH	END MH	STREET	OBSERVATION	PROPOSED CORRECTIVE ACTION
1	2024-0400	2024-0399	BURKE ST	Broken; Fractures	Lining
2	2024-0445	2024-0444	AERO DR	Fracture	No action needed*
3	2025-0188	2025-0192	CLAYMORE ST	Broken	Point Repair
4	2025-0046	2025-0045	SUNGLOW ST	Broken	Point Repair
5	2025-0124	2025-0123	DALEWOOD AV	Fracture	No action needed*
6	2024-0423	2024-0422	BENNINGTON AV	Broken	Lining
7	2024-0402	2024-0401	BURKE ST	Hole at base of MH	Manhole base repair
8	2024-0401	2024-0400	BURKE ST	Broken	No action needed*
9	2024-0399	2024-0398	BURKE ST	Hole	No action needed*
10	2024-0447	2024-0448	AERO DR	Broken; Fractures	Lining
11	2024-0458	2025-0090	MASONCREST DR	Hole at base of MH	Manhole base repair
12	2025-0154	2025-0158	ROMA ST	Broken	No action needed*
13	2024-0391	2024-TRNK	SLAUSON AV	Broken	No action needed*
14	2025-0131	2025-0133	CLARINDA AV	Hole at base of MH	Manhole base repair
15	2024-0487	2024-0488	ALLEY	Hole at base of MH	No action needed*

16	2024-0411	2024-0402	BURKE ST	Hole	Lining
17	2025-0188	2025-0187	PICO VISTA RD	Hole at base of MH	Manhole base repair
18	2024-0481	1971-0291	MYRON ST	Broken	Lining
19	2024-0416	2024-0415	HASTY AV	Fractures	No action needed*
20	2025-0127	2025-0122	TERRADELL ST	Fractures	No action needed*
21	2025-0112	2025-0124	DALEWOOD AV	Cracks	No action needed*
22	2024-0445	2024-0446	AERO DR	Fractures	No action needed*
23	1971-0270	1971-0271	MANZANAR AV	Fractures	No action needed*
24	2024-0415	2024-0413	BURKE ST	Fractures	Lining
25	2024-0454	2025-0079	ORANGE AV	Cracks	No action needed*
26	1971-0271	1972-0002	MANZANAR AV	Cracks	No action needed*
27	2025-0081	2025-0082	SHADE LN	Broken	No action needed*
28	2024-0392	2024-0391	SLAUSON AV	Fracture	No action needed*
29	2025-0158	2025-0159	ROMA ST	Cracks	No action needed*
30	2025-0129	2025-0128	CLARINDA AV	Fracture	No action needed*
31	2025-0164	2025-0165	ROMA ST	Cracks	No action needed*

32	2025-0083	2025-0085	SHADE LN	Cracks	No action needed*
33	1971-0249	1971-0250	SLAUSON AV	Cracks	No action needed*

ITEM NO.	START MH	END MH	STREET	OBSERVATION	PROPOSED CORRECTIVE ACTION
34	2024-0395	1971-0252	ALLEY	Fracture	No action needed*
35	2025-0156	2025-0157	GREENVALE AV	Fracture	No action needed*
36	2025-0128	2025-0127	TERRADELL ST	Cracks	No action needed*
37	2025-0130	2025-0129	CLARINDA AV	Cracks	No action needed*
38	2025-0105	2025-0106	HOMESTEAD ST	Fractures	No action needed*
39	2025-0076	2025-0075	SONGFEST DR	Fractures	No action needed*
40	2025-0111	2025-0112	LA DOCENA LN	Fractures	No action needed*
41	1971-0262	1971-0263	BIRCHLEAF AV	Fractures	No action needed*
42	2025-0054	2025-0055	LA DOCENA LN	Fracture	No action needed*
43	2024-0413	2024-0410	BURKE ST	Fracture	No action needed*
44	2024-0385	2024-0384	PERKINS ST	Fractures	No action needed*
45	2024-0482	2024-TRNK	SERAPIS AV	Broken	Lining
46	2024-0398	2024-TRNK	BURKE ST	Cracks	No action needed*
47	2025-0024	2025-0023	EGLISE AV	Broken	Point Repair
