December 23, 2021

**Subject:** Status Report for the Oak Woodland Habitat Revegetation/Mitigation Program for the Santa Anita Dam Riser Modification and Reservoir Sediment Removal Project, Los Angeles County, California

Enclosures:    Exhibit 1 – Project Vicinity  
                  Exhibit 2 – Sediment Placement Site Locations  
                  Exhibit 3 – Mitigation Site Location (Lower Sediment Placement Site)  
                  Attachment A – Site Photographs  
                  Attachment B – Supplemental Seed and Plant Species (December 2021)

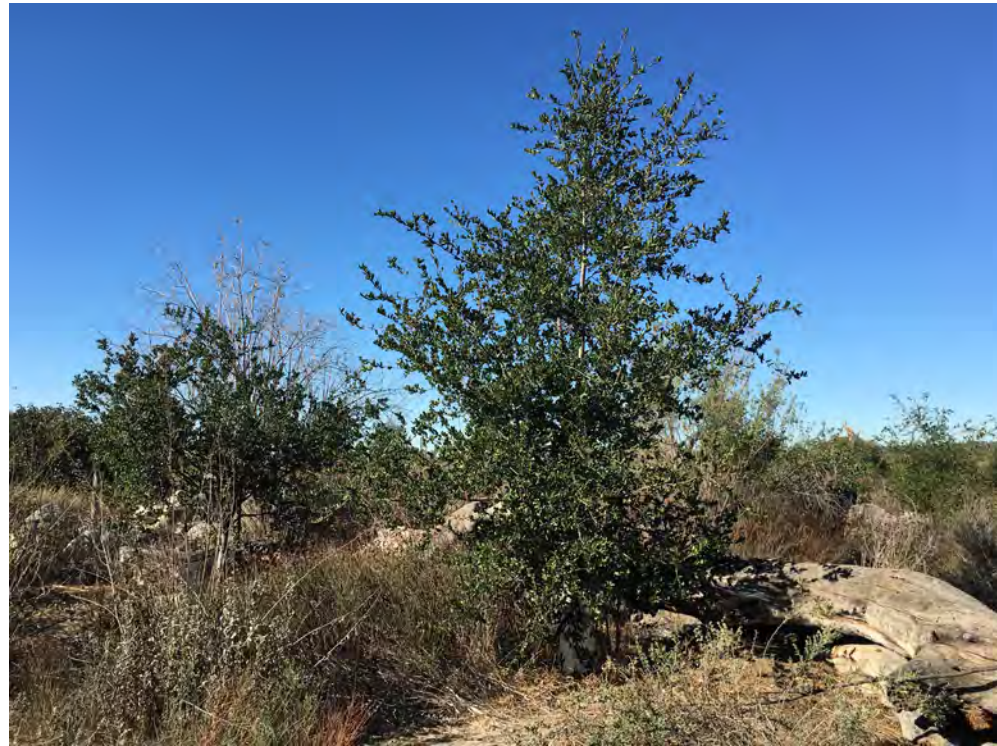
**October 2021.** There was excellent growth and survival of the planted oak species in 2021 despite acute drought conditions during the October 2020 to September 2021 water year.

It is important to note that the overall survival of planted oaks currently exceeds 100 percent on the mitigation site due to the planting of numerous supplemental oaks outside the initially designated 399 oak planting locations. The planted oaks exhibit excellent growth and survival, and there is a diverse mosaic of associated understory vegetation. Many of the oak saplings now exceed 10 to 12 feet in height.

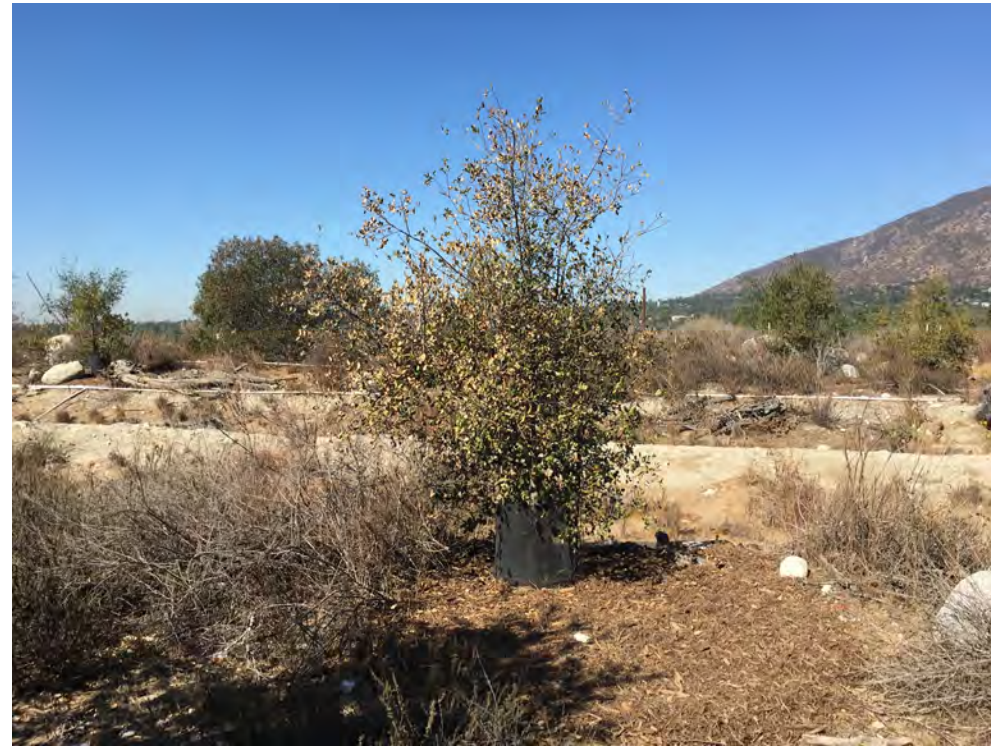
**October 2021.** Approximately 5 percent of the planted oaks exhibited marked drought stress in 2021. Psomas' subcontractor Nakae & Associates applied mulch to the stressed oaks in July and August 2021.

Beginning in July 2021, Psomas’ Certified Arborist (Arborist) performed monthly health evaluations of planted oak trees to identify signs of water stress due to recent drought conditions. While most of the planted oaks exhibited good health during the summer and fall of 2021, approximately 20 oaks (5 percent of the plantings) showed marked drought stress (yellowing leaves and general loss of vigor). To aid the survival of the stressed oaks, the Arborist recommended the placement of approximately 2 inches of certified weed-free mulch (Forest Floor™ by Aguinaga Green, Inc.). Nakae applied the specified mulch over the root zone of the drought-stressed oaks in July 2021 under the supervision of the Arborist. Despite the acute drought conditions, the planted oak population performed well in 2021 without the need for resumption of artificial irrigation. This indicates that the oaks are well-rooted and resilient, 3 years after irrigation was terminated in October 2018.

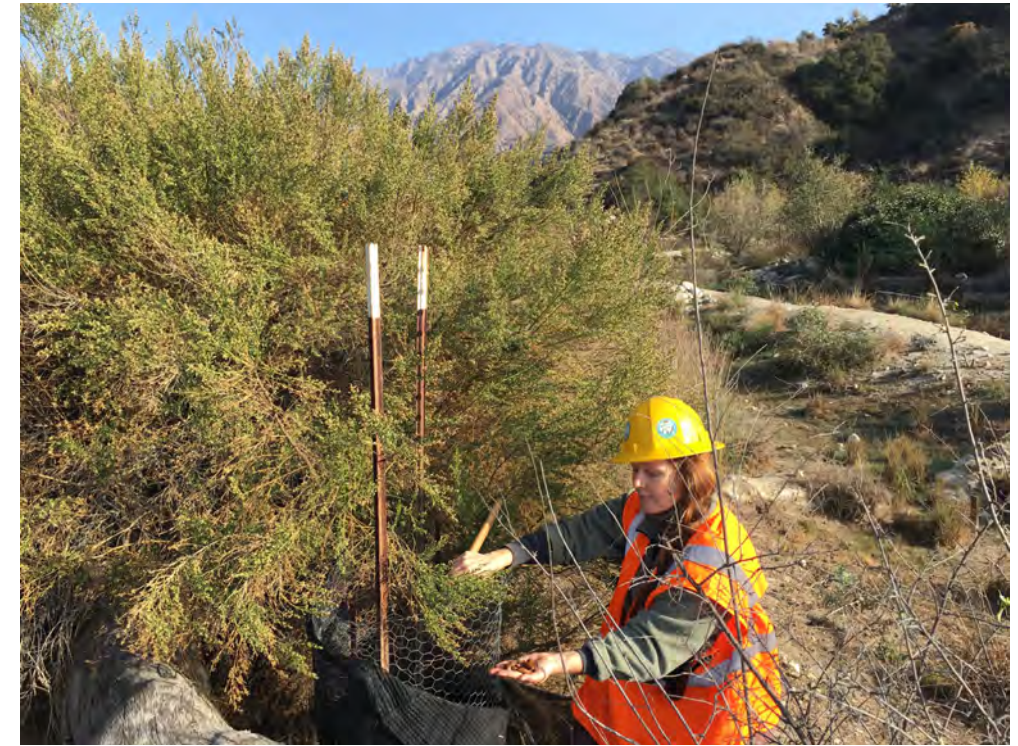
**December 2021.** Psomas' Biological Monitor planted supplemental oak acorns (coast live oak; Engelmann oak) at the planting locations that currently lack a surviving oak.

The Restoration Ecologist planted a total of 10 acorns, 5 of each species (coast live oak and Engelmann oak), at each of the 37 oak planting locations that did not currently support a surviving oak in December 2021. One location was only able to accommodate 5 acorns (*Q. agrifolia*) due to the presence of a dense/brushy dead oak within the cage. Each acorn was placed approximately 1/2–1 inch below the soil and loosely covered with soil, then covered with a thin layer of leaf litter. The OWHRMP specifies that oak acorns shall be planted each year for the first 5 years of the long-term maintenance period. Therefore, the December 2021 acorn plantings represent Public Works' voluntary efforts beyond Year 5 to provide a robust contingency of acorn seedlings to improve measured oak survival performance during the maintenance period. Based on similar acorn planting events in prior years of the maintenance period, it is anticipated that at least one acorn will germinate at each location. The acorns are expected to establish on rainfall amounts only—no irrigation will be applied to the acorn planting sites.

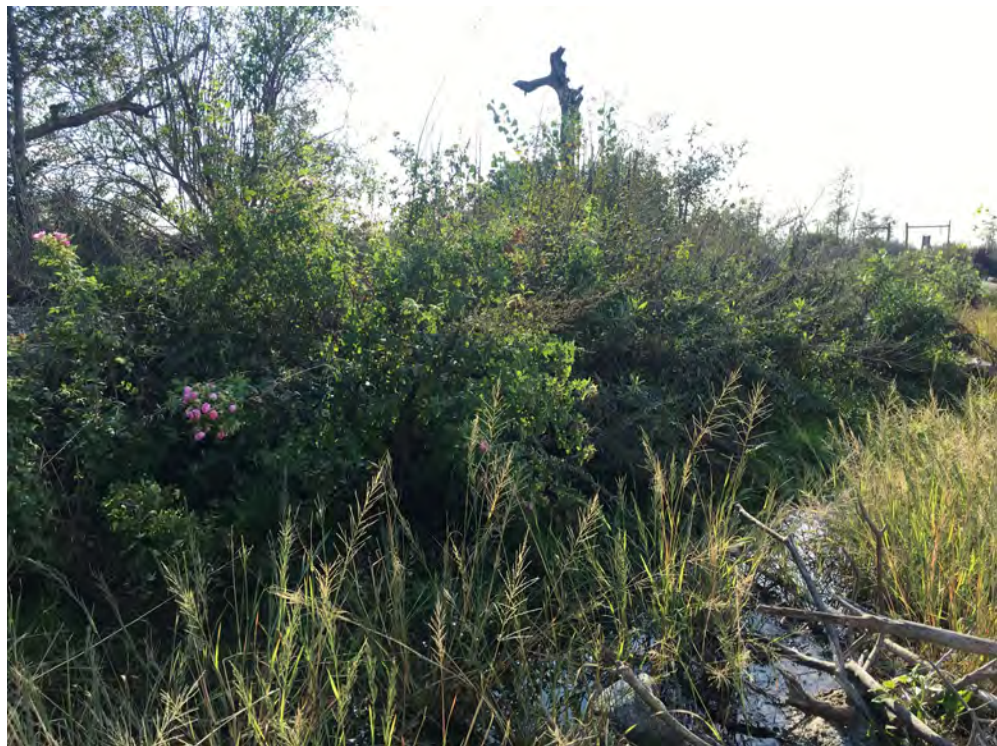
**December 2021.** View of high quality planted/seeded native cover along one of the spiraling drainages (designed by Los Angeles County Public Works) on the deck of the Lower Sediment Placement Site.

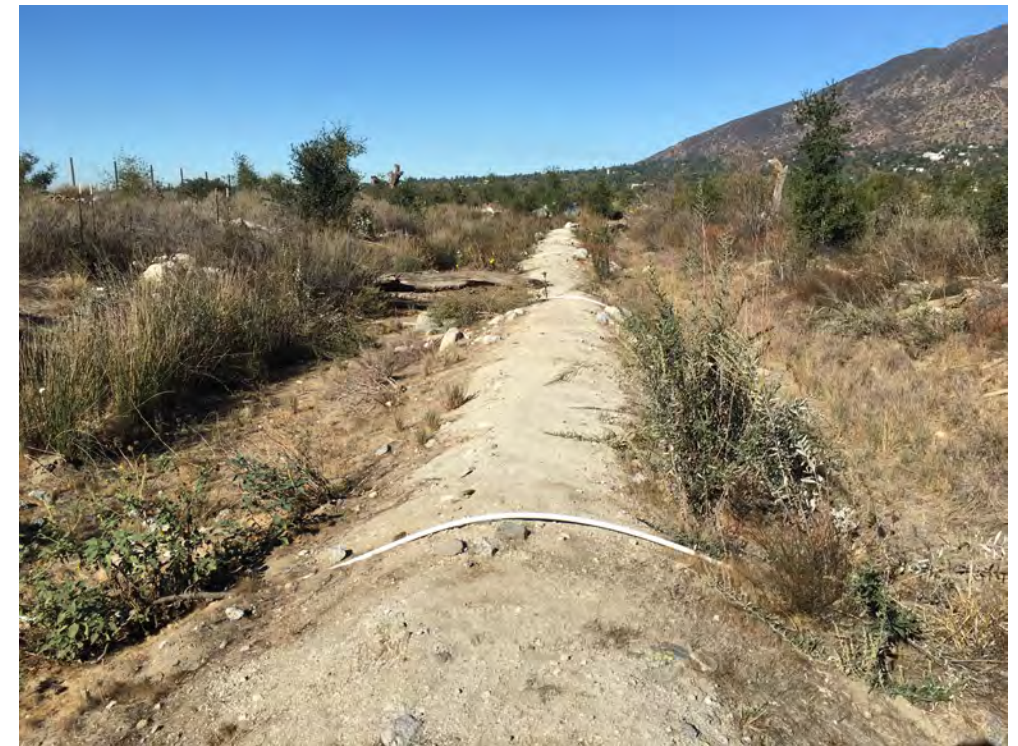
**October 2021.** View of a portion of the Lower SPS drainage areas under acute drought conditions. A supplemental seed mix was applied to portions of the drainage slopes in December 2021 to improve native vegetation cover and diversity.

Psomas' Biological Monitor hand broadcasted the seed in various combinations/mixes in December 2021, shortly before a significant rain event. Psomas' Biologists, along with Nakae personnel, scratched the seed approximately 1/4-inch into the soil surface using heavy metal bow rakes. A portion of the seed species was combined into an herbaceous understory mix for application within (1) the designated herbaceous understory portions of the oak woodland mitigation site (which are maintained to be free of woody shrubs), and (2) patches of cactus and yucca within the Coastal Sage Scrub (CSS) mitigation site. A total of 130 locations were reseeded with the herbaceous understory mix, and a red wire flag was placed in the approximate center of each seeded patch for reference during subsequent weeding activities. The locations of the 130 seeding patches are shown on Exhibit 3. A xeric shrub/herbaceous seed mix was also applied to numerous lower cover patches within the CSS mitigation site (slopes) and portions of the Buffer Area 1 slope (where the straw wattles were installed); however, these seeding areas were not flagged. A transitional seed mix was applied to the upper slopes of the ephemeral drainages. Seed of chaparral yucca (*Hesperoyucca whipplei*) was also sown in areas of the mitigation site that contained

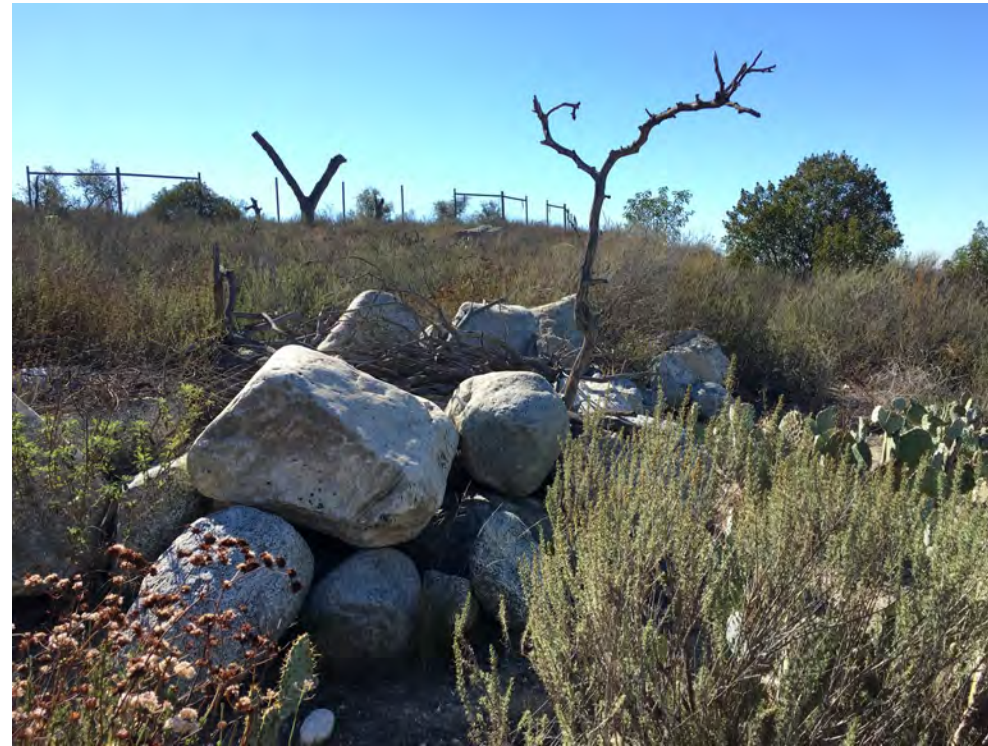
**November 2021.** Psomas' Biological Monitor continues to place upright woody debris amongst the placed boulder assemblages to provide important perching opportunities for birds and other wildlife species.

Various habitat enhancements that were incorporated into the mitigation site's design (e.g., natural snags, coarse woody debris, brush piles, boulder assemblages) provide valuable cover for wildlife species and habitat niches for the establishment of a variety of plant species (e.g., ferns). The Psomas team installs various smaller branches amongst the placed boulders on the site on an ongoing basis to provide additional perches for wildlife.

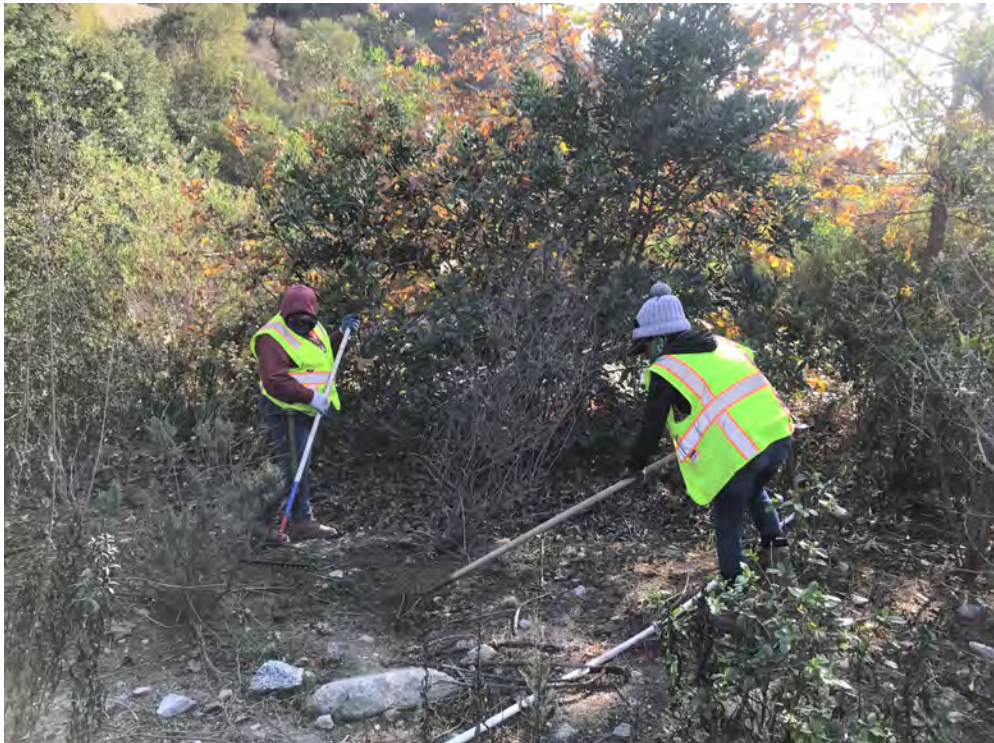
**December 2021.** Psomas' subcontractor Nakae & Associates (Nakae) is using heavy metal bow rakes to vigorously scratch the native herbaceous seed mix onto a patch with lower vegetation cover on the oak woodland mitigation site.

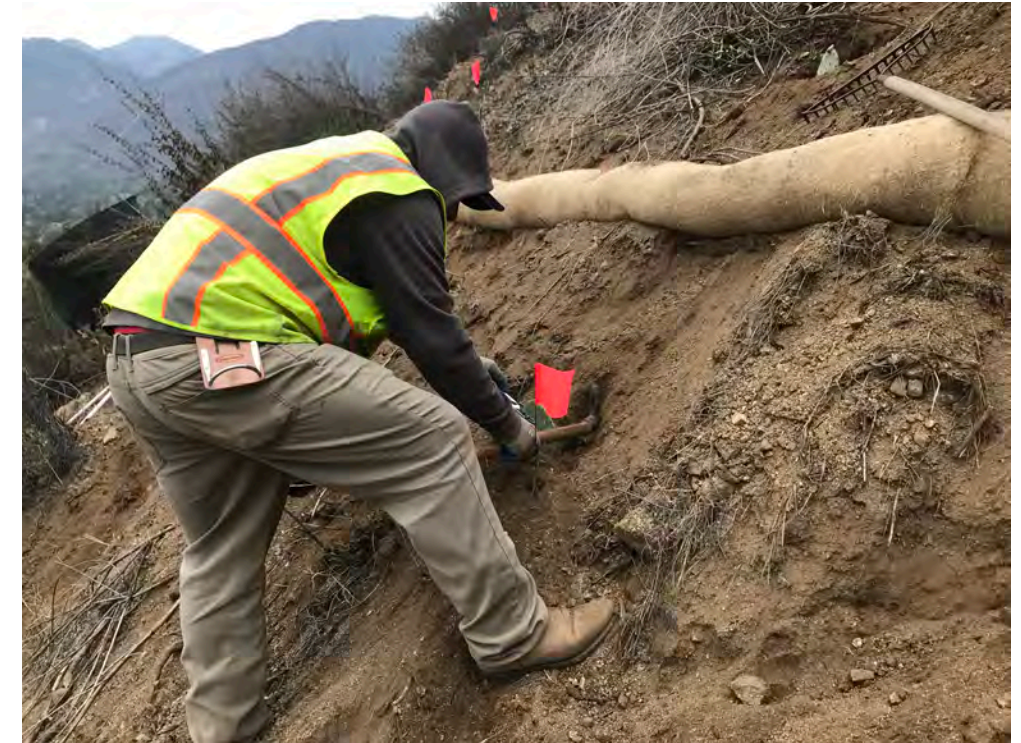
**December 2021.** View of Nakae staff planting cuttings of native Vasey's prickly-pear (cactus) onto the eastern non-mitigation slope in "Buffer Area 1". Native seed was also applied to the cactus planting areas.

Psomas' Restoration Ecologist collected a total of 76 cuttings of Vasey's prickly-pear (*Opuntia vaseyi*) (cactus) from the Santa Anita Middle SPS in November 2021. Following a period of scabbing-off in shaded storage, the pads were planted by Nakae on the eastern slope (Buffer Area 1) prior to the onset of substantial seasonal rains in December 2021. The Biological Monitor placed colored wire flags to mark the planting locations of the cactus cuttings, which will be non-irrigated and expected to establish on rainfall amounts only. As they develop roots, the planted cactus pads will enhance soil stability on these steeper slopes that are currently poorly vegetated.
