CONSOLIDATED SEWER MAINTENANCE DISTRICT CONDITION ASSESSMENT PROGRAM REPORT PROJECT Y0TV0506D

**CONDITION ASSESSMENT REPORT
COUNTY OF LOS ANGELES DEPARTMENT OF PUBLIC WORKS
CONSOLIDATED SEWER MAINTENANCE DISTRICT**

PROJECT NAME:	Y0TV0506D	PROJECT MGR:	Kari Eskridge
PROJECT DATE:	4/17/06-8/14/06	CONTACT NO:	(626) 300-3390
SUP. DISTRICT(s):	5	MAP PAGE(S):	2166, 2212
Report By:	Colin McCarter	Report Date:	01/09/09

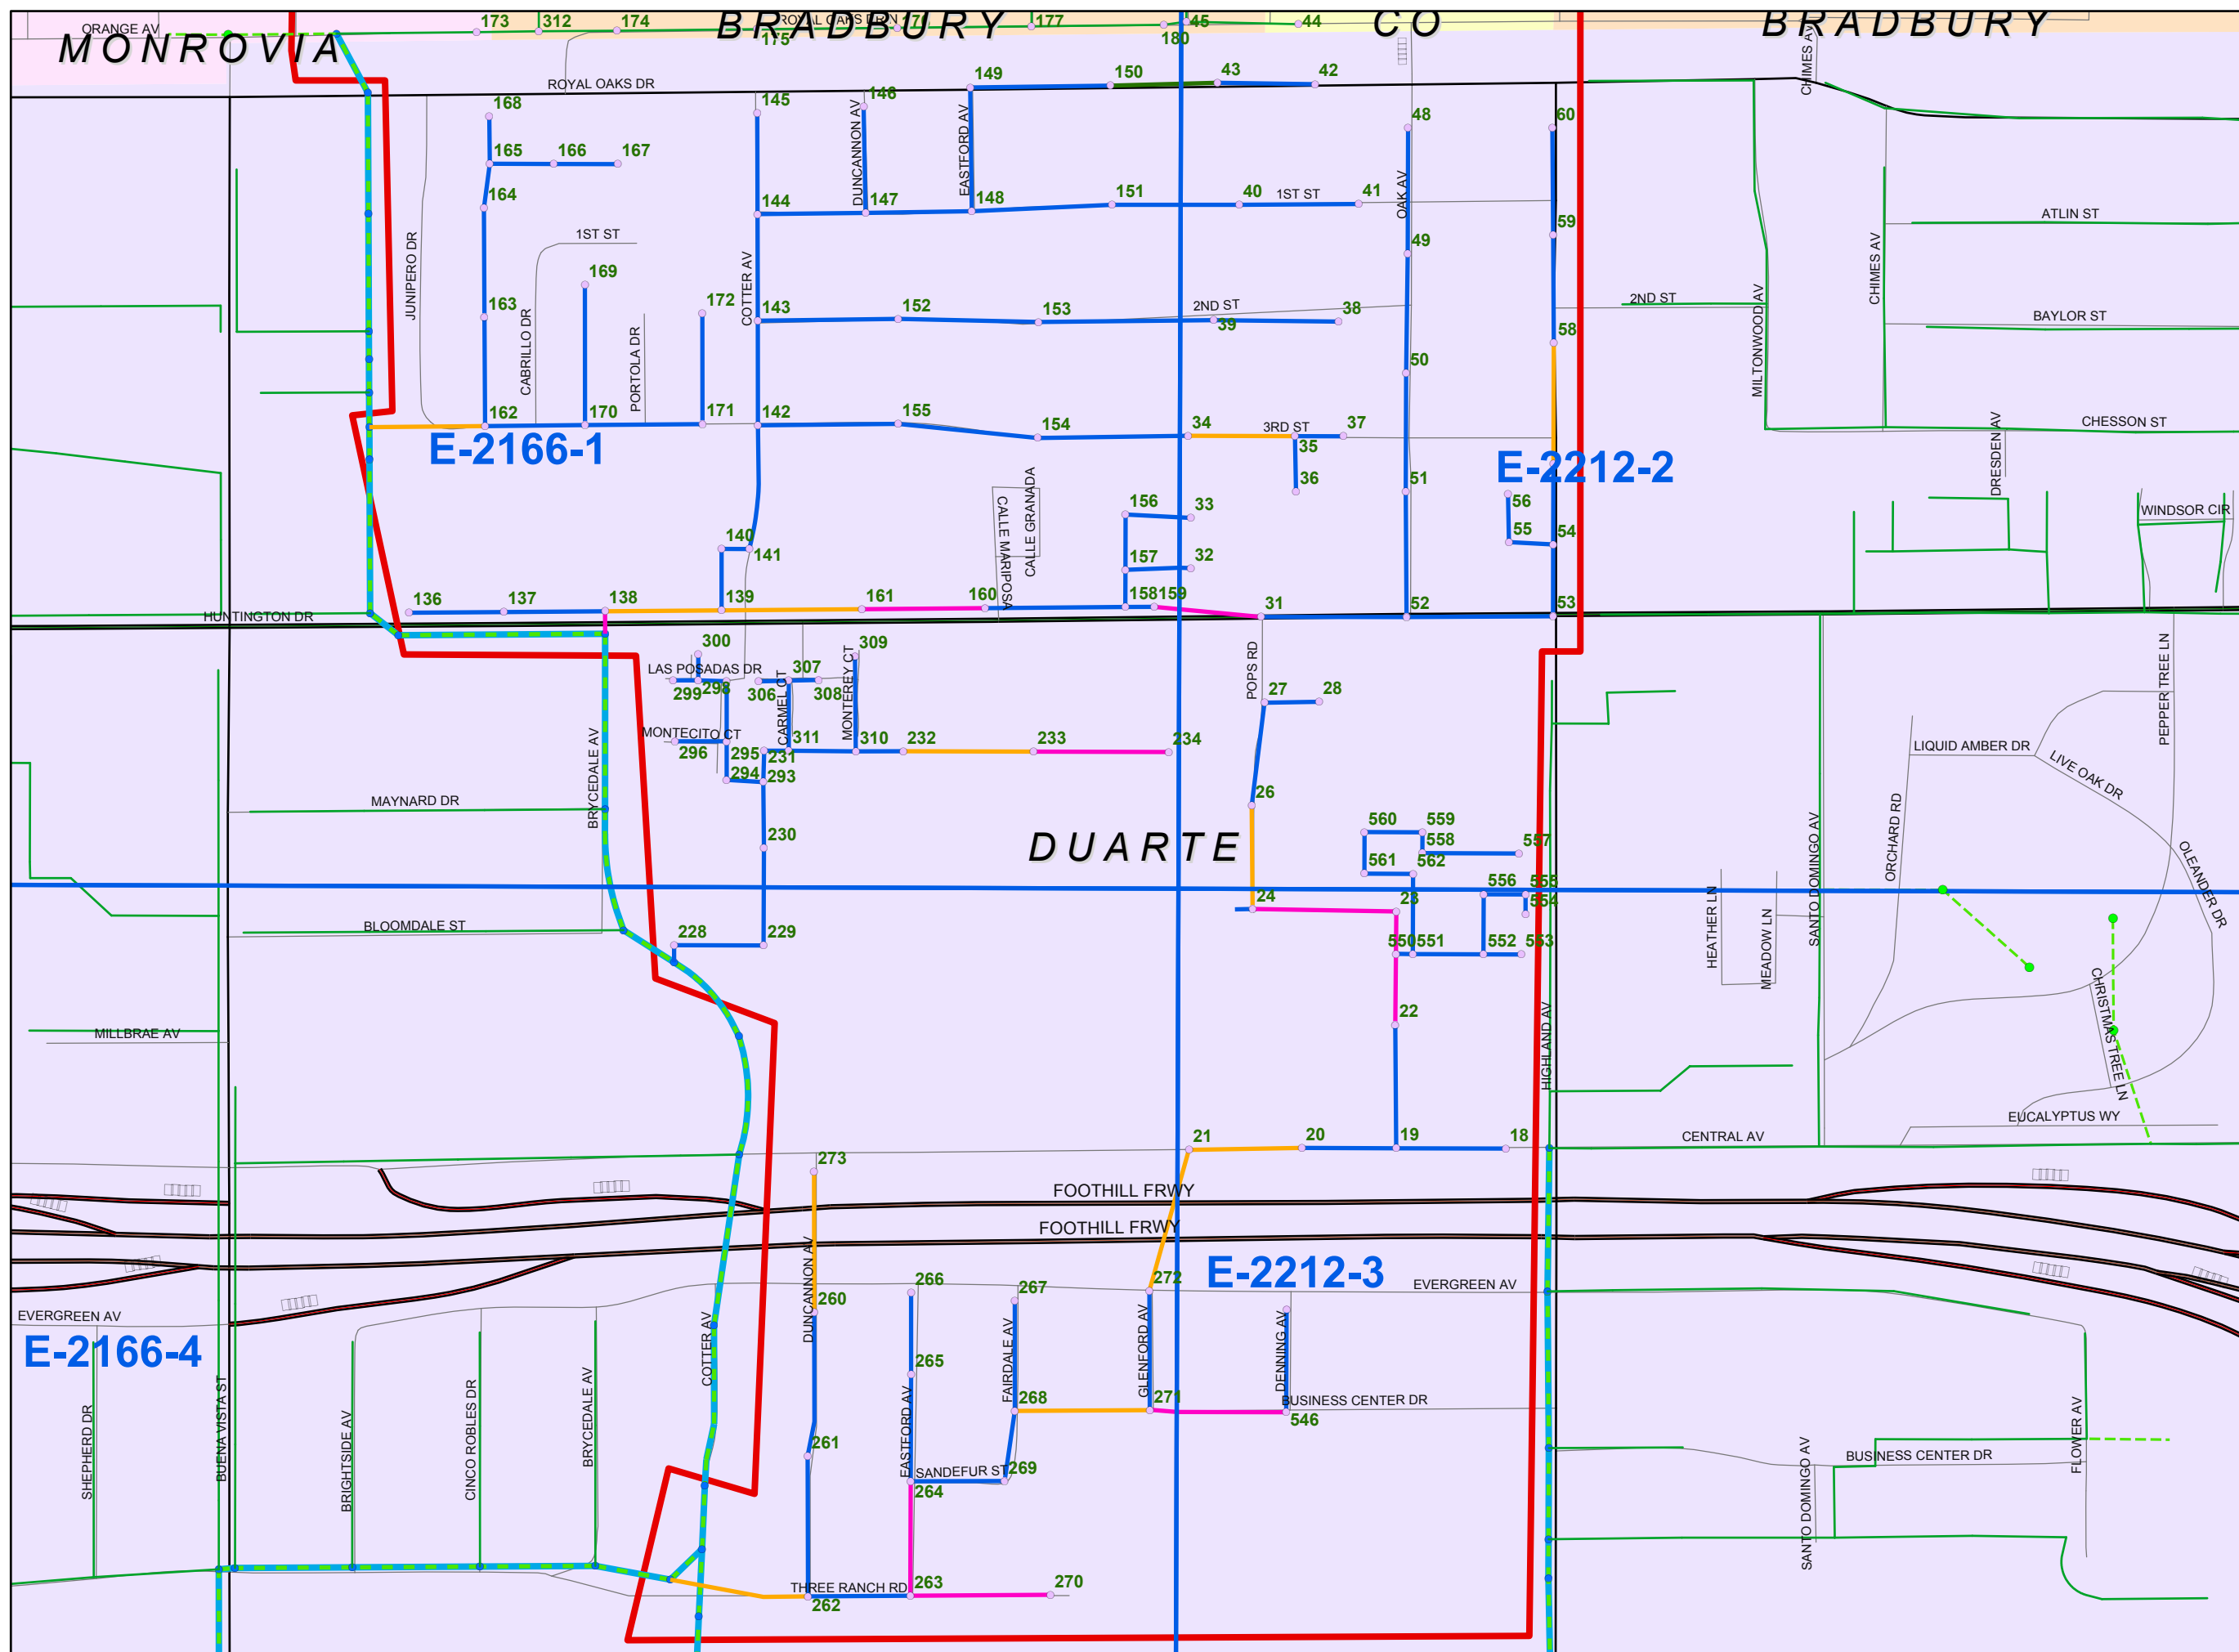
ENCLOSURE 2

Our inspection revealed that approximately 90.5 percent of the system televised was free of blockages or restrictions that would impede sewer flows. However, the remaining 9.5 percent of the inspected pipe segments within the City of Duarte area had a PACP maintenance grade of 4 as indicated in the Quick Maintenance Rating Table shown below. These segments have been incorporated into our routine cleaning schedule with corrective action taken as noted on the Quick Maintenance Rating Report Priority List (Enclosure 2). Also included is a color-coded map showing the quick maintenance rating for each pipe segment.

Item No.	QMR	Start MH	End MH	Street	Observation	Corrective Action Taken
1	4231	2166-0263	2166-0270	THREE RANCH RD	Roots	Hydrojet (Last Serviced: 7/08/08)
2	4231	2166-0138	2166-TRNK	HUNTINGTON DR	Sag in Pipe	Rodder (Last Serviced: 7/25/08)
3	422D	2212-0023	2212-0024	POPS RD R/W	Roots	Rodder (Last Serviced: 7/29/08)
4	4223	2212-0031	2166-0159	HUNTINGTON DR	Roots	Hydrojet (Last Serviced: 1/30/08)
5	4222	2212-0550	2212-0022	POPS RD R/W	Camera underwater	Rodder (Last Serviced: 7/29/08)
6	4221	2212-0546	2166-0271	BUSINESS CENTER DR	Root ball from lateral	Laterals are the responsibility of the property owner.
7	4133	2166-0160	2166-0161	HUNTINGTON DR	Roots	Rodder (Last Serviced: 7/25/08)
8	4121	2212-0023	2212-0550	POPS RD R/W	Roots	Rodder (Last Serviced: 7/08/08)
9	4121	2166-0233	2166-0234	DUARTE PARK R/W	Roots	Rodder (Last Serviced: 7/29/08)
10	4121	2166-0264	2166-0263	EASTFORD AV	Root ball from lateral	Laterals are the responsibility of the property owner.

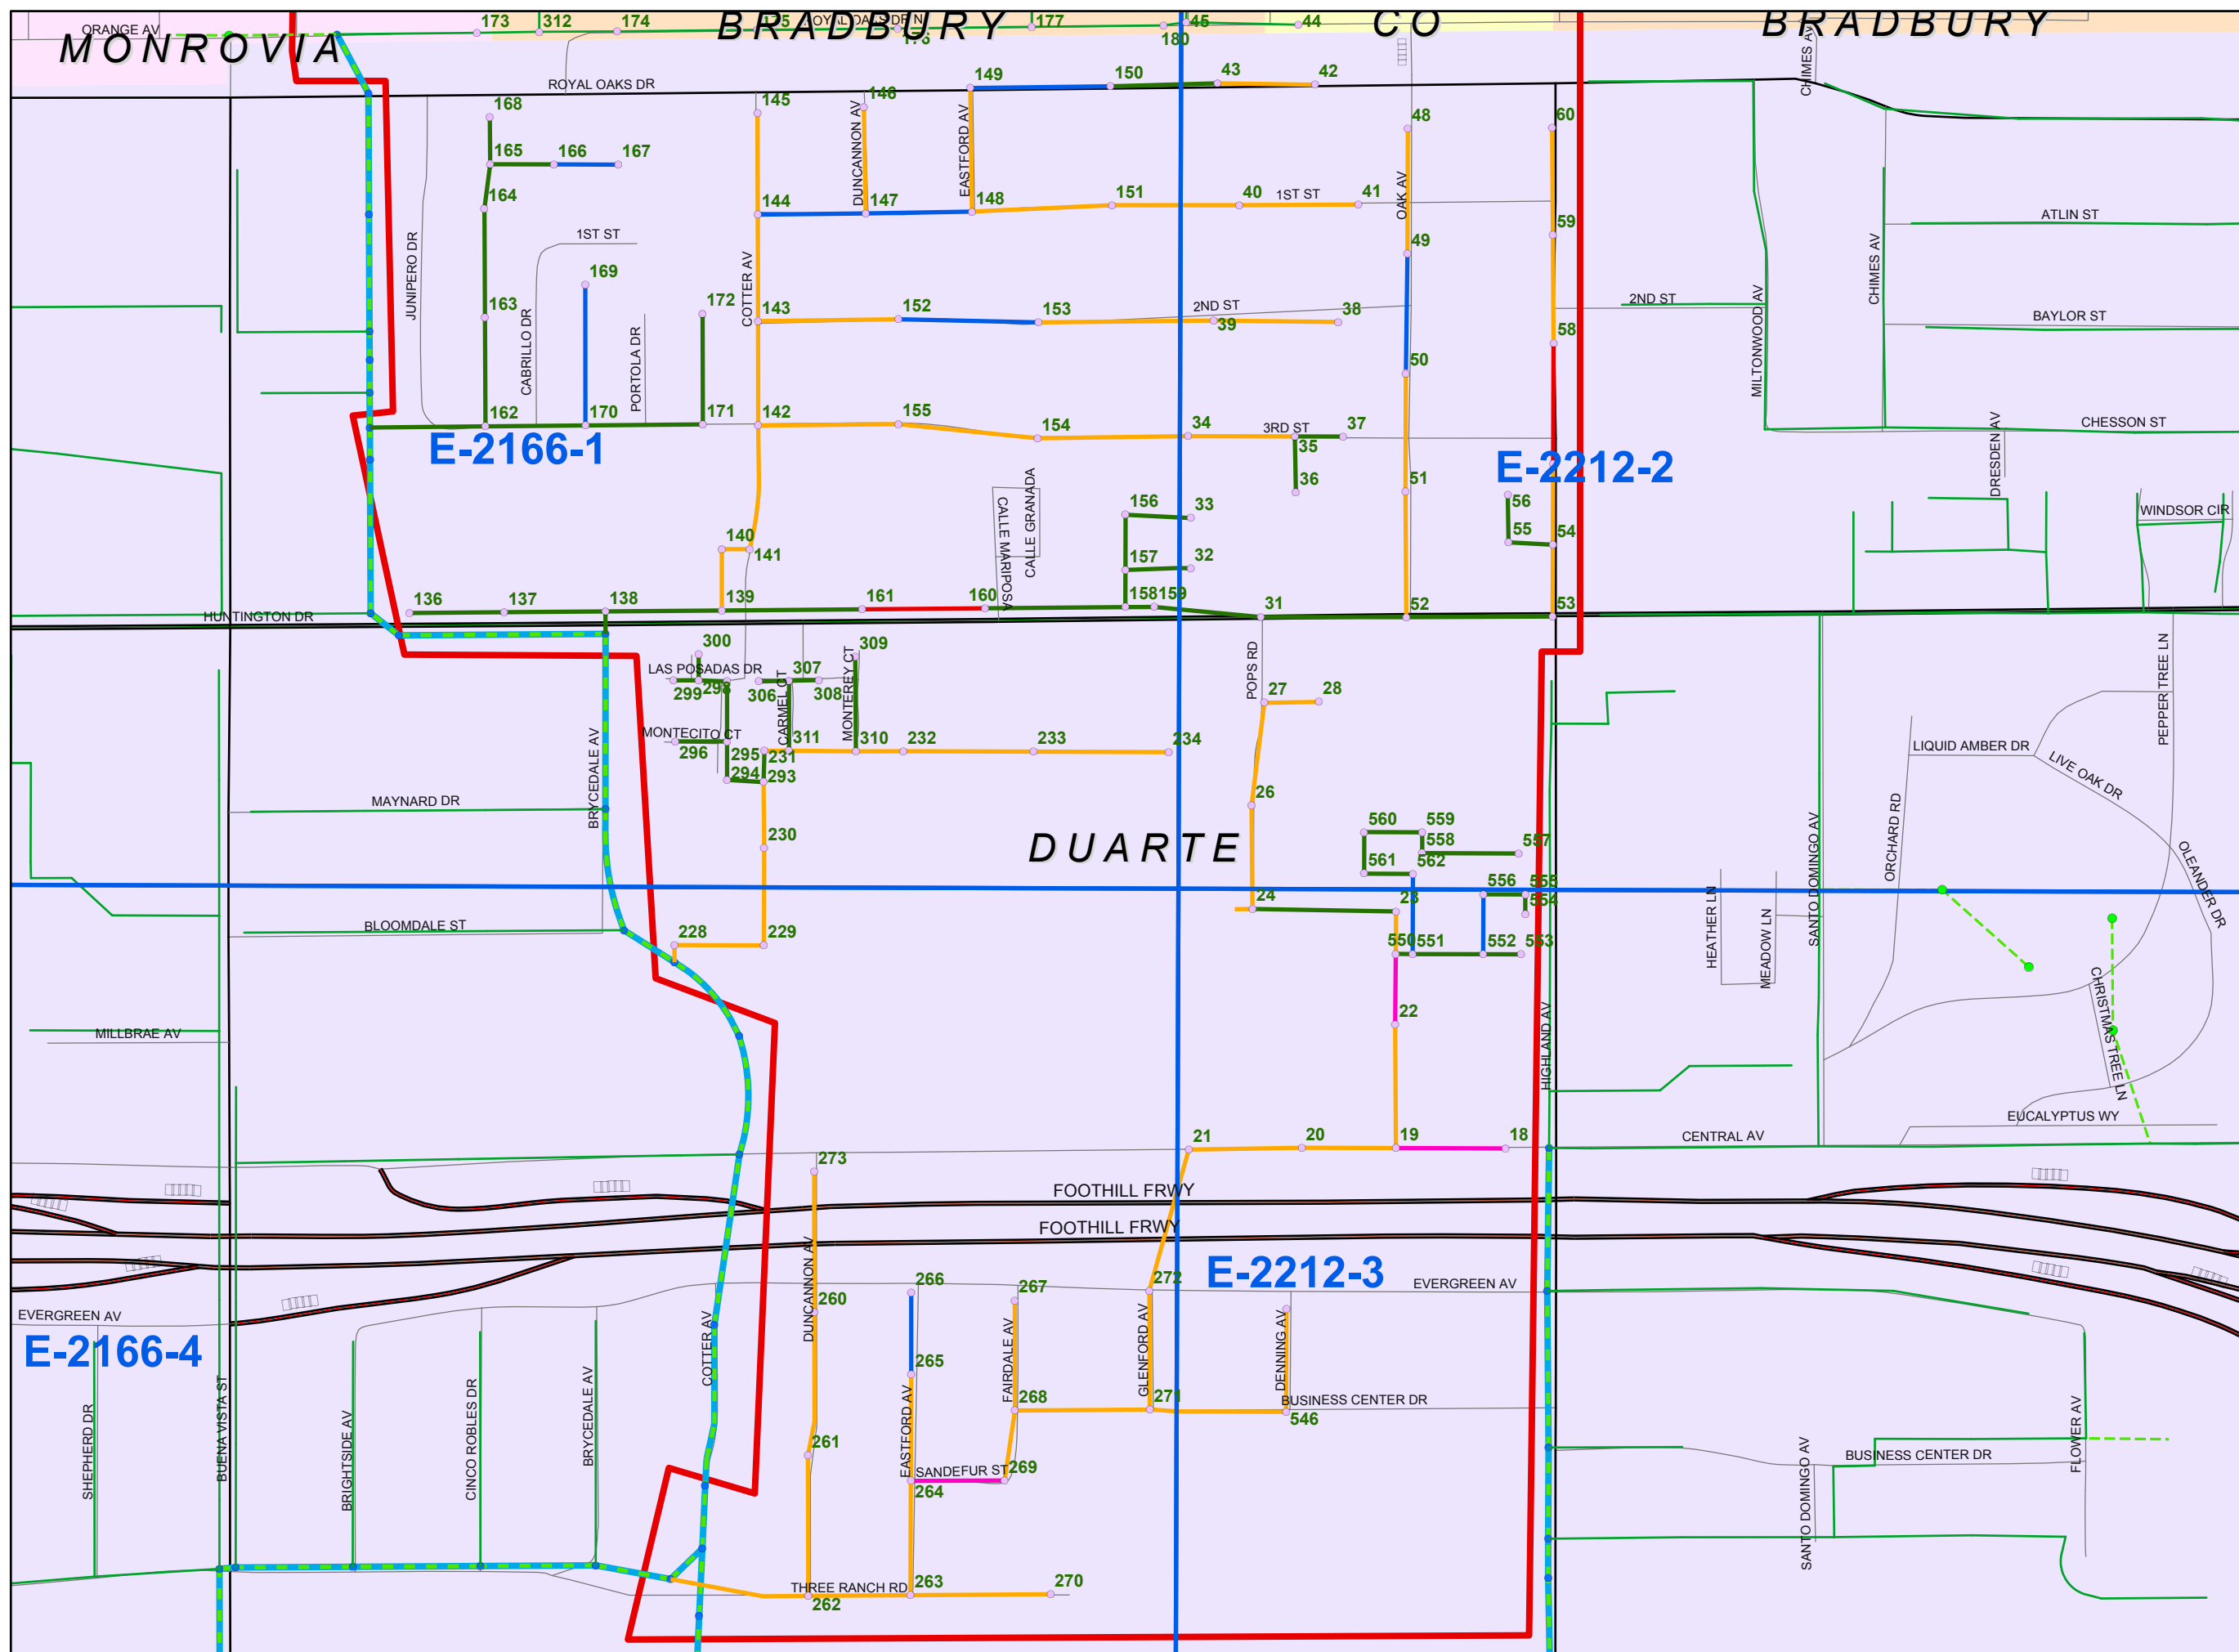
ENCLOSURE 3

Our inspection revealed that approximately 95.3 percent of the inspected pipe segments within the City of Duarte were free of severe structural defects. However, the remaining 4.7 percent of the inspected pipe segments had a PACP structural grade of 4 or 5 as indicated in the Quick Structural Rating Table shown below. These segments have been placed on a priority list based on the severity and the need for action. For Items 1 through 5 in the Quick Structural Rating Report Priority List (Enclosure 3) which require a corrective action, the proposed corrective method will be scheduled in the next 24 months as part of the ongoing Accumulative Capital Outlay Project. A color-coded map showing the Quick Structural Rating for each pipe segment is located in Enclosure 3. Copies of the actual inspection reports for these five segments are included in Enclosure 4.

Item No.	QSR	Start MH	End MH	Street	Observation: Location	Proposed Corrective Method	Length of Repair (FT)
1	5135	2212-0058	2212-0057	HIGHLAND AV	Broken at joint with gasket visible: 180'	Structural integrity in tact. No action needed.	-
2	5100	2166-0160	2166-0161	HUNTINGTON DR	Broken with soil visible: 101'	Structural integrity in tact. No action needed.	-
3	4137	2212-0550	2212-0022	POPS RD R/W	Joint offset: 128'; multiple fractures and cracks	Point repair at 128'; Lining: MH to MH after point repair	183
4	4133	2166-0269	2166-0264	SANDEFUR ST	Hole: 223'	Structural integrity in tact. No action needed.	-
5	4122	2212-0019	2212-0018	CENTRAL AV	Broken: 38'	Lining: MH to MH	274
